REDWOOD CREEK LEVEE GEOTECHNICAL EVALUATION PROJECT ORICK, HUMBOLDT COUNTY, CALIFORNIA

June 2011
Fugro Project No. 04.B3502002
CGI Project No. 10-1949.01

Subject: Geotechnical Report, Redwood Creek Levee Geotechnical Evaluation Project, Orick, Humboldt County, California

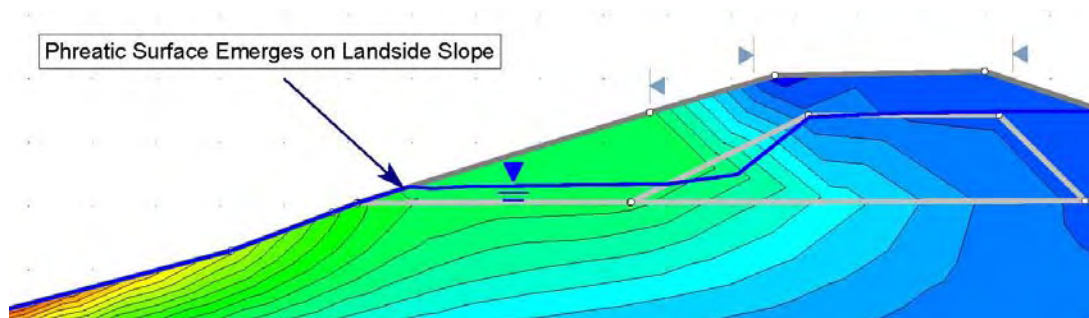
The potential for through-seepage was estimated at each section by reviewing the seepage analyses output to determine if the phreatic surface emerges on the landside slope during the design flood event. As noted in USACE (2000), seepage exiting on the landside slope could potentially decrease the stability of the slope as a result of sloughing or internal erosion of the slope. An example of output illustrating through-seepage is presented below.
