GEOTECHNICAL REPORT

JACOBS AVENUE LEVEE EVALUATION PROJECT

CITY OF EUREKA, CALIFORNIA

July 25, 2016
CGI: 15-1949.03

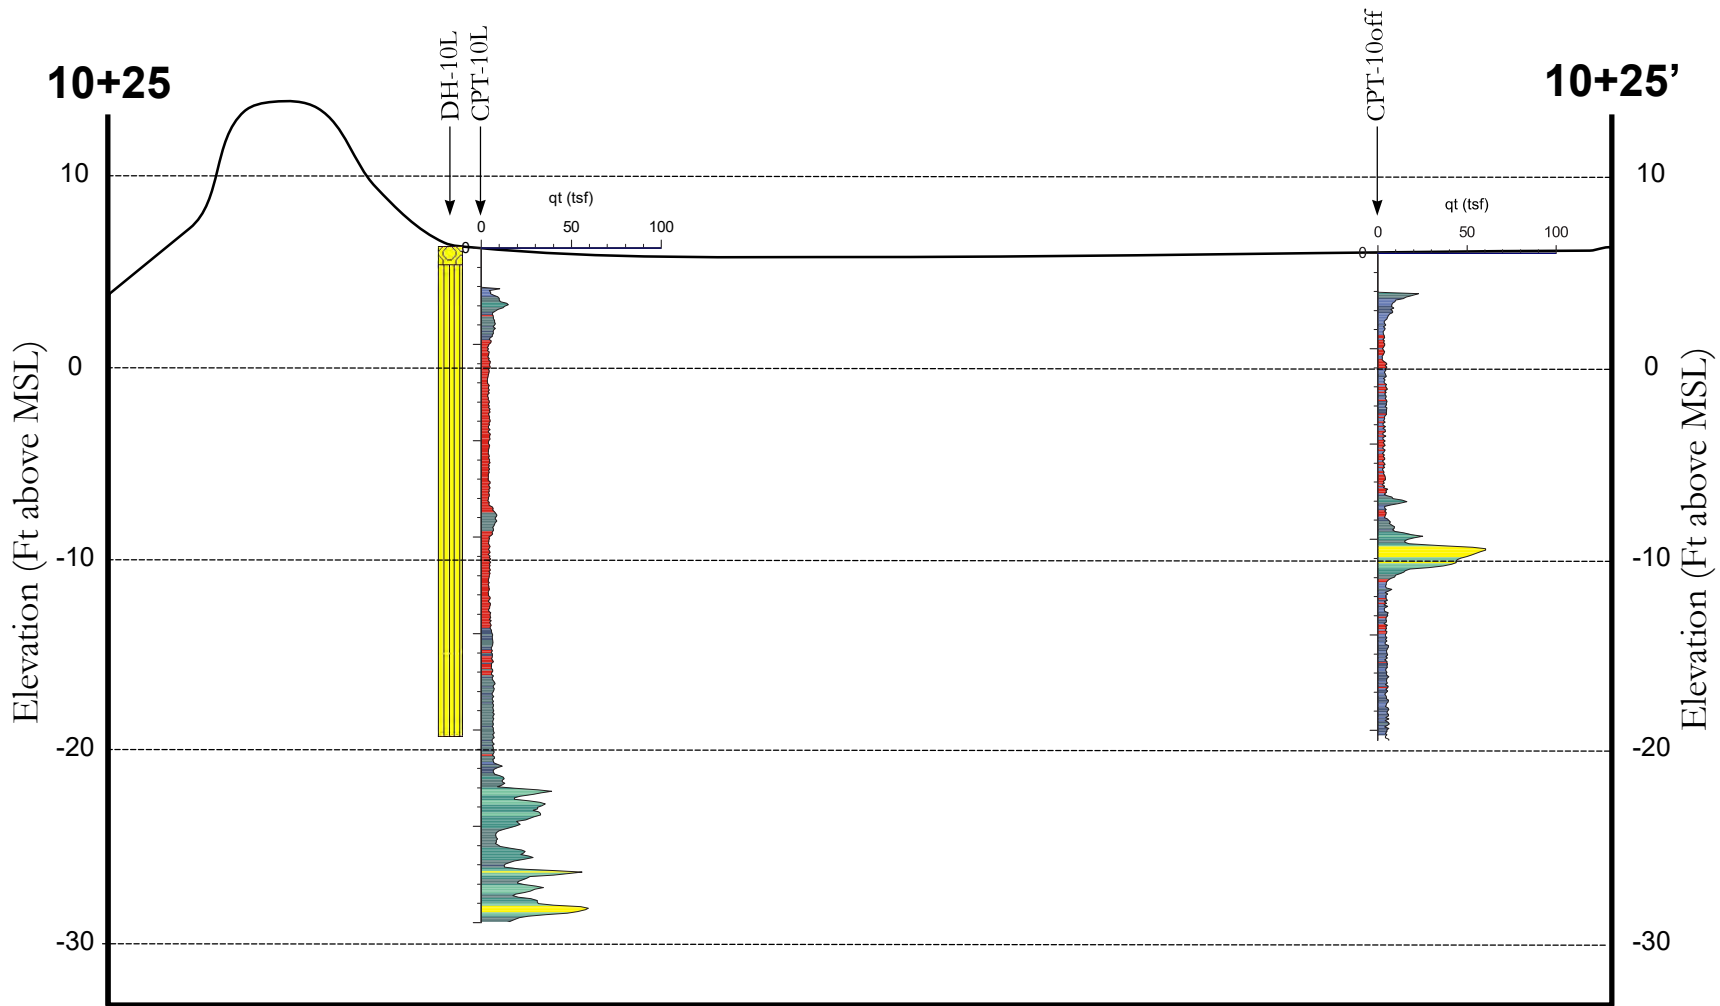
Levee Embankment Materials. Levee embankment thicknesses appear to range from about less than 3 feet to up to about 9 feet, as estimated from cross sections presented on Plates 4.1 through 4.5. A total of 3 explorations, consisting of rotary-wash drill holes (1) and CPT soundings (2), were advanced through the levee embankment materials to sample and characterize selected geotechnical conditions within the embankments.

Impervious Foundation Blanket Materials. Fine-grained materials consisting of sandy silt to clayey silt are present beneath the levee embankment soils. These soils vary in thickness from 5 to 17 feet. As shown on Plates 4.1 through 4.5, impervious materials were encountered on both the landside and waterside of the levee at each location explored.

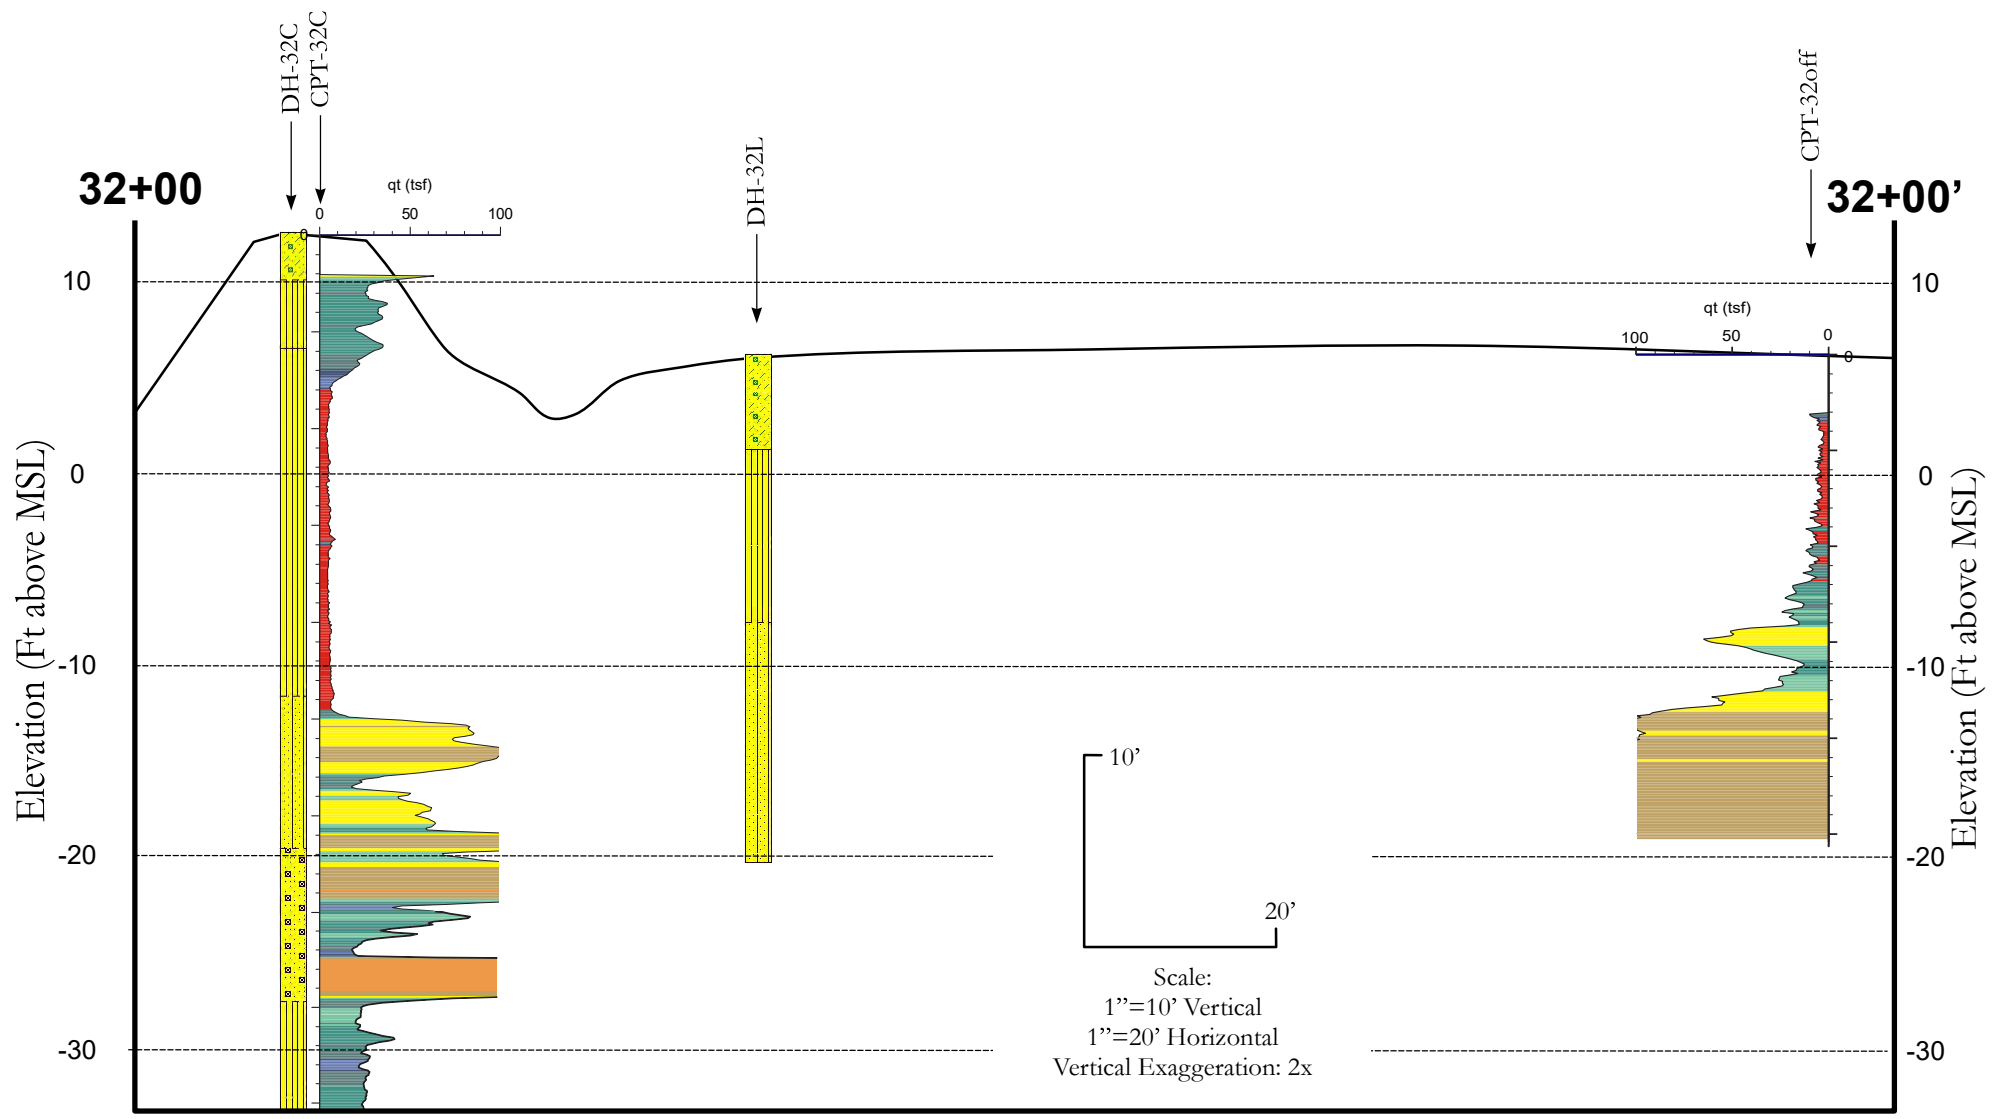
Plate
4.3

CROSS SECTION 32+00
 JACOBS AVENUE LEVEE EVALUATION PROJECT
 HUMBOLDT COUNTY PUBLIC WORKS DEPARTMENT
 CITY OF EUREKA, CALIFORNIA
