## Jacobs Avenue Levee: Preliminary Needs Assessment

March 1, 2021

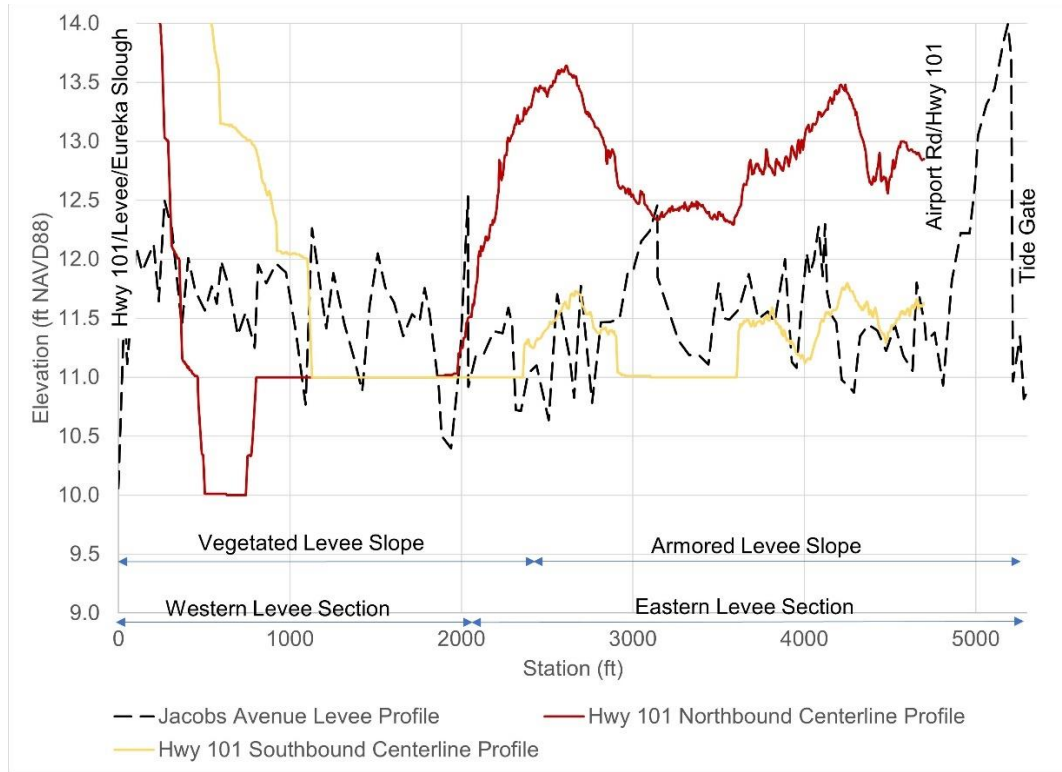
**Figure 2. Profile of Jacobs Avenue Levee Crest**

As previously shown in Figure 2, overtopping of the levee initiates at a tidal water level of approximately 10 feet, near the intersection of the levee with the Highway 101 road prism. Approximately 100 feet of levee is overtopped between tidal water levels 10 to 10.6 feet. Above water levels of 10.6 feet, the extent of overtopping rapidly increases, with more than half of the levee system overtopped at a water level of 11.6 feet. Failure of the levee due to significant erosion of the levee crest and landward slope is expected to occur when overtopping depth exceeds 1-foot for a duration exceeding 2 hours (USBR & USACE, 2019). These levee failure conditions are met at three locations on the levee when tidal water levels reach between 11.6 and 12.6 feet. While many factors can contribute to the rate of erosion as water crests over a levee, 1-foot depth criteria provides a planning-level threshold, as levees are typically designed to not be overtopped. Furthermore, FEMA/USACE criteria require the levee crest elevation be a minimum of 2-feet above the design water elevation, typically the 100-year event.

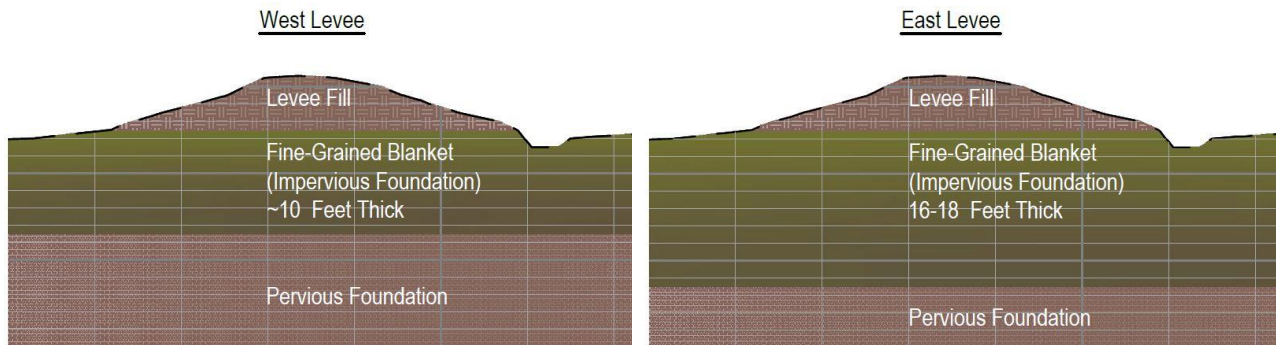
information. Initial analysis has determined that the eastern portion of the levee is generally in better condition relative to the western portion, largely due to a thinner fine-grained blanket layer underlying the western 2,000 feet of levee (Figure 3).

**Figure 3. Typical cross-sections of the west and east levee segments facing south with Eureka Slough on left of each cross-section. A thinner fine-grained blanket layer underlays the western 2,000 feet of levee (CGI 2016).**

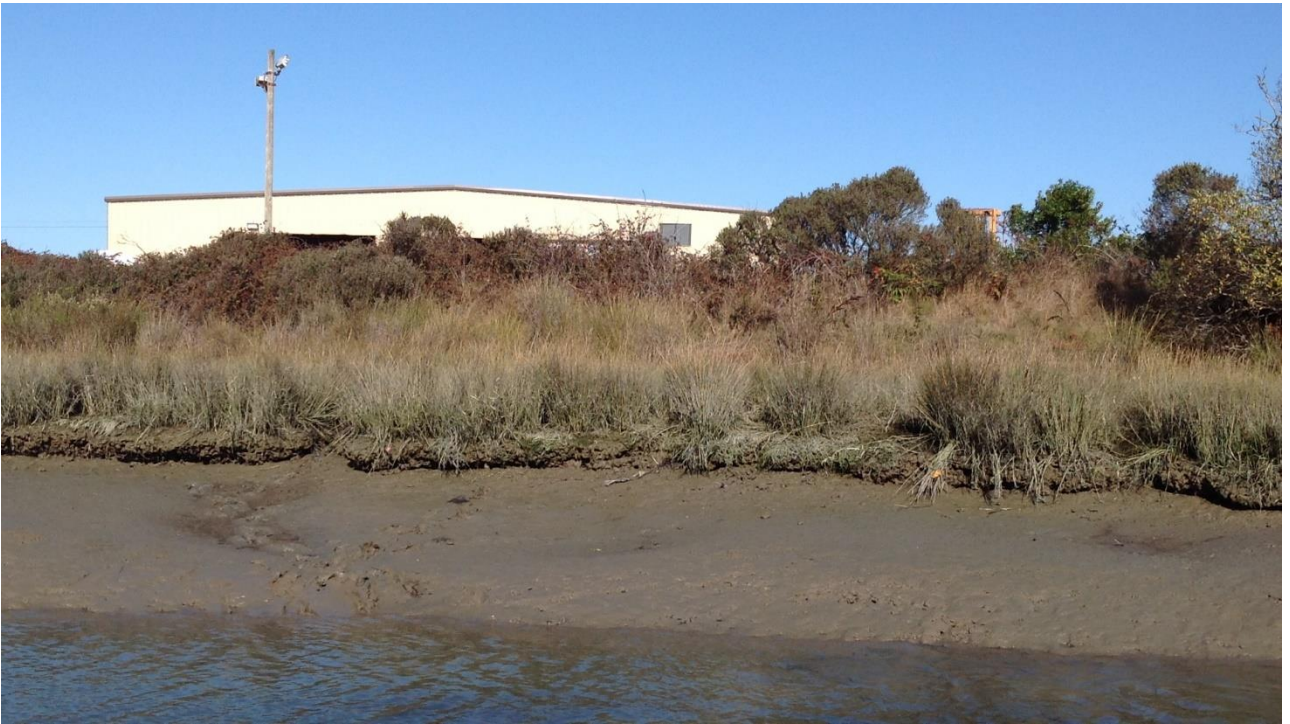
Nearly all of the western levee section is unarmored and vegetated with limited, localized areas of observable erosion (Figure 4). The western levee is located along an inside bend of Eureka Slough, where erosional forces are typically lower. Additionally, a tidal marsh bench at approximate elevation 6-7 feet (NAVD88) with variable width fronts much of the vegetative section of the slough-side levee. Without significant changes to the geomorphic characteristics of the slough channel, increased erosion is not expected in the near term. However, increased tidal prism at this location, due to sea level rise or levee breaches, could result in increased erosion.

**Figure 4. The western levee section is vegetated, fronted by a tidal marsh bench and does not show indications of surface erosion.**

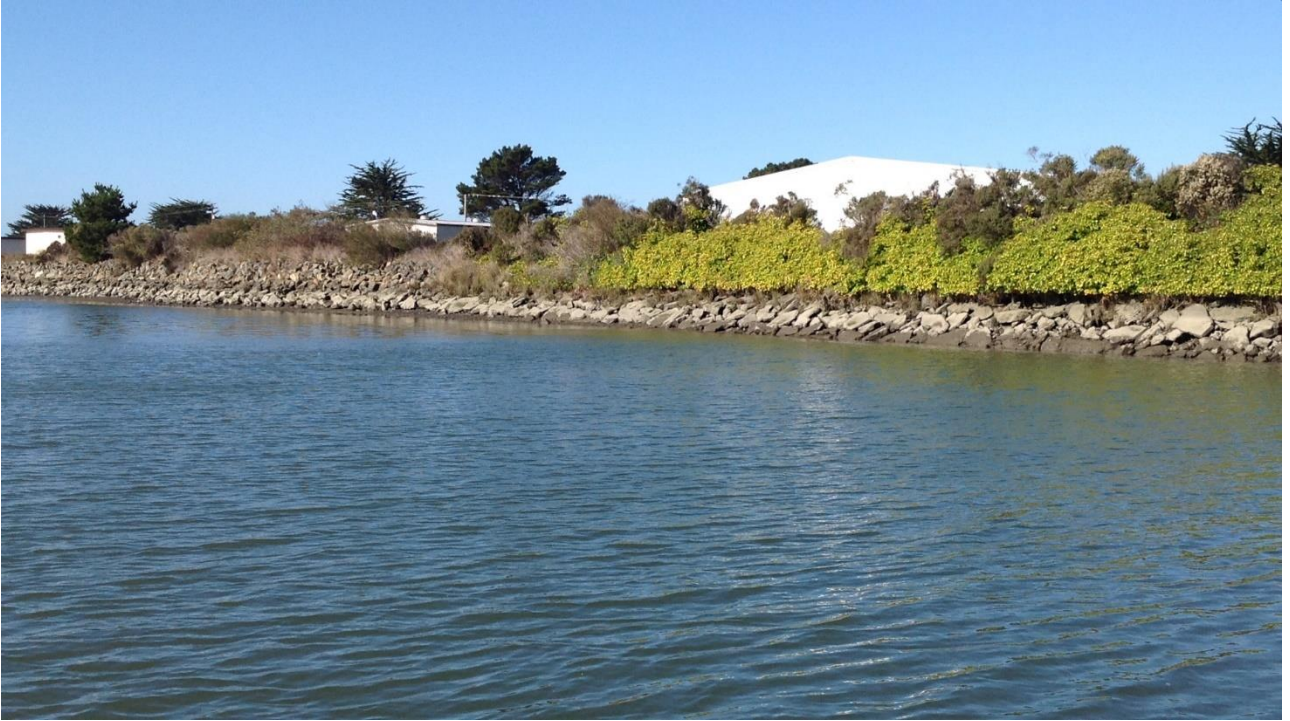
The eastern levee section is armored with rock slope protection and/or concrete rubble to resist erosion (Figure 5). These preventative measures were implemented in the 1980s and appear to be providing sufficient erosion protection.

**Figure 5. The eastern levee is armored with rock slope protection and concrete rubble.**

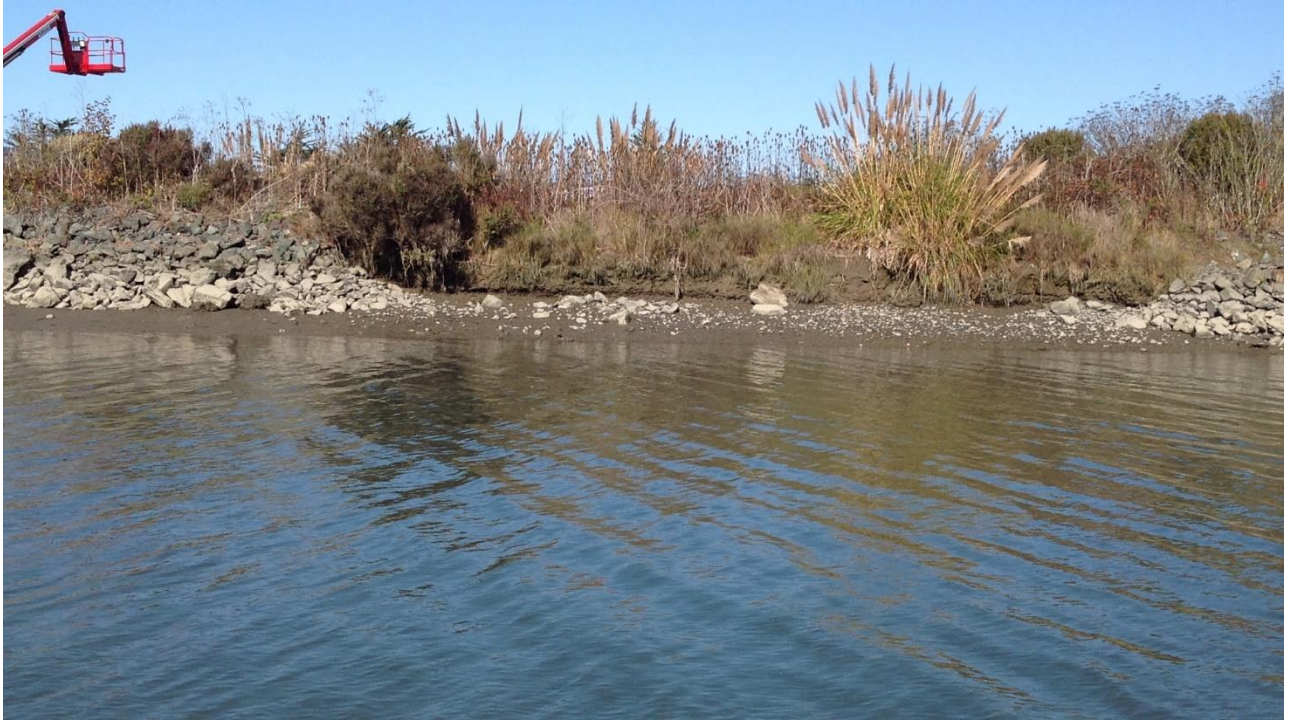
Erosion was noted in isolated, short reaches of the levee corresponding to individual property shorelines (Figure 6). The erosion is typically at the base of the slope and the upper portion of the slope is vegetated. These erosional areas are located within gaps of armoring or vegetated toes and will require future observations to assess whether erosion is active and ongoing, or if the material is consolidated and resistant to further erosion.

**Figure 6. Short Sections of Levee between Armored Sections show Indications of Erosion.**

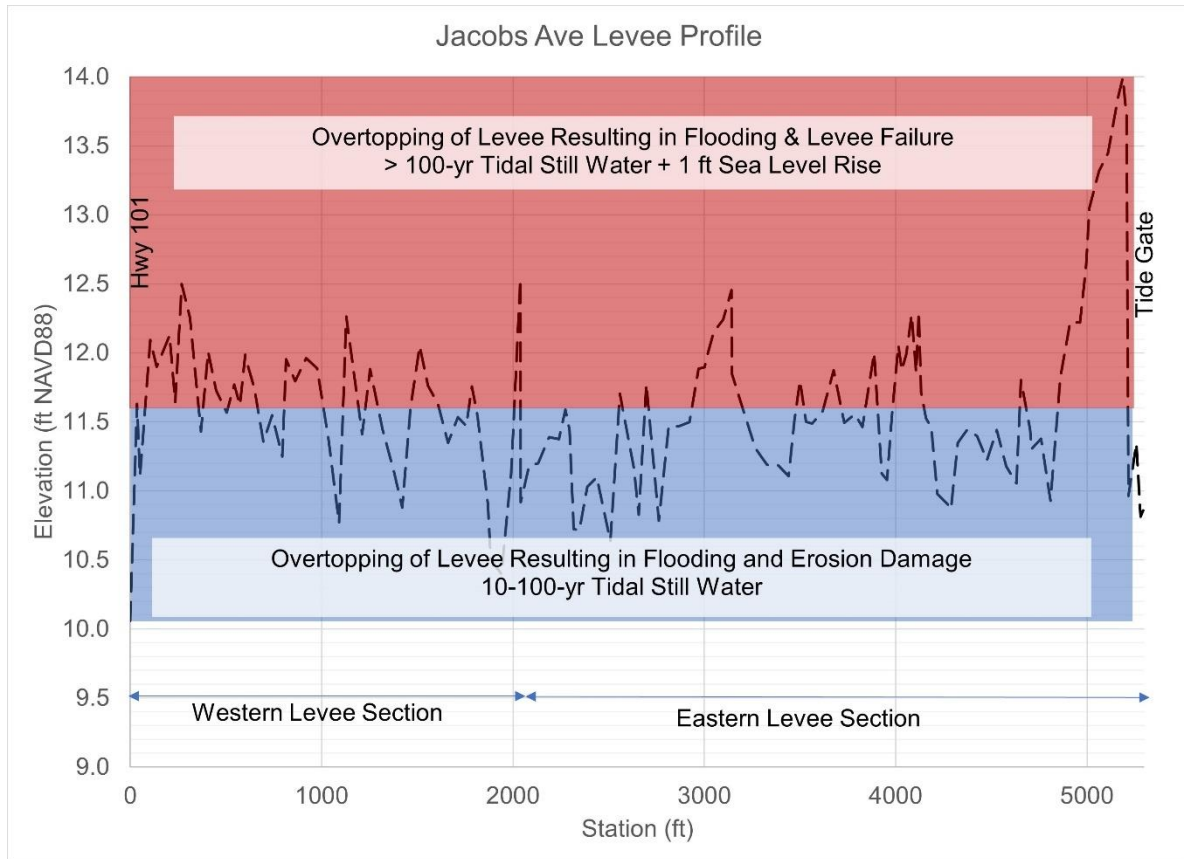
Temporary flooding of the Jacobs Avenue area from overtopping is initiated between tidal water levels between 10 to 10.6 feet, which corresponds to the 10- and 100-yr tidal still water event, resulting in flood depths up to approximately 1 foot. At a water level of 11.6 feet, flooding depth increases to 3-6 feet. Levee failure is likely to initiate when tidal water levels reach 11.6 to 12.6 feet, which corresponds to the 100-yr tidal still water event plus 1 to 2 feet of sea level rise (Figure 7). Levee failure could result in a breach allowing several feet of daily tidal flooding in the Jacobs Avenue area.

**Figure 7. Tidal Still Water Levels Above 11.6 feet result in approximately 1 foot of depth over the levee crest for > 2 hours and potential levee failure due to overtopping.**

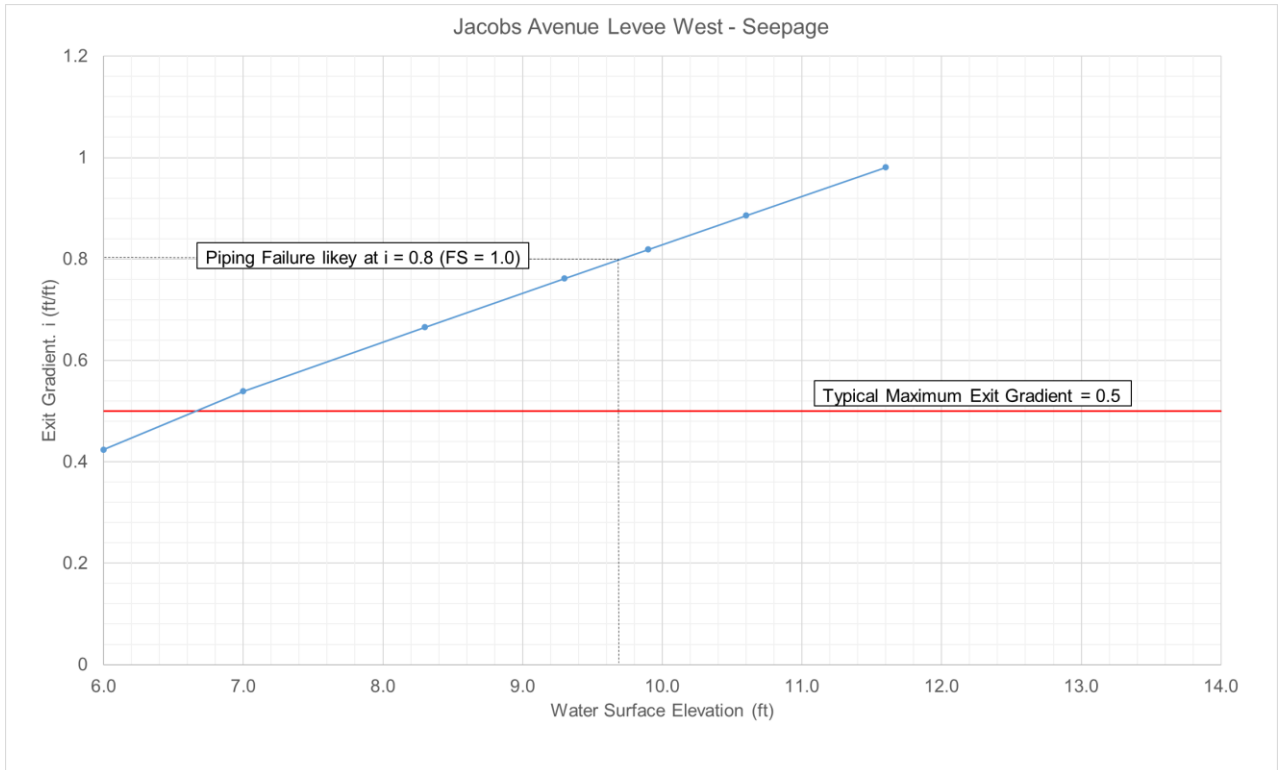
Figure 9. Seepage Analysis Results for West Levee

The results of the seepage analysis for the water surfaces analyzed for the west levee are shown on Figure 9. In steady-state conditions, FEMA/USACE criteria are not achieved along the west levee at a water level greater than 6.6 feet. Failure for seepage would be expected to occur at an exit gradient of 0.8 (equivalent to an FS of 1.0), which would be anticipated at a water level greater than 9.7 feet.

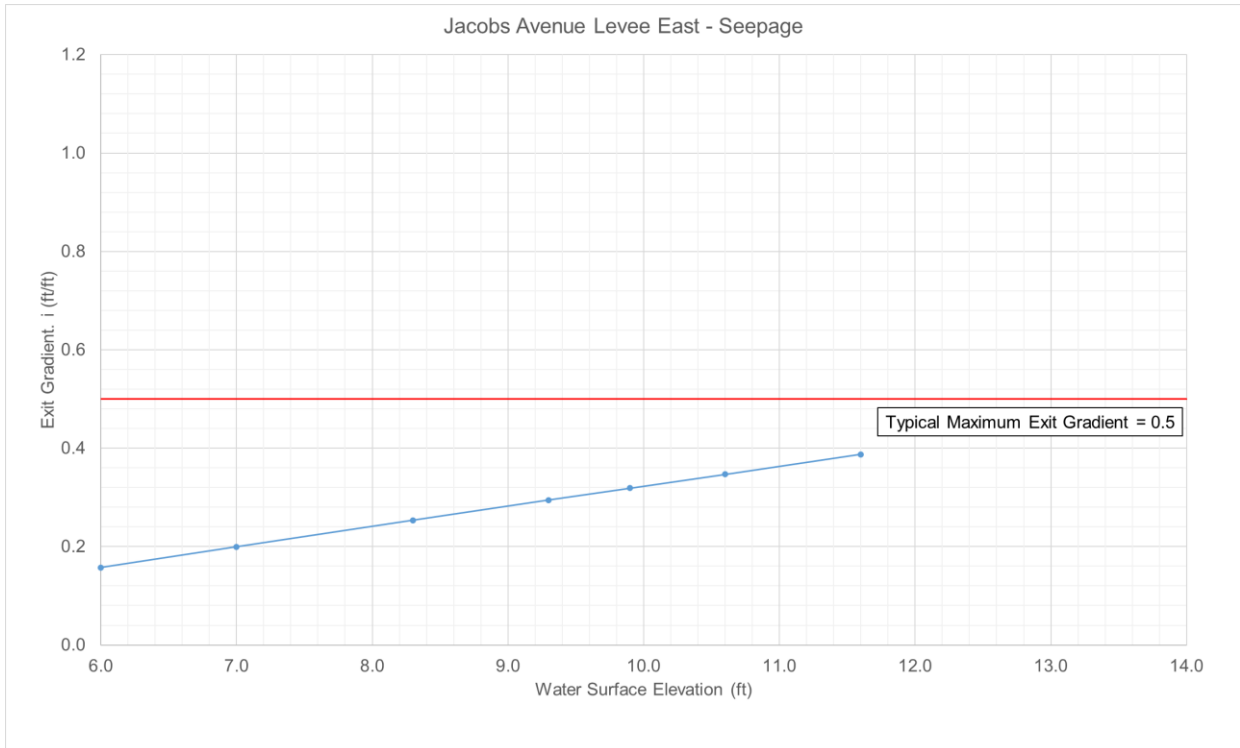
**Figure 10. Seepage Analysis Results for East Levee**

The results of the seepage analysis for the water surfaces analyzed for the east levee are shown on Figure 10. FEMA/USACE levee criteria are achieved along the east levee for all water levels analyzed. Failure due to seepage would not be anticipated along the east levee.

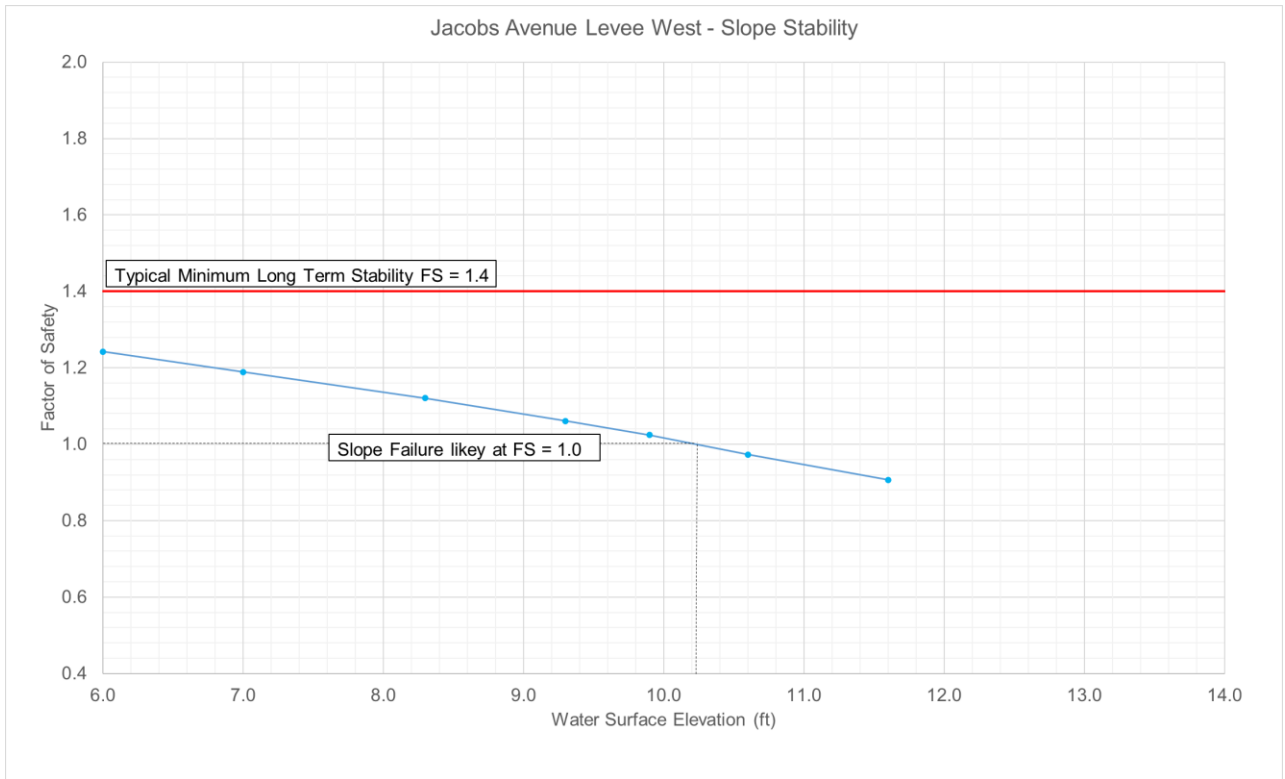
**Figure 11. Slope Stability Analysis Results for West Levee**

Stability results for the water levels analyzed are shown in Figure 11 for the west levee. The levee did not meet FEMA/USACE criteria for all water levels analyzed. Failure for stability would be expected to occur at an FS of 1.0, at an approximate saturated foundation elevation of approximately 10.2 feet.

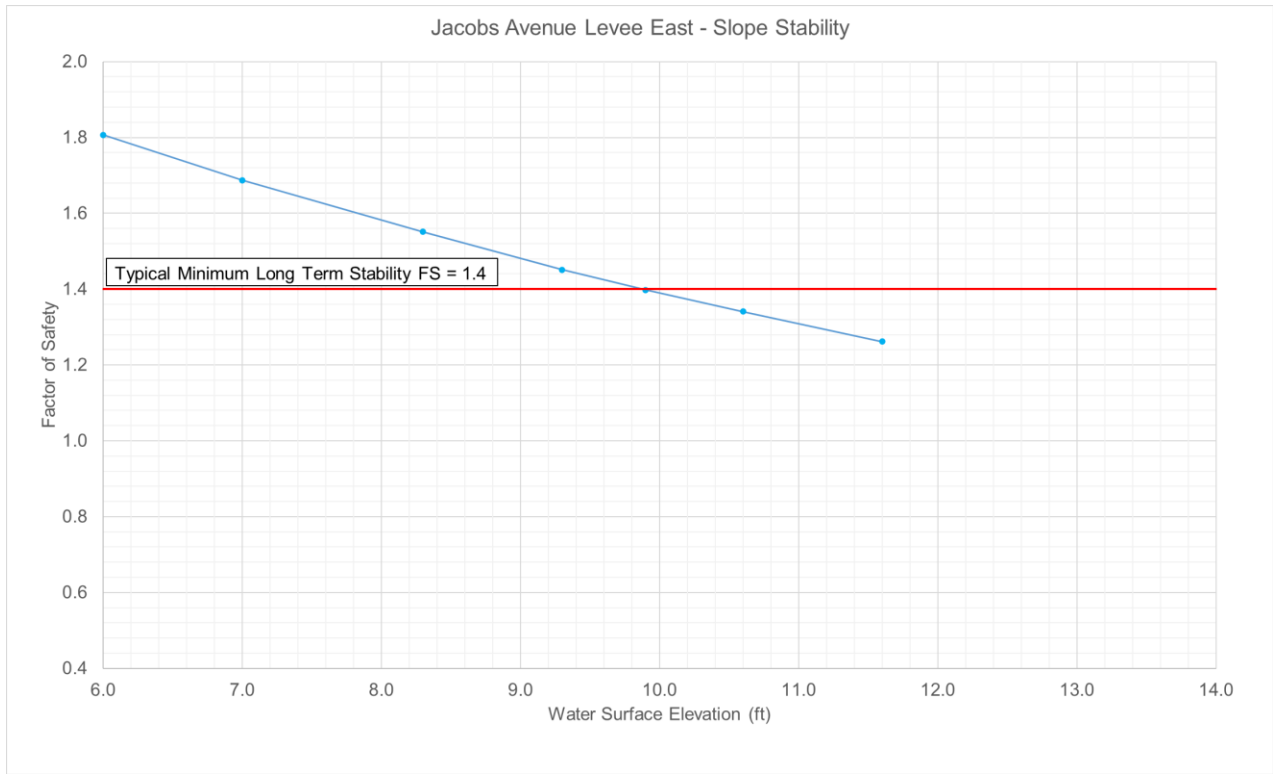
**Figure 12. Stability Analysis Results for East Levee**

Stability results for the water levels analyzed are shown in Figure 12 for the east levee. The levee met FEMA/USACE criteria for water levels less than approximately 9.9 feet. Failure for stability was not determined to be a potential failure mode for the water surface elevations analyzed.
