Humboldt Bay Trail Planning Study: Eureka to College of the Redwoods

Preliminary Flood Hazards, Sea Level Rise, and Tsunami Vulnerability Assessment

County of Humboldt, Department of Public Works

December 2024

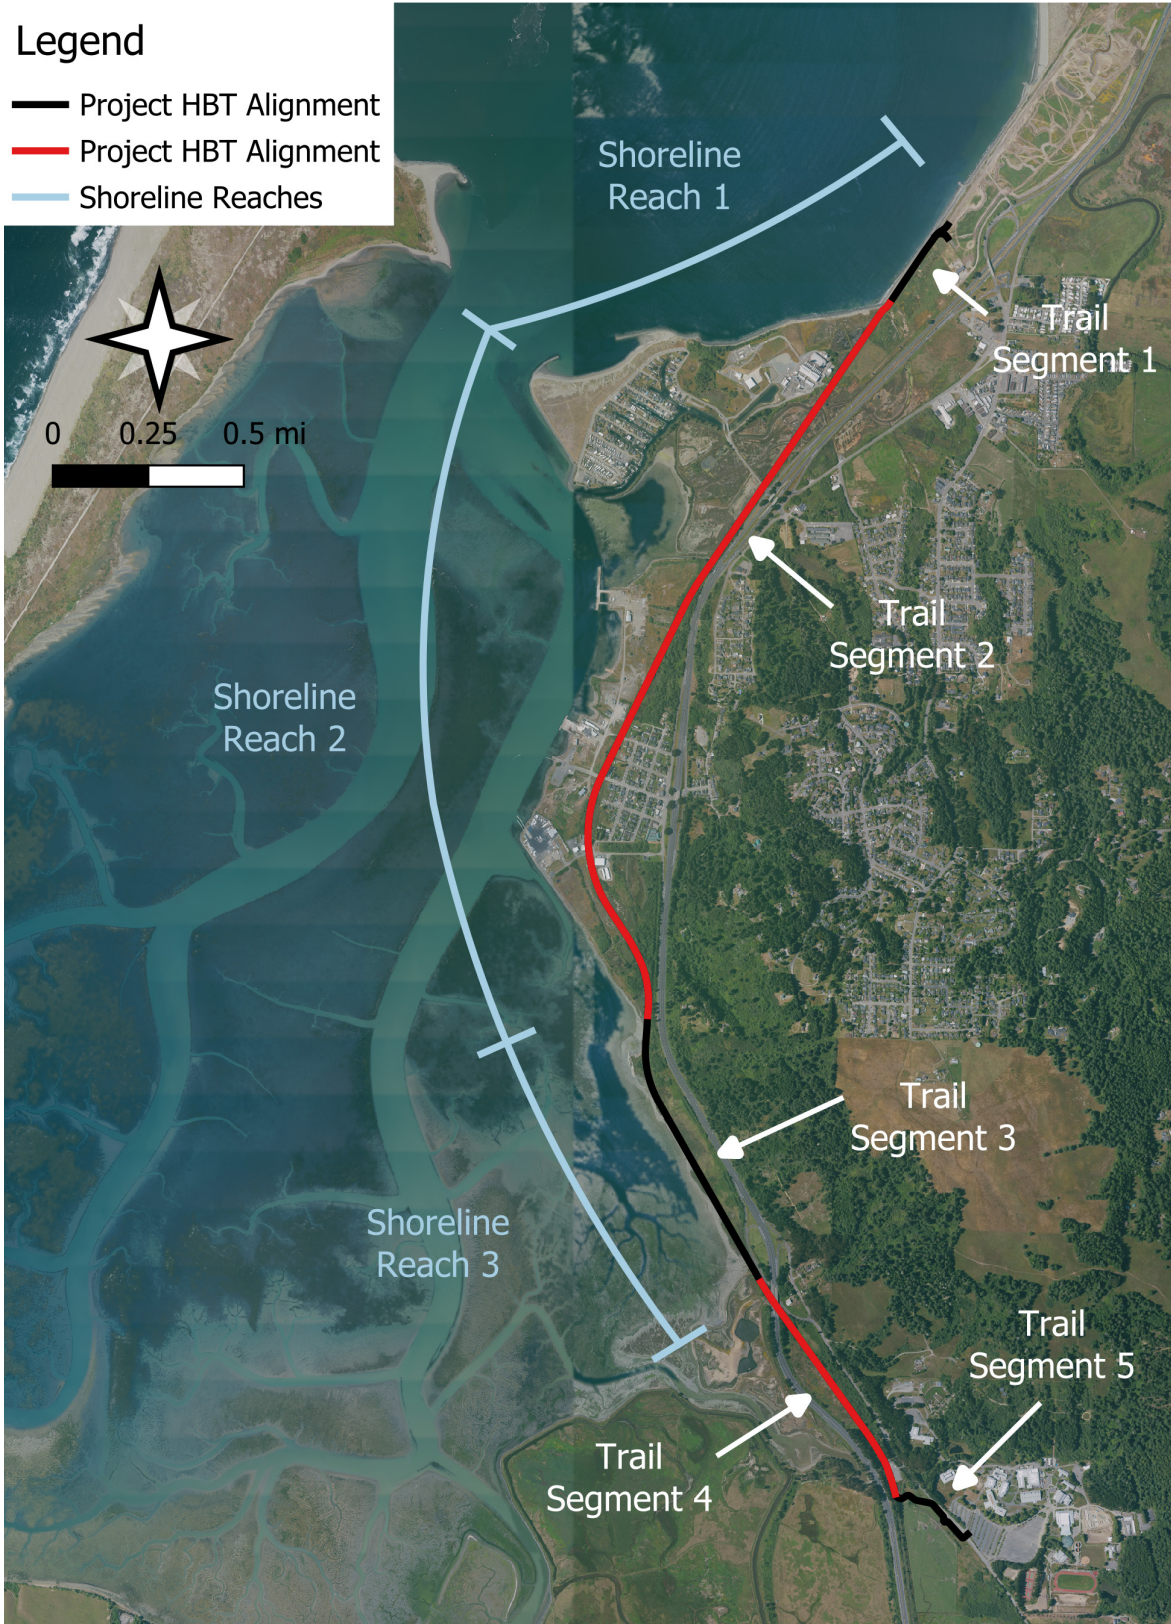
Figure 3. Proposed Project Humboldt Bay Trail (HBT) segments (Trail Segments 1, 2, 3, 4 and 5) and defined shoreline reaches (Shoreline Reach 1, 2, and 3) of the eastern Entrance Bay and South Bay shoreline.

This section describes the existing condition of the three shoreline reaches (Shoreline Reach 1, Shoreline Reach 2, and Shoreline Reach 3) as previously defined (Figure 3). Existing conditions were based on review of recent aerial images, drone images of the HBT alignment provided by the County, and a site walk of Shoreline Reach 3.

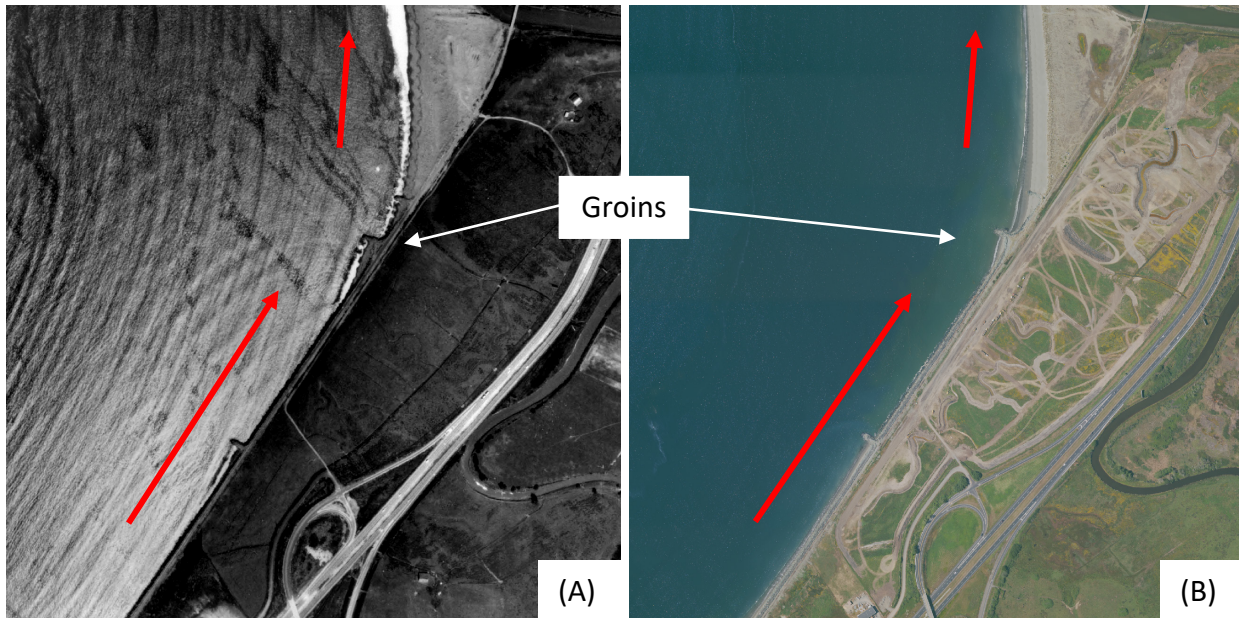
Figure 4. Easterly shoreline offset at groins in Entrance Bay on 1965 (A) and 2022 (B) aerial images indicating south to north net longshore transport or net drift directions (red arrows).

No longshore transport information was found for South Bay, and review of imagery did not indicate any obvious net shoreline drift direction. However, the easterly shoreline of South Bay (Shoreline Reach 3 in Figure 3) is perpendicular to the southerly wind directions (refer to Section 3.4), and this orientation indicates that shoreline drift likely occurs in both directions.

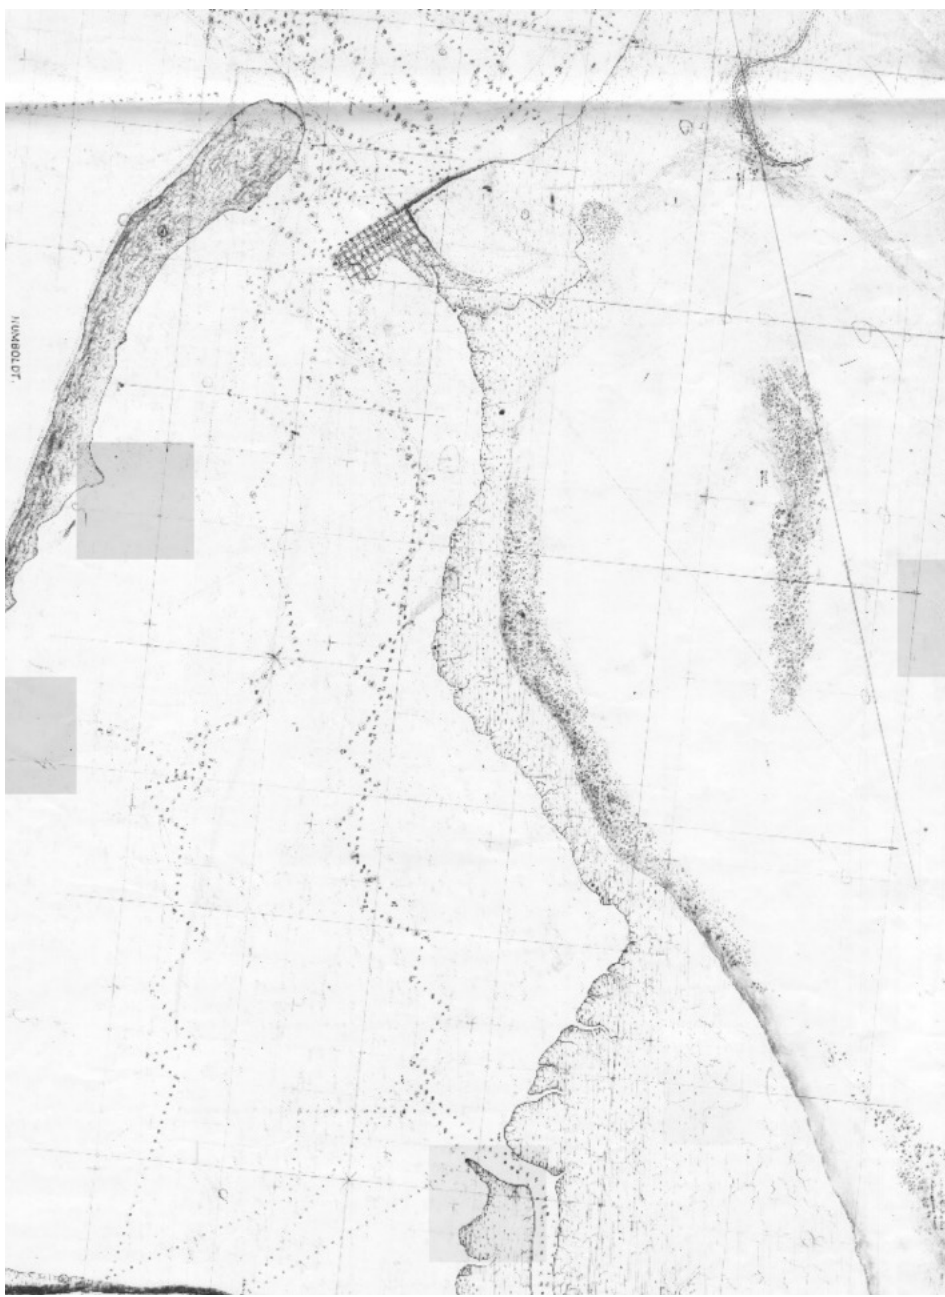
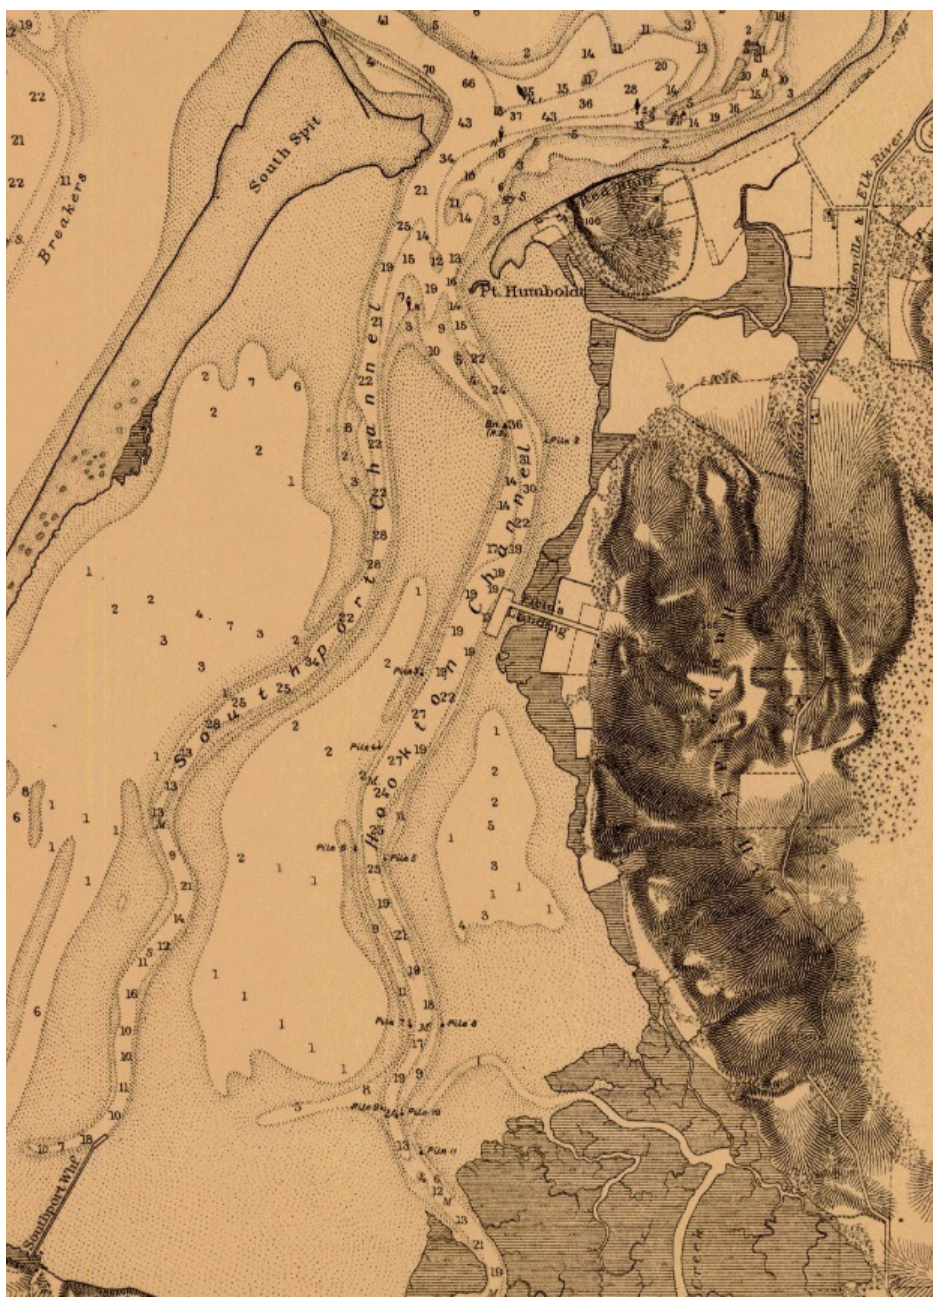
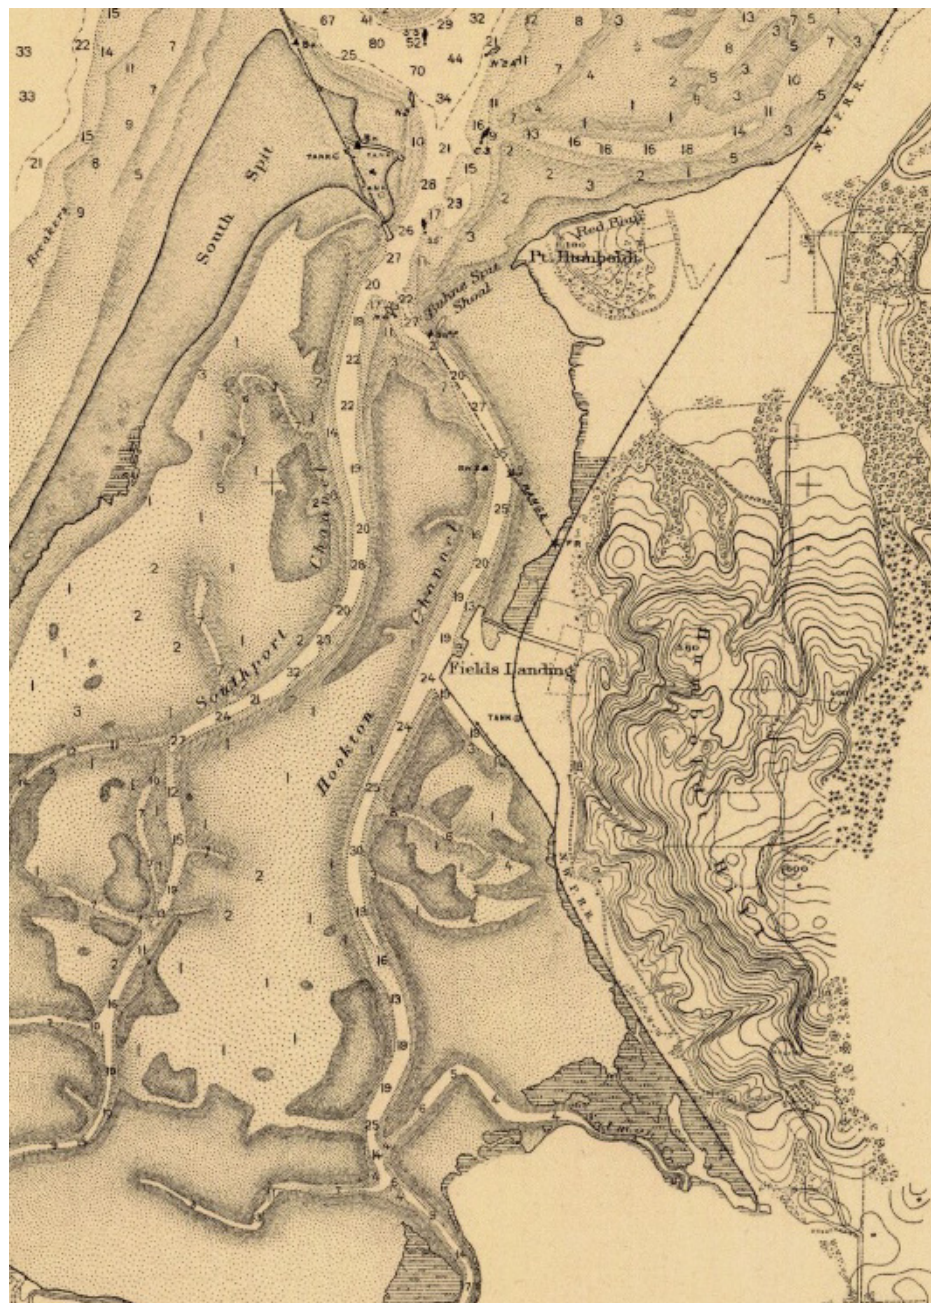
Figure 6. Comparison of 1851 Preliminary U.S. Coast Survey map (A), 1870 U.S. Coast Survey Map (B), 1894 U.S. Coast and Geodetic Survey Map (C), and 1916 U.S. Coast and Geodetic Survey Map (D) for the proposed HBT alignment. The 1870 map (B) is georeferenced and the HBT alignment and shoreline reaches are shown for reference. Maps A, C and D are clipped to the approximate extents of Map B but are not scaled.

Figure 6 provides a side-by-side comparison of the 1851 Preliminary U.S. Coast Survey map, 1870 U.S. Coast Survey Map, 1894 U.S. Coast and Geodetic Survey Map, and 1916 U.S. Coast and Geodetic Survey Map. This figure is clipped to the vicinity of the proposed HBT alignment and shows the changes of the shoreline and land use over the approximate period of 1851 to 1916. The 1851 preliminary U.S. Coast Survey map is one of the earliest maps showing conditions at these locations of the bay prior to significant shoreline development. For reference, the proposed HBT alignment and shoreline reaches are provided on the 1870 map (Figure 6C).

Land use changes from the historic natural landscape to a developed condition are evident in Figure 6 along the HBT alignment shoreline and are generally indicated by the removal of the historic or natural map symbol pattern to agricultural/cultivated pattern or a blank or white fill pattern. Comparison of the 1851 (Figure 6A) and 1870 (Figure 6B) maps indicates that large portions of the tidal wetland and grassland had been converted to likely agricultural uses, although limited wetland conversion had occurred along the south-eastern shoreline of South Bay (Shoreline Reach 2 and 3). Since 1870 predates levee construction, most of the agricultural land in this area was offset from the shoreline by a strip of tidal wetland, with the agricultural land likely occupying the higher upland areas adjacent to the wetlands. A road had also been established at the base of the eastern hillslope, and it is interesting to note that in Shoreline Reach 3 a spur road extended to an outbuilding (rectangle with an X in the center) located at the closest point of the upland to the bay. Perhaps this building was a barn or boat access location, but another indication that the ground elevation at this location was likely higher than tidal marsh elevations (6 to 7 ft) that would have been tidally inundated often.

There was limited change along the shoreline between 1870 and 1894 (Figure 6C) except for establishment and expansion of Fields Landing, and the construction of the Fields Landing wharf. By 1916 (Figure 6D) Fields Landing and Fields Landing wharf, docks and bulwark had been significantly expanded, and the Northwest Pacific Railroad had been constructed through the area. All the land east of the railroad grade had been converted to agricultural or other land uses, indicating that the railroad grade was high enough to act as a levee from the bay. Most of the shoreline levee construction had been completed by 1914 and large sections of tidal wetland conversion are apparent at Hookton Slough and south of Point Humboldt (Buhne Point). Only small, fragmented sections of tidal wetland remained along the bay shoreline or between the railroad grade and the bay.

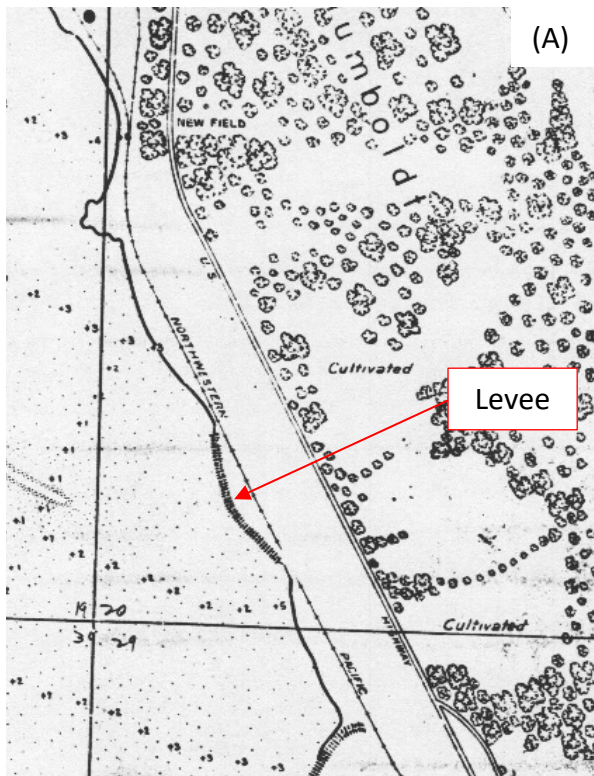
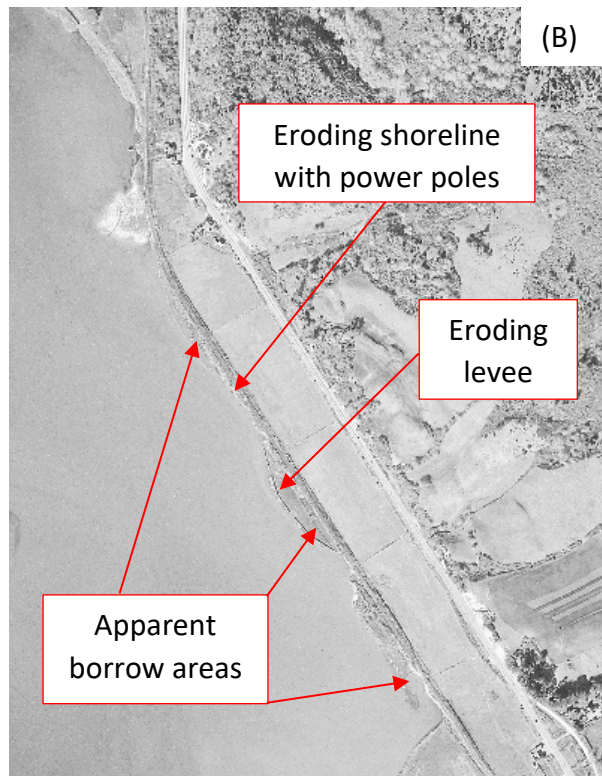
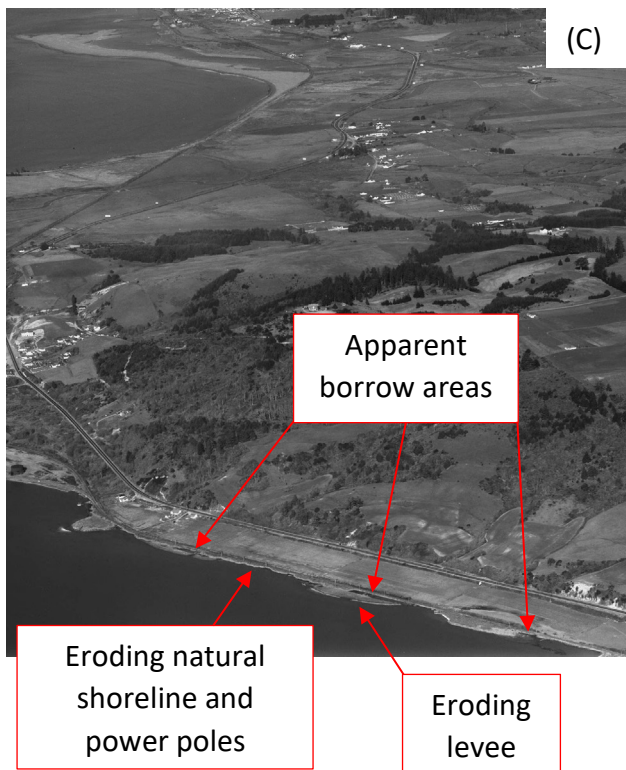
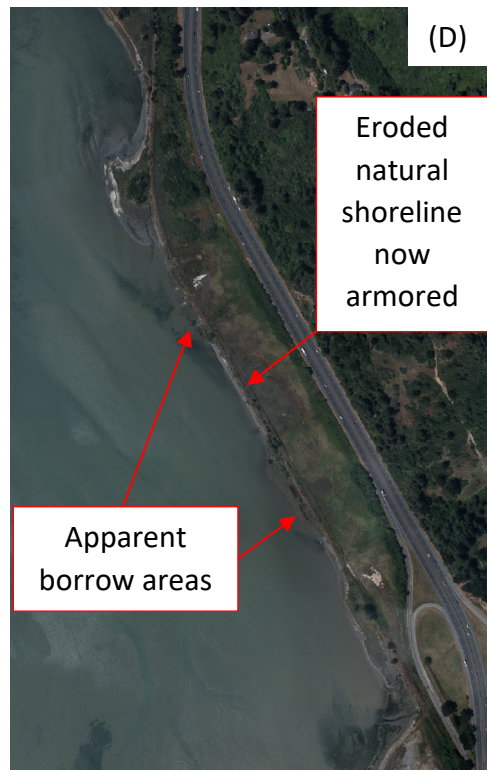
Figure 7. Comparison of 1940 U.S. Army Corps of Engineers map (A), 1941 aerial image (B), 1948 Merle Shuster oblique photo (C), and 2019 aerial image (D) for Shoreline Reach 3 and Trail Segment 3 of the proposed HBT alignment.

- A series of borrow areas or pits are apparent at multiple locations in this reach (Figure 7B and Figure 7C). It is not clear exactly what these features were used for, but more than likely the excavated material was used for the railroad fill prism during initial construction or for repair. Most of these pit locations are adjacent to the higher upland areas, where material would have been better suited for railroad grade fill material than the wetland materials. It is possible that they were created by a dredger, but since they are fragmented and extensive levee construction was not done in this reach, they were more likely excavated with land or rail-based equipment.

- A few of these borrow areas still exist today (Figure 7D), although some have filled in with sediment and vegetation, or have been partially eroded away by the retreating shoreline.

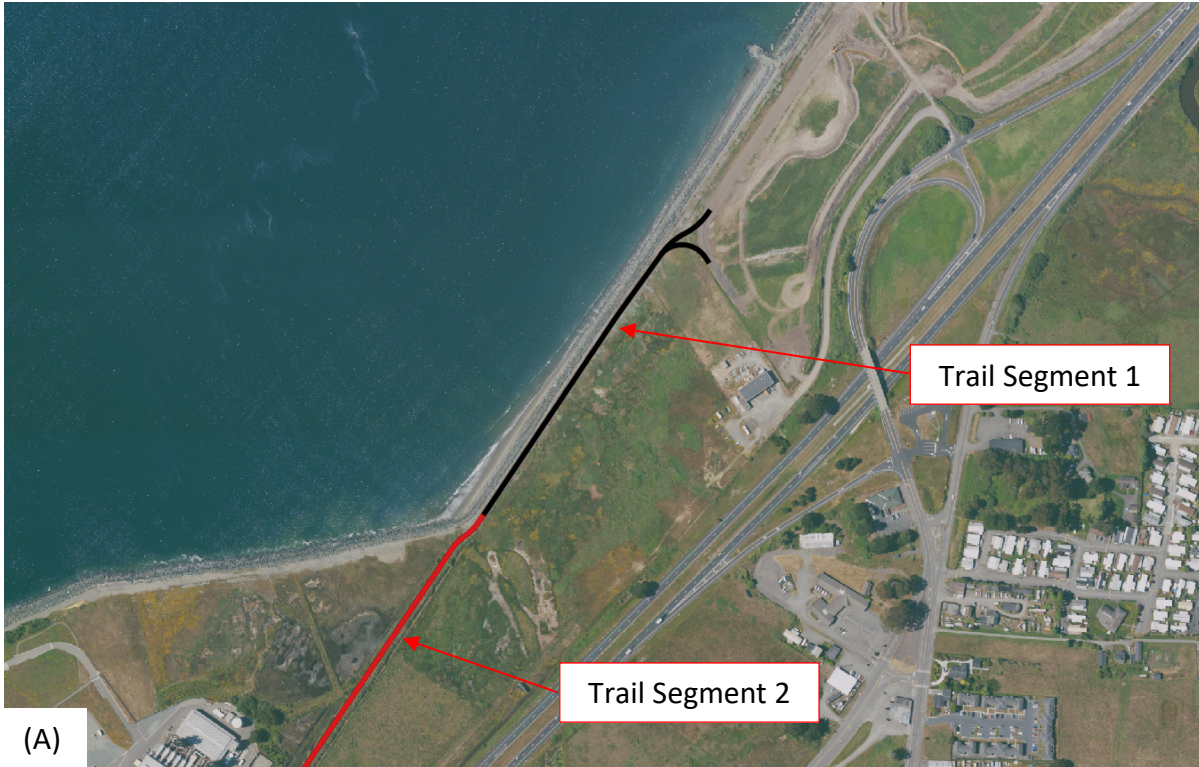
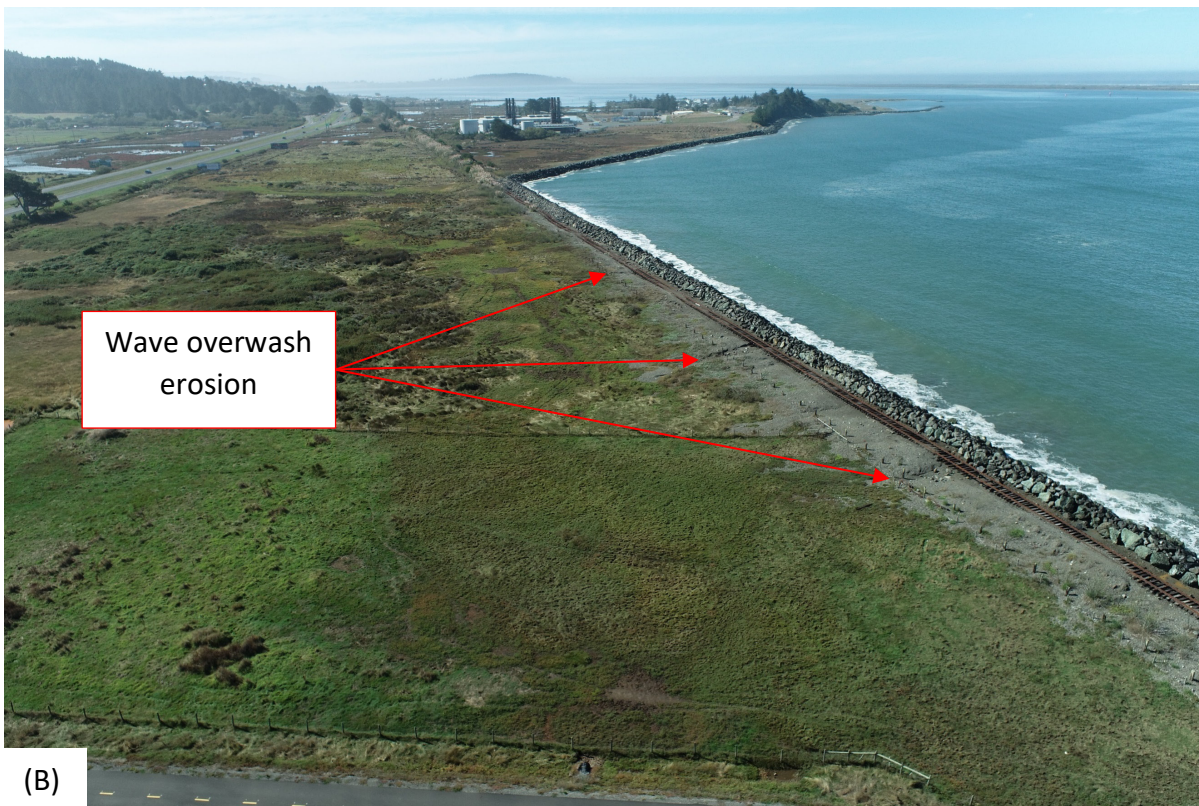
Figure 8. 2022 aerial image of Trail Segment 1 & 2 within a portion of Shoreline Reach 1 (A); and 2023 oblique aerial view of Shoreline Reach 1 existing rock revetment along the proposed Trail Segment 1 (B), note the localized overwash erosion from wave runup and overtopping on the back area of the revetment. Drone image (B) provided by County of Humboldt.

In general, the rock revetment in Shoreline Reach 1 appears to be in reasonable condition. However, it is apparent that smaller rock is being dislodged from the revetment as rock is scattered seaward of the toe, and wave overtopping is displacing rock onto the railroad grade (Figure 9). Also, evidence of localized overwash erosion of the railroad grade material, likely caused by wave runup and overtopping flow, are apparent along back areas of the revetment (Figure 8B and Figure 9B). The locations of the overwash erosion may indicate low crest elevations of the rock revetment.

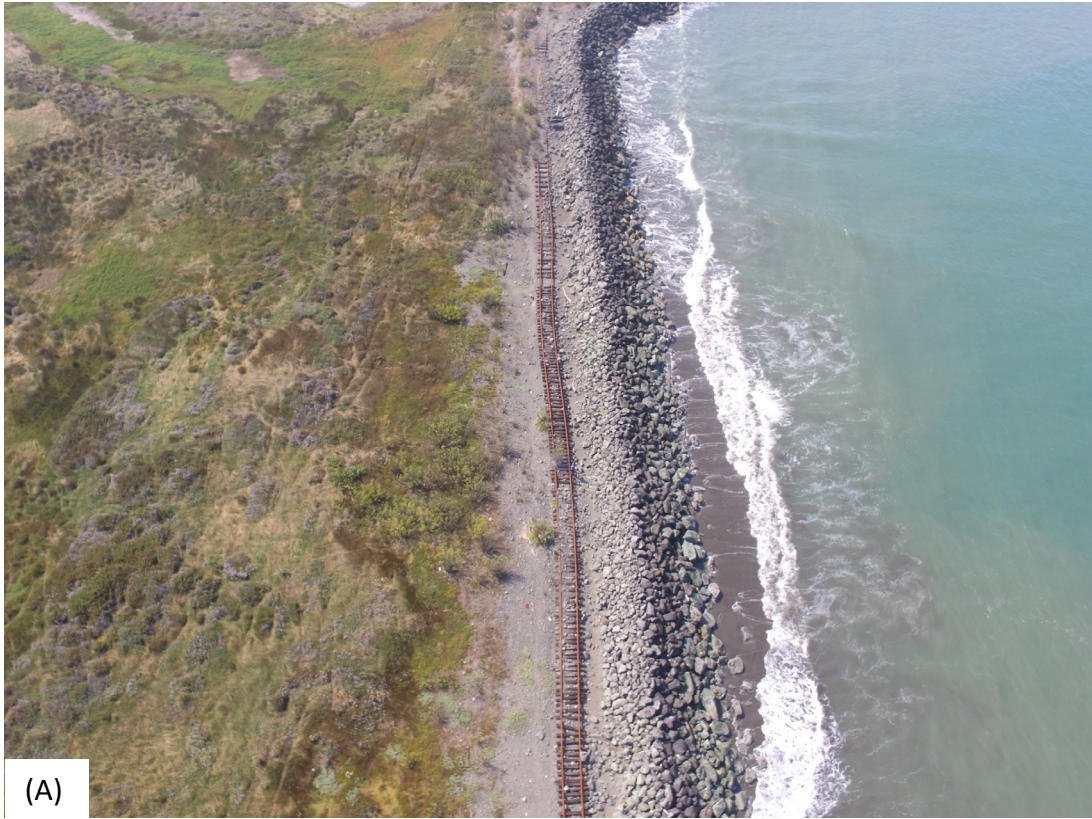
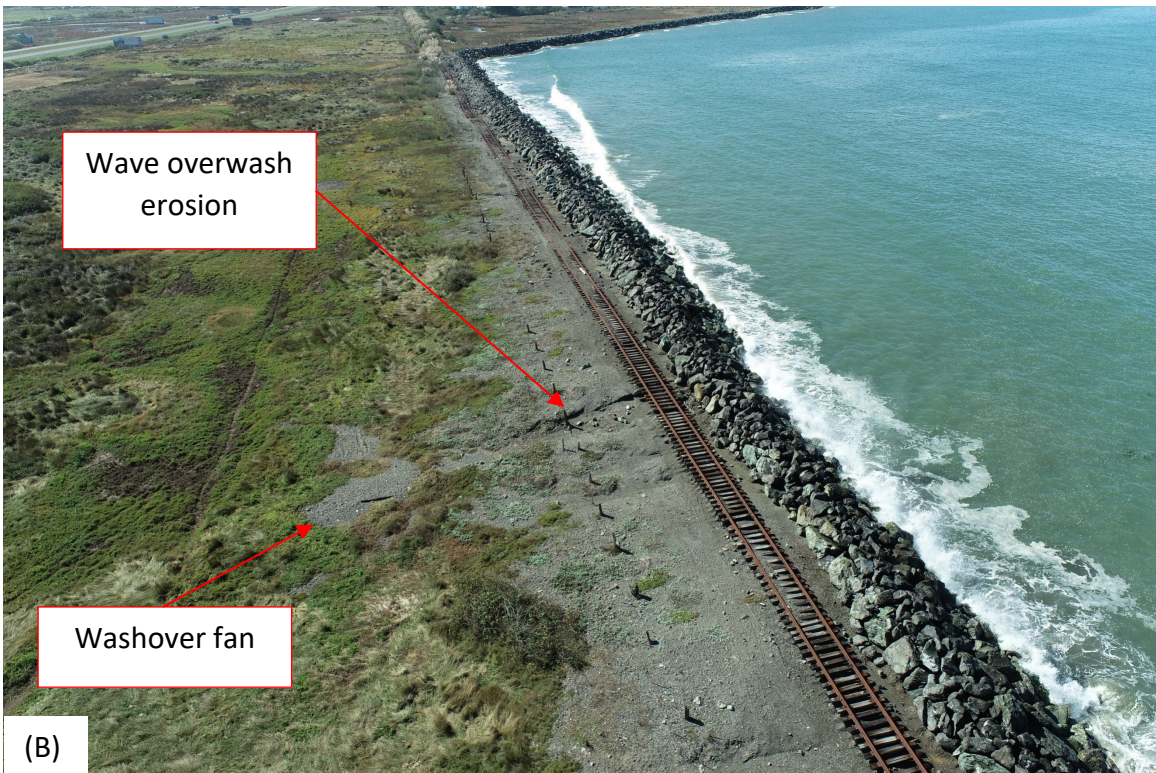
Figure 9. 2023 oblique aerial view of Shoreline Reach 1 existing rock revetment and dislodged rock along beach and on top of railroad grade (A); and localized overwash erosion and washover fan of the railroad grade fill from wave runup and overtopping behind the revetment (B). Drone images provided by County of Humboldt.

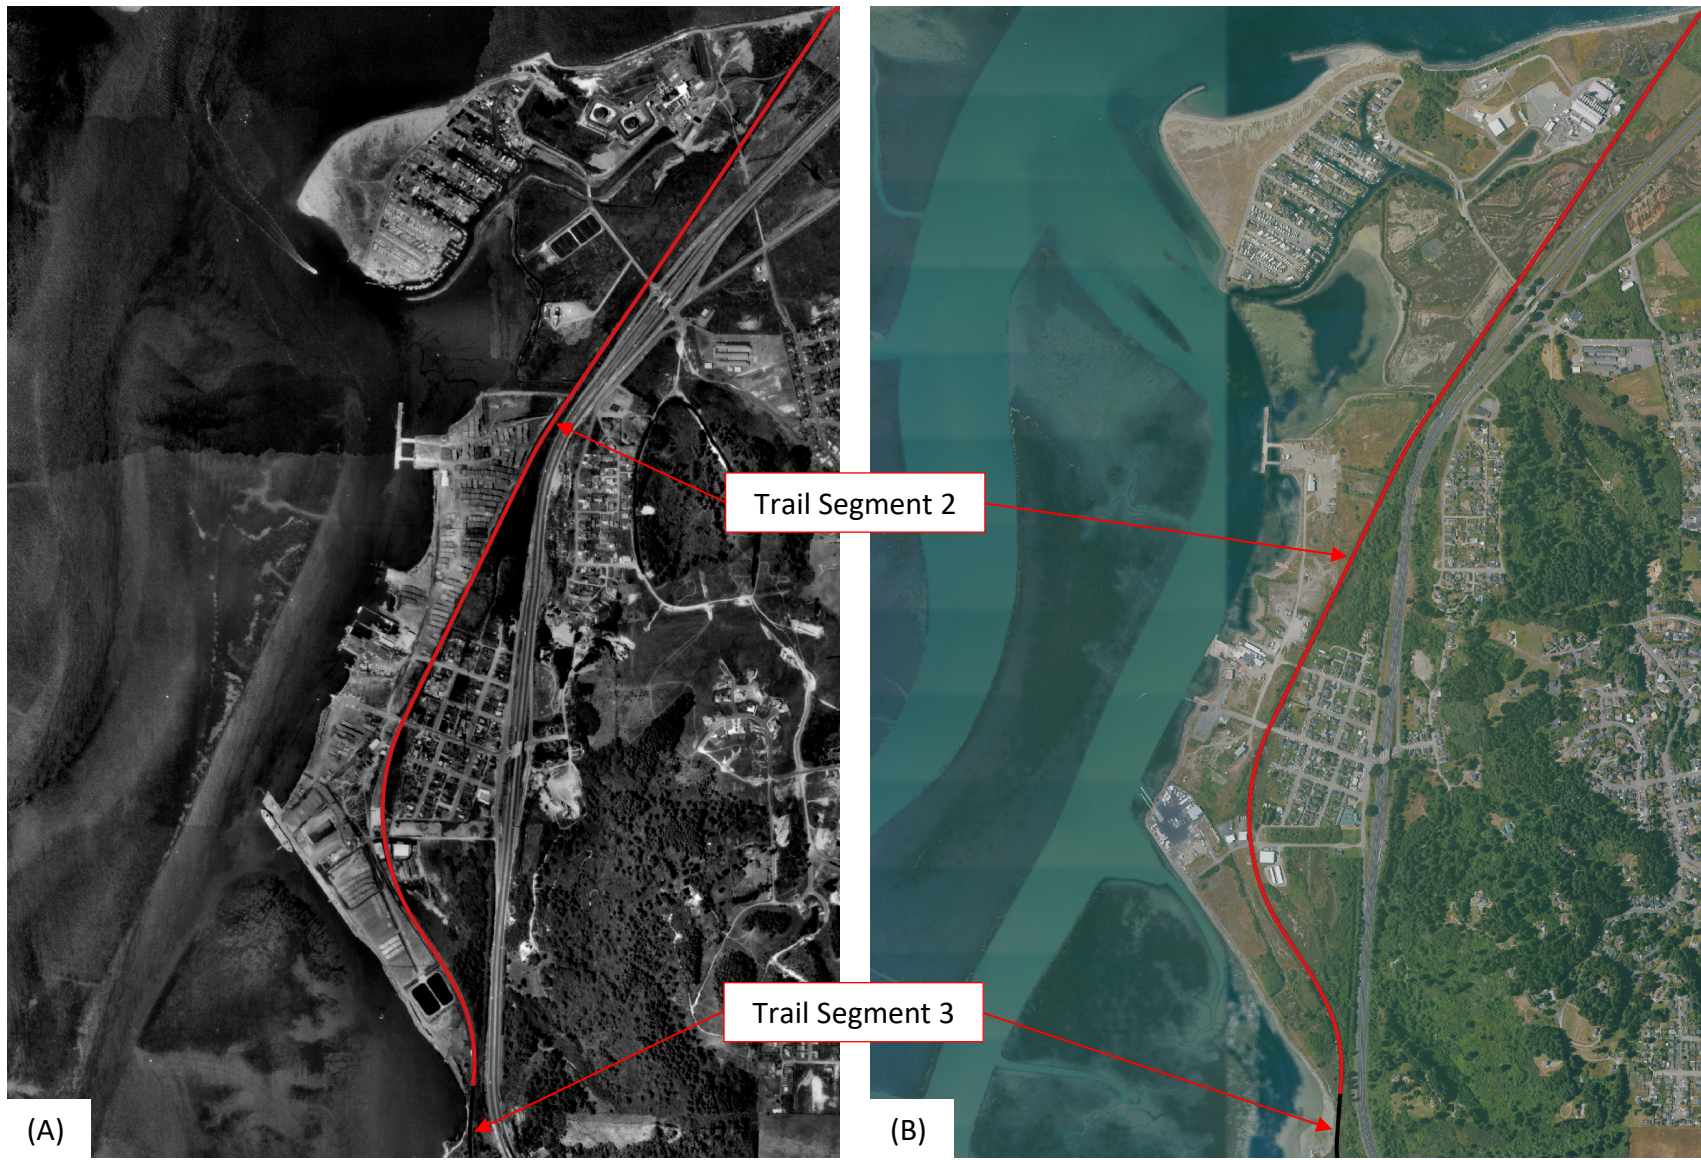
Figure 10. Comparison of aerial images of Fields Landing and the Fields Landing shoreline wharf and dock infrastructure and the King Salmon Development for 1970 (A) and 2022 (B) within Shoreline Reach 2 for Trail Segment 2.

Shoreline Reach 2 extends from Buhne Spit at the northern end to the Fields Landing wharf and dock infrastructure at the southern end (Figure 3), which was quite extensive historically. Figure 10 shows a comparison of the 1970 aerial image, which was at the height of shoreline development in this area, and the condition of the shoreline today (2022 aerial image). The following describes the general condition of the shoreline today from north to south:

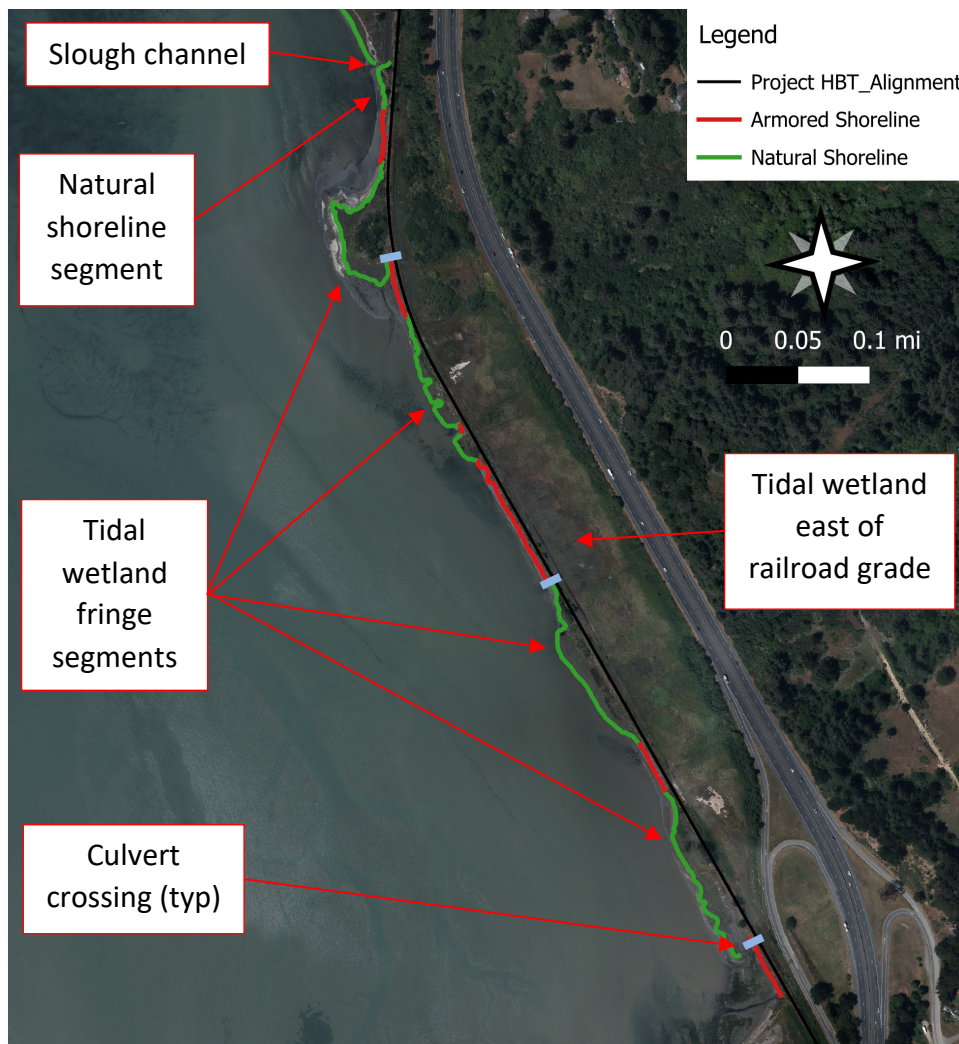
Figure 11. 2019 aerial image of Shoreline Reach 3 showing the HBT Trail Segment 3, natural tidal wetland and armored sections of shoreline, locations of three culvert crossings (blue line) through the railroad prism, and the tidal wetland area east of the railroad grade.

- Three railroad grade culvert crossings with failed tide gates provide drainage from the easterly area into South Bay. The failed tide gates are providing a muted tidal inundation and tidal prism to the easterly tidal wetland areas (Figure 11, Figure 14 and Figure 15).

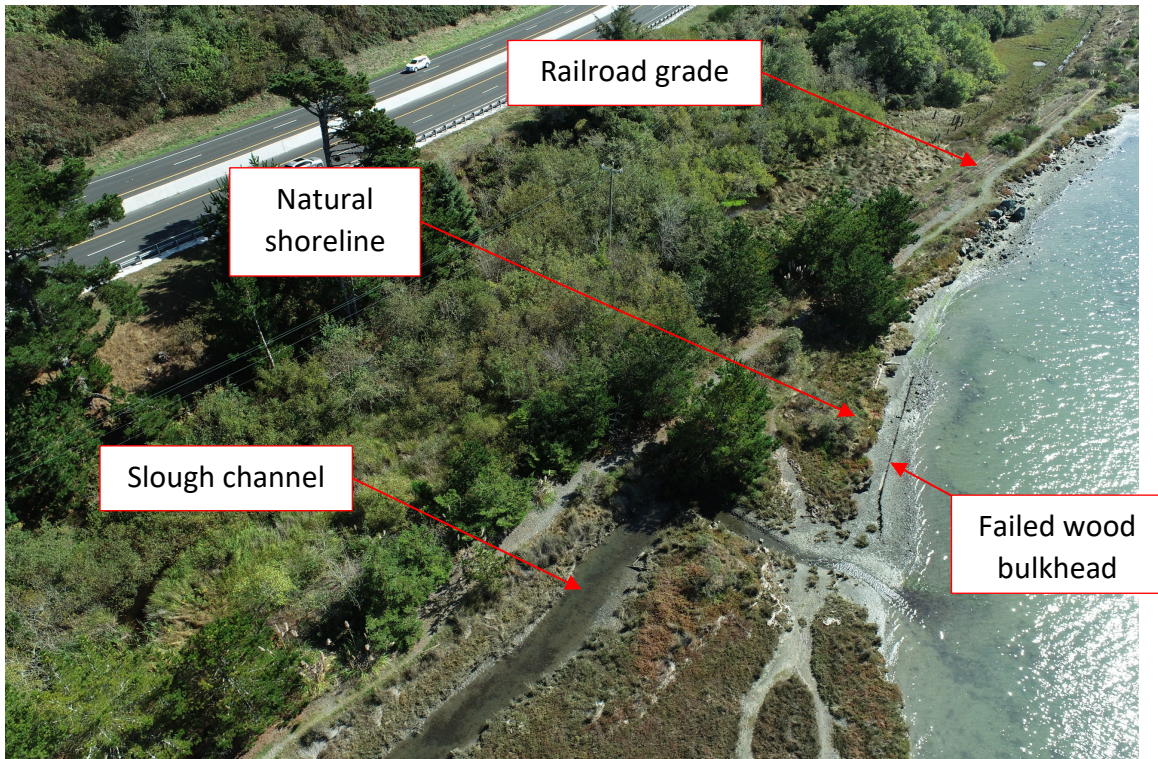
Figure 12. 2023 oblique aerial view looking south of the north end of Shoreline Reach 3 that shows natural section of shoreline that has eroded behind a failed wood bulkhead, and the slough channel separating Shoreline Reach 2 from Shoreline Reach 3 to the north. Drone image provided by County of Humboldt.

- The northern end of Reach 3 contains a small section of natural shoreline at a typical elevation of 8 to 9 ft (Figure 5), that has eroded behind a failed wood bulkhead to its current location (Figure 12).

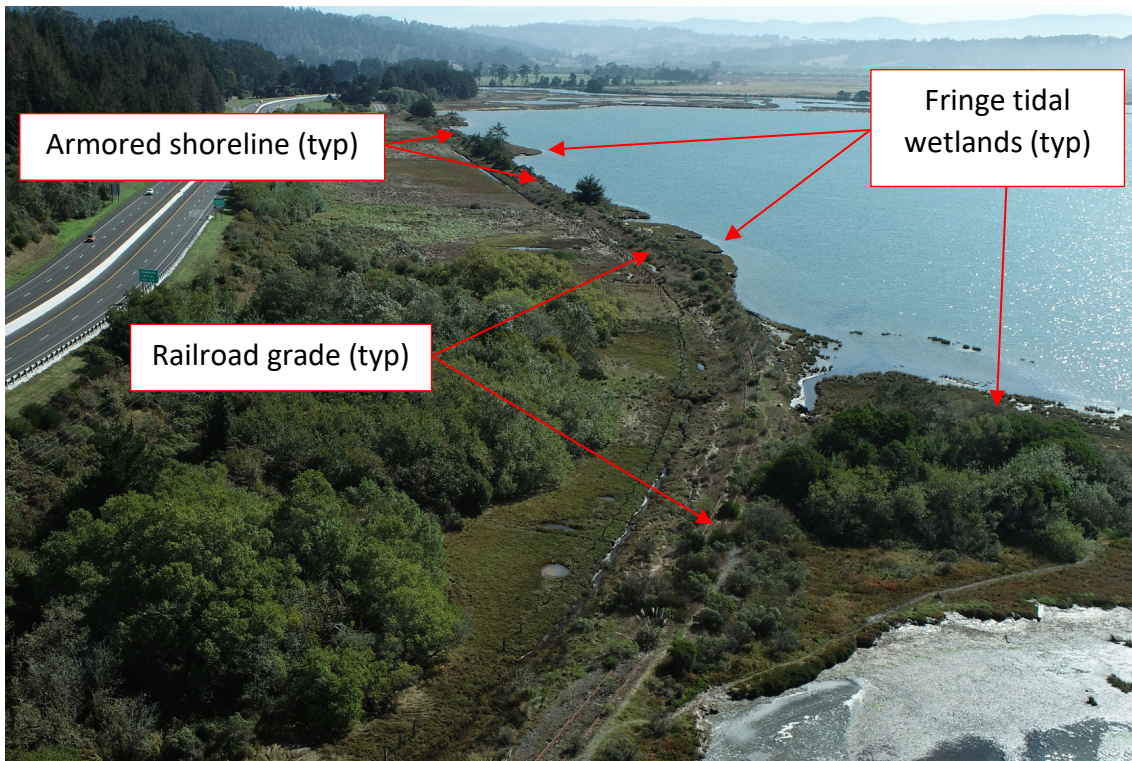
Figure 13. 2023 oblique aerial view looking south along Shoreline Reach 3 showing the fringe tidal wetland and armored shoreline sections bayward of the railroad grade. Drone image provided by County of Humboldt.

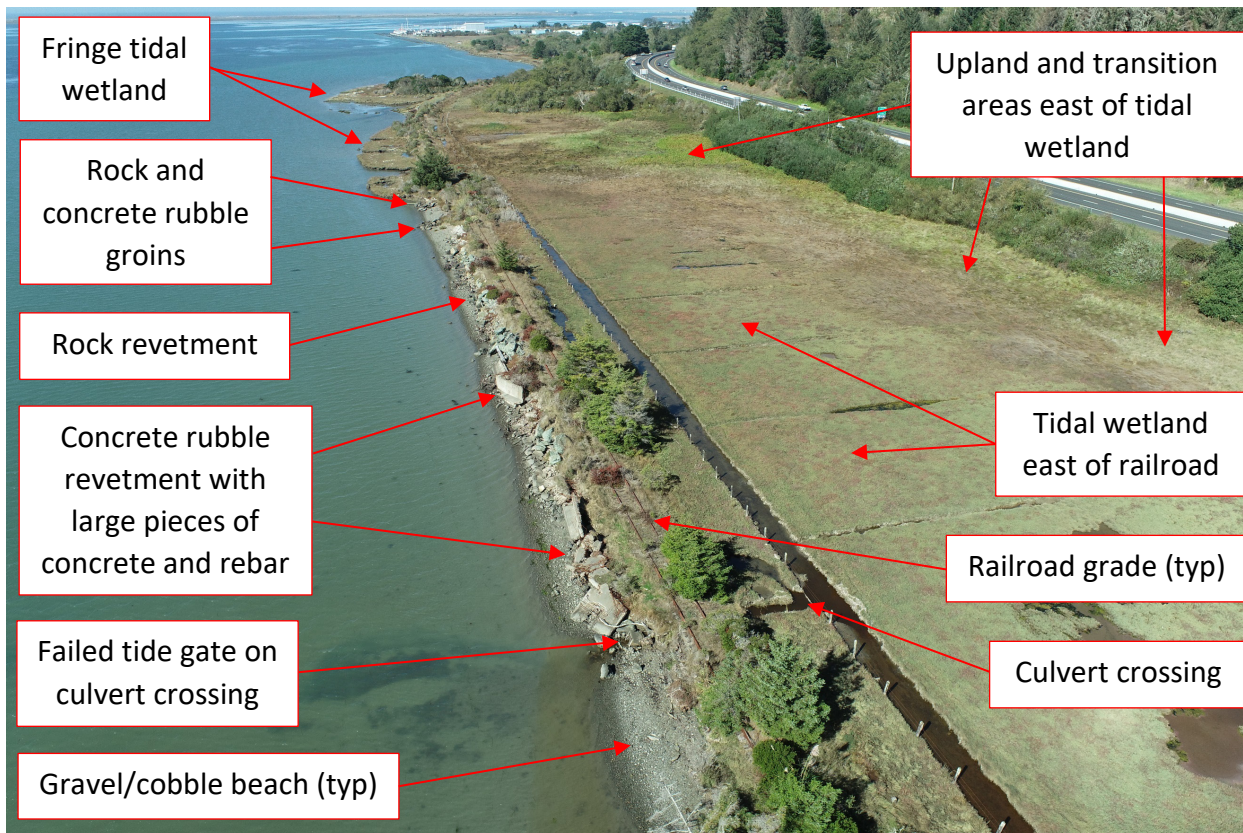
Figure 15. 2023 oblique aerial view looking north along Shoreline Reach 3 showing an armored section of shoreline with rock and concrete rubble revetments, tidal wetland east of the railroad grade surrounded by upland area, failed tide gate structure (door missing) on culvert crossing through railroad prism, thin layer of gravel/cobble beach on top of mudflat from eroded railroad prism fill, two small rock and concrete rubble groins at the north end armored shoreline, and large pieces of concrete and rebar rubble. Drone image provided by County of Humboldt.

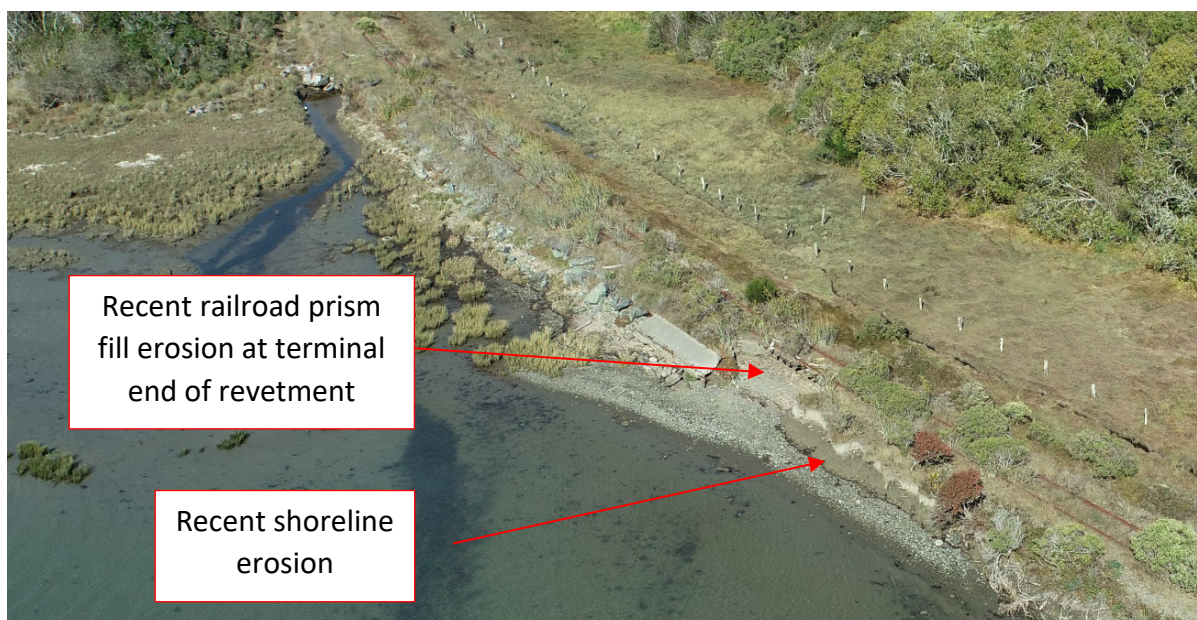
Figure 16. 2023 oblique aerial view looking east along Shoreline Reach 3 showing recent erosion of shoreline and railroad prism fill at terminal end of rock and concrete revetment. Drone image provided by County of Humboldt.

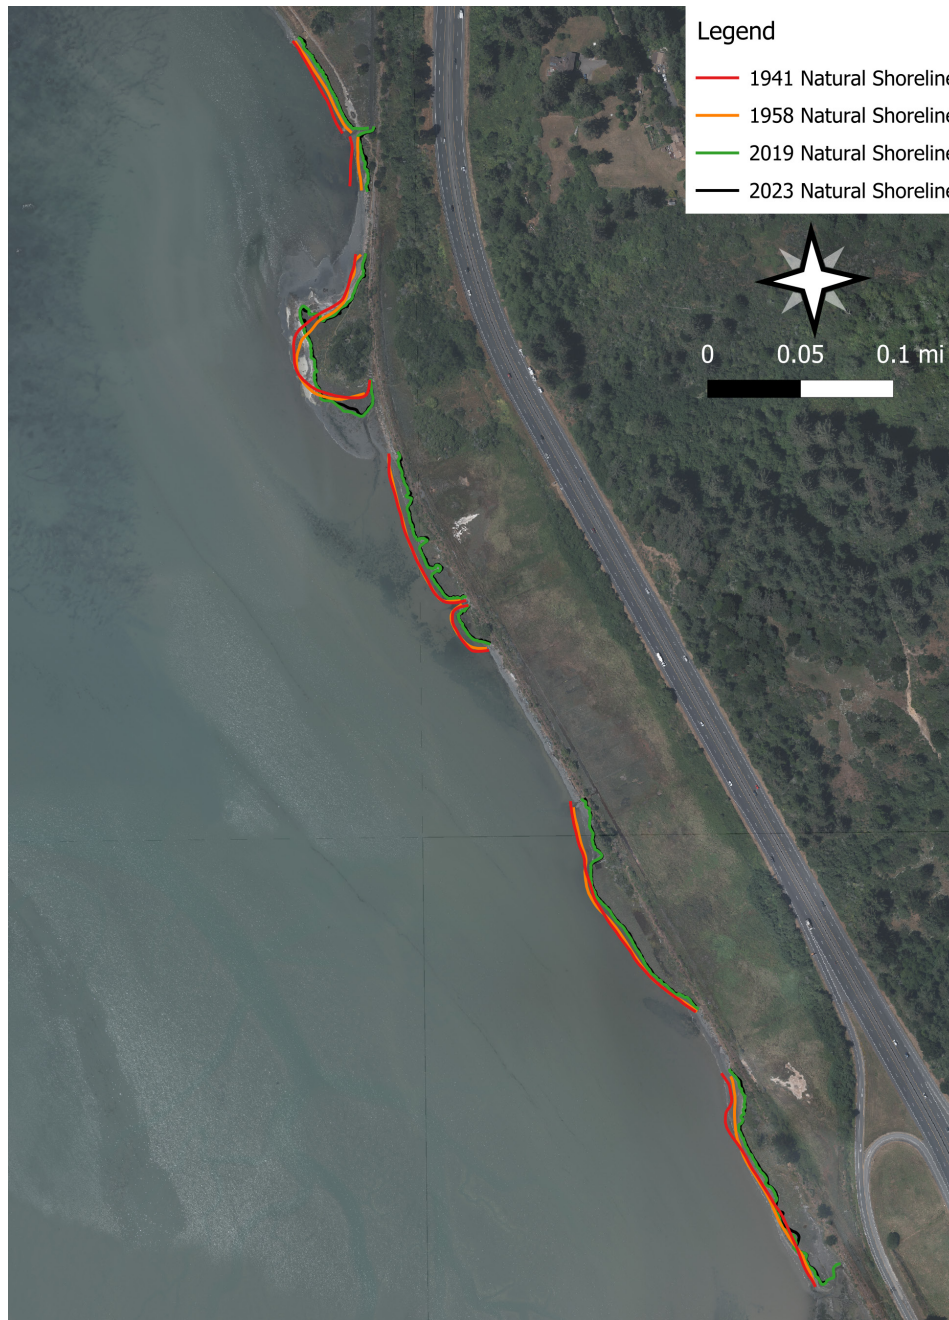
Figure 18. 2019 aerial image of Shoreline Reach 3 showing the digitized natural shoreline segments for 1941, 1958, 2019 and 2023. Most of the natural shoreline segments are tidal wetlands, except for the two north segments.
