Humboldt Bay Trail Planning Study: Eureka to College of the Redwoods

Preliminary Flood Hazards, Sea Level Rise, and Tsunami Vulnerability Assessment

County of Humboldt, Department of Public Works

December 2024

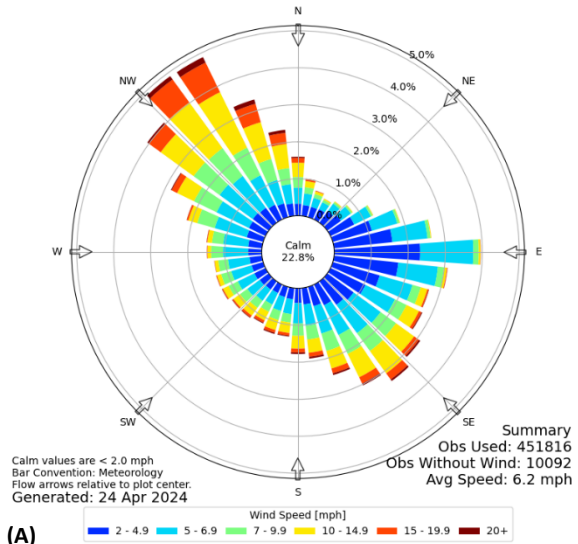
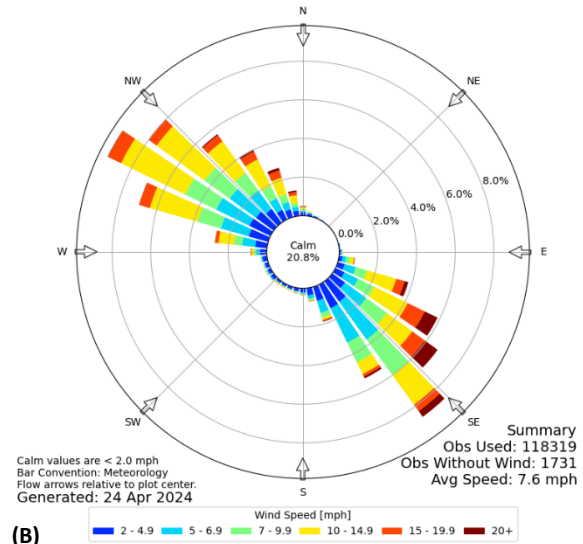
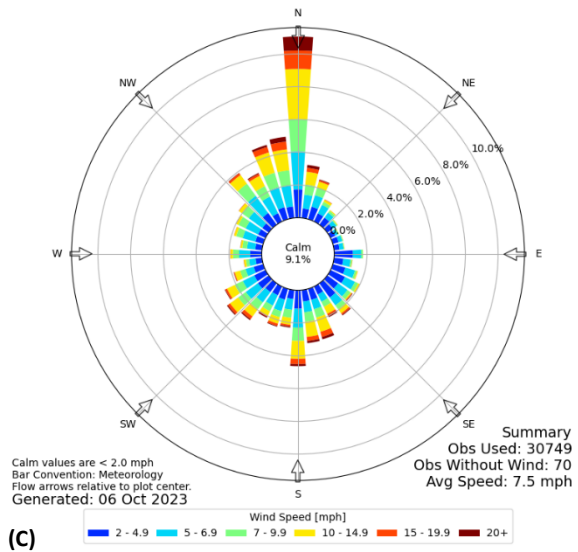
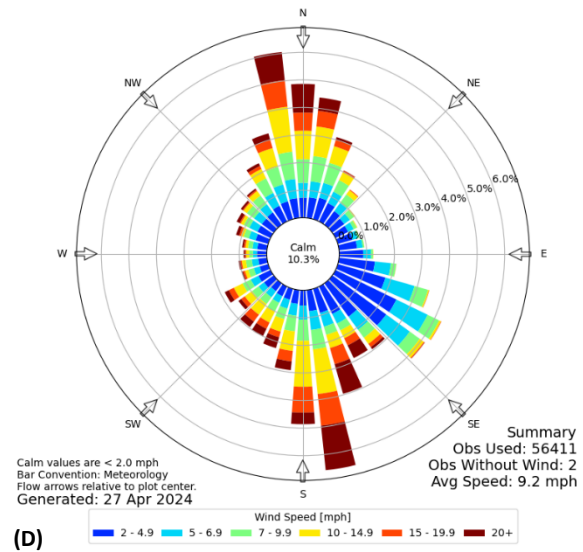
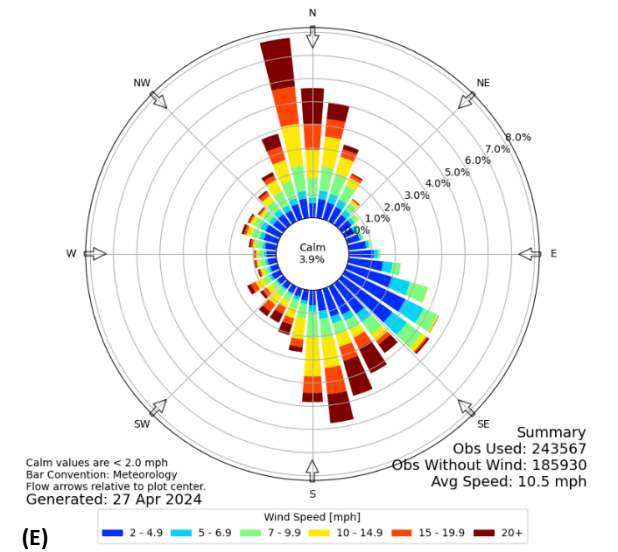
Figure 20. Wind rose for Arcata/Eureka Airport (A), Fortuna (B), Eureka (C), North Spit (D) and North Jetty Landing (E). Plots generated from Iowa Environmental Mesonet of Iowa State University.

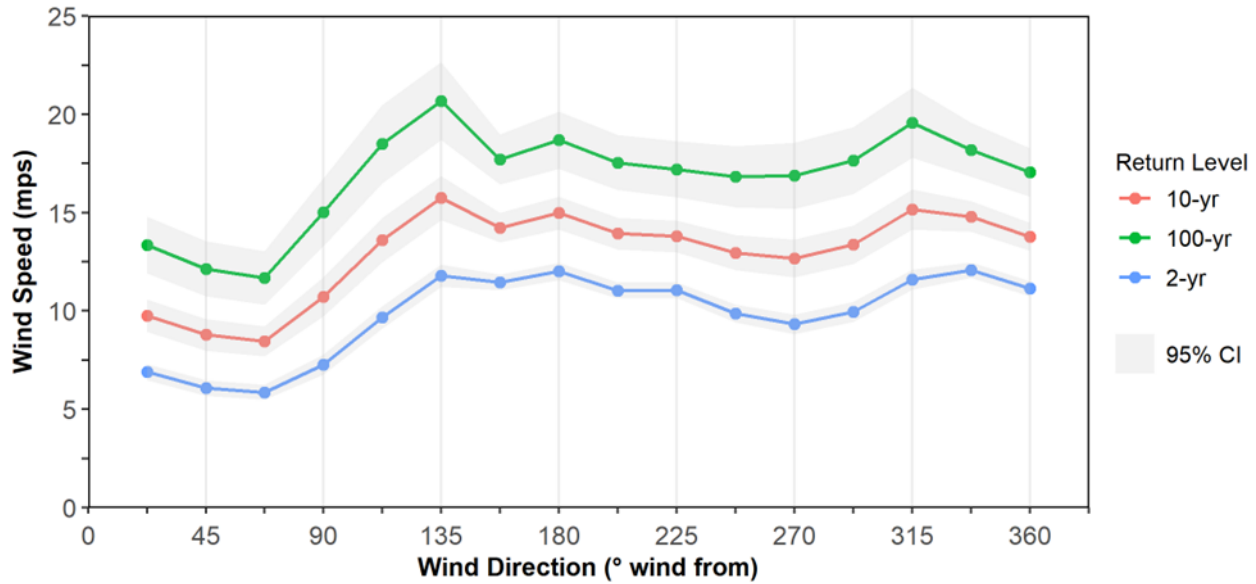
Figure 21. Peak 2-min wind speed estimates and 95% confidence intervals by wind direction from a Gumbel distribution for the 2-yr, 10-yr and 100-yr return levels (figure from Appendix G, GHD et al., 2022).

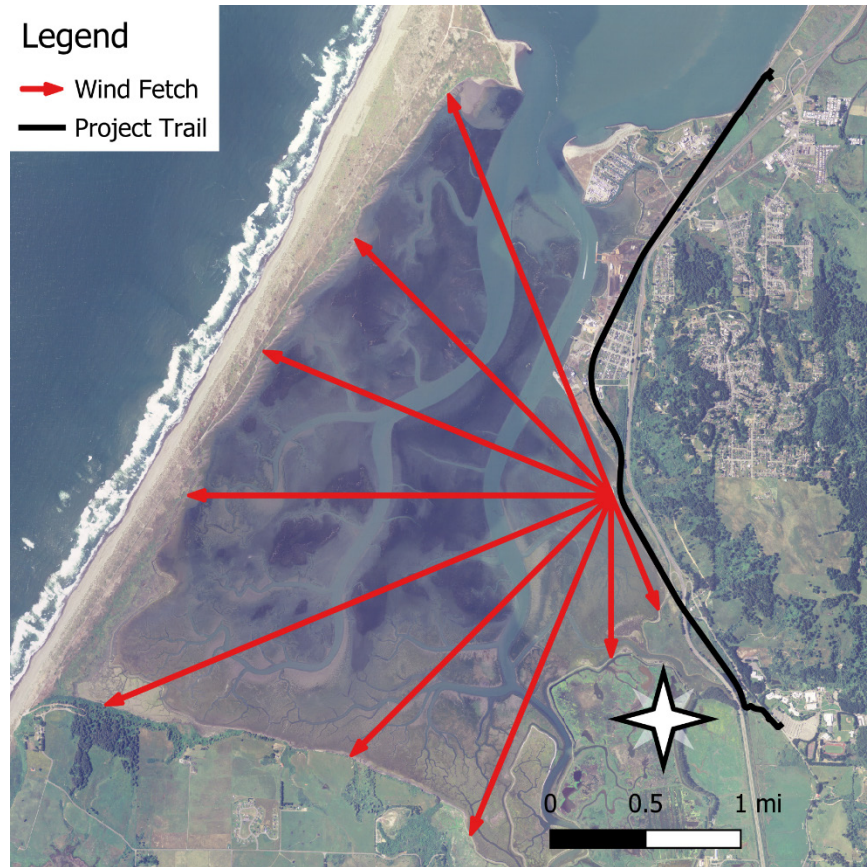
Figure 22. Fetch directions for Shoreline Reach 3 of the Project area in South Bay.

Reach 3 are provided in Figure 22. Since waves in South Bay are fetch limited, the longest fetch length for a given constant wind speed will produce the largest wave heights. For this preliminary assessment, wind-wave heights and periods were estimated for winds from the west-southwest (247.5°) direction, which is the longest fetch with a length of 4.6 km (2.9 miles). It should be noted that the Reach 3 shoreline is approximately perpendicular to the maximum fetch direction.

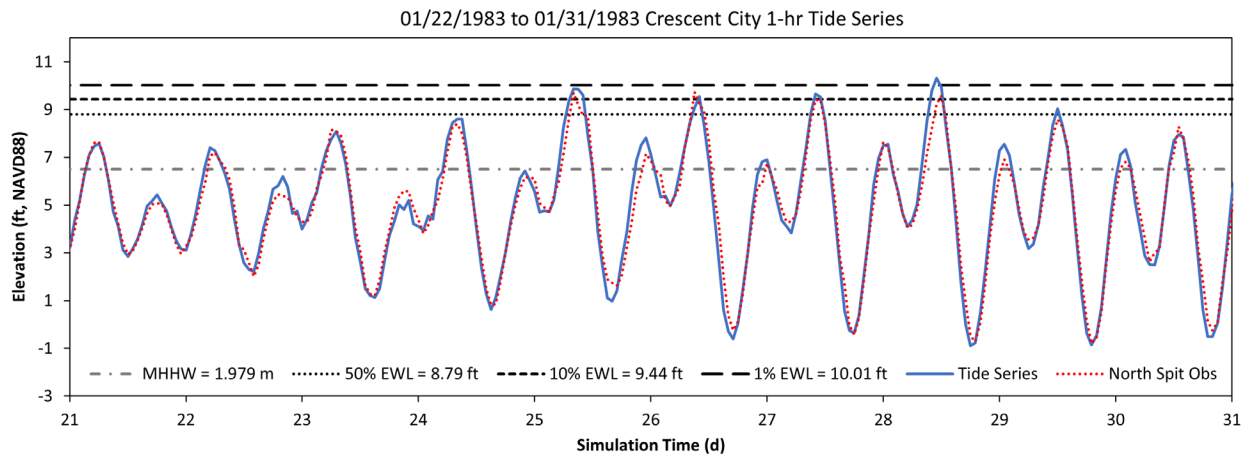
Figure 24. Tidal open boundary condition (blue line) used for the hydrodynamic model simulations. Tidal series based on Crescent City tide station (NOAA Station ID: 9419750). Observed North Spit tide station (NOAA Station ID: 9418767) observations (red dotted line) corrected for ~2.3 mm sea-level change from 1982 to 2012. MHHW is mean higher high water; #% EWL (e.g. 1% EWL) represents the #% annual chance extreme high-water level (e.g. 1% chance extreme high-water level).

The tidal open boundary condition (Figure 24) for the analysis consisted of a 10-day period from the 100-yr hourly sea level height series derived for the Crescent City tide station (NOAA Station ID: 9419750) as part of the Humboldt Bay sea-level rise vulnerability analysis (NHE 2015). The 10-day period spanned 22 to 31 January 1983, which was during the 1982-83 El Niño. During this 10-day period a large El Niño driven storm coincided with higher-than-normal astronomical tides producing the highest water levels of record at the Crescent City tide gauge. This 10-day tidal series contains a large tidal height range spanning mean higher high water (MHHW) to above the 1% annual chance extreme high-water level event. The wind speeds and directions were held constant for each 10-day simulation.

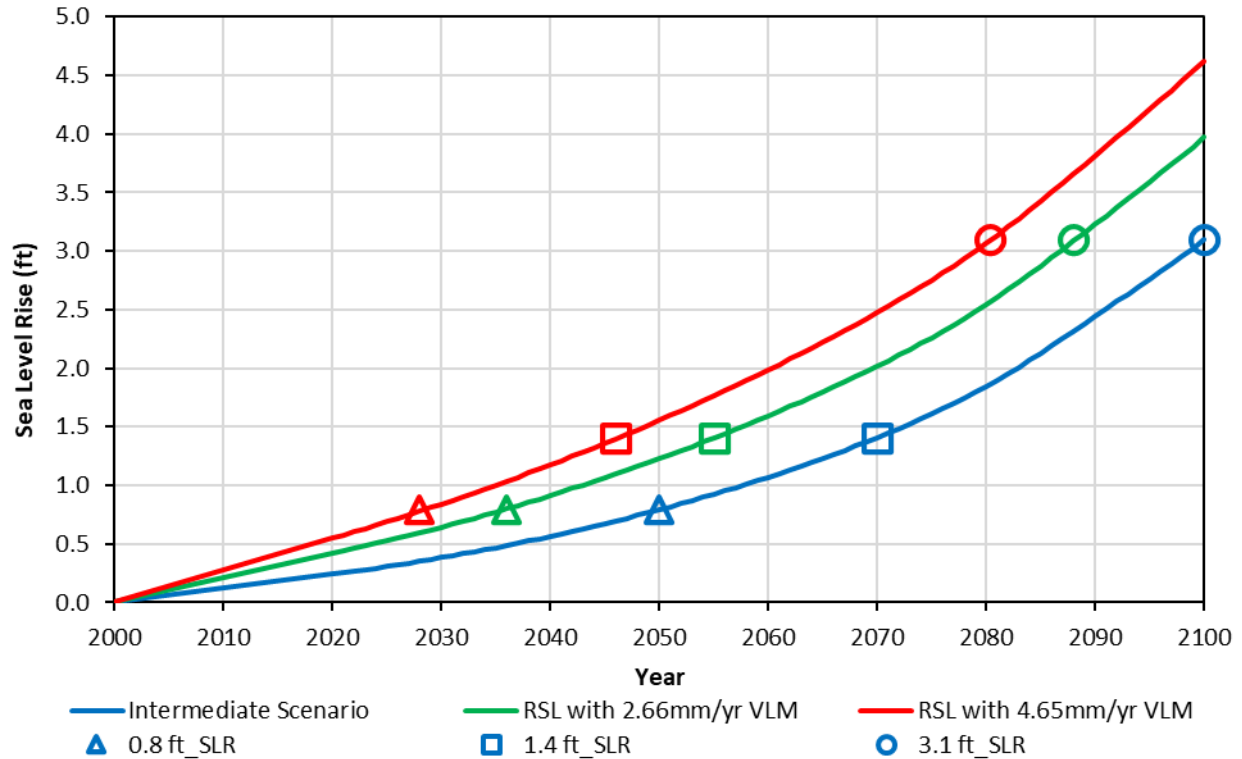
Figure 27. California Sea Level Rise Guidance (2024) Intermediate Sea Level Scenario for California (Intermediate Scenario) and the relative sea level (RSL) curves generated by adding 2.66 mm/yr vertical land motion (VLM) (for Fields Landing) and 4.65 mm/yr VLM (for Hookton Slough) to the Intermediate Scenario. All curves have a Year 2000 baseline. The 0.8 ft sea level rise (SLR) increase (triangle symbol), 1.4 ft SLR increase (square symbol), and 3.1 ft SLR increase (round symbol) represent the same water levels, and the color of the symbols represent how the dates change based on each sea-level curve.

Table 20 summarizes the future dates associated with the SLR increases of 0.8 ft, 1.4 ft, and 3.1 ft linked to the Intermediate Scenario, and how these future dates change with RSL by adding VLM rates of 2.66 and 4.65 mm/yr to the Intermediate Scenario. For example, under the Intermediate Scenario a 1.4 ft regional SLR increase will occur in 2070. However, VLM shortens the timing when the 1.4 ft SLR increase occurs. For a 2.66 mm/yr VLM rate, the 1.4ft SLR increase will occur 15 years earlier around 2055, and the 4.65 mm/yr VLM rate further shortens the timing to 24 years resulting in a 1.4 ft SLR increase occurring in 2046.
