Final Report
**Jacoby Creek Water Sustainability and Anadromous
Fish Habitat Enhancement Feasibility Study**

Bayside, California

August 2024

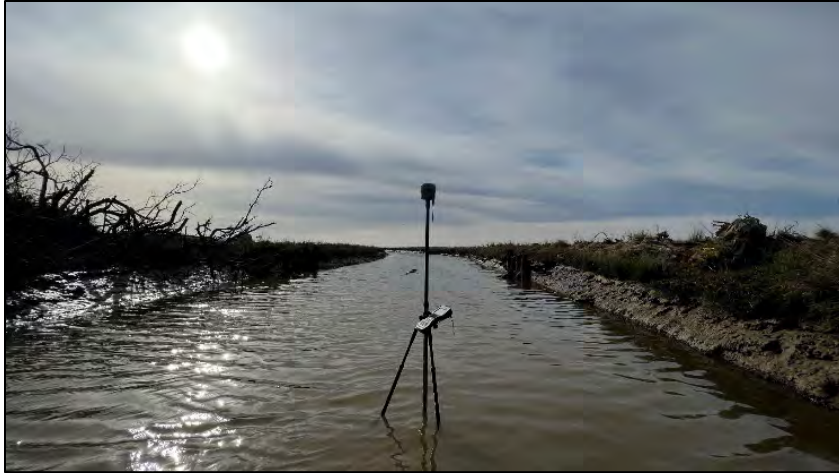
Figure 2-2. RTK rover in Jacoby Creek tidal channel west of US 101

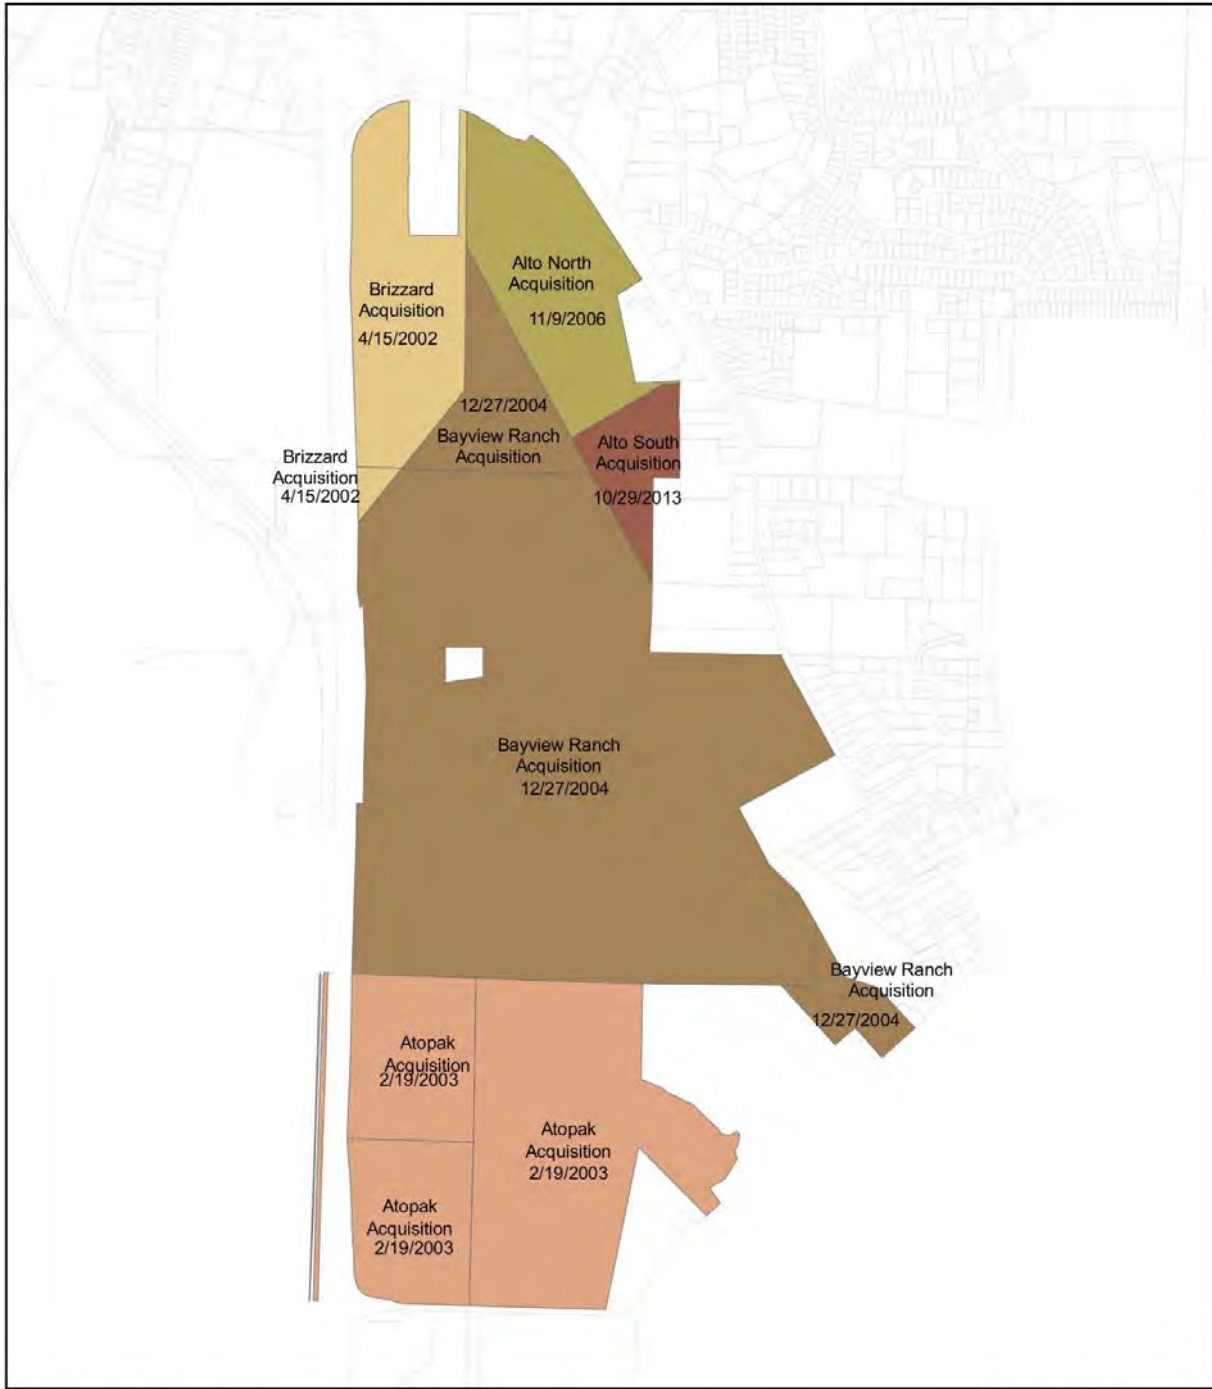
Figure 2-5. City of Arcata Restoration Projects within the Jacoby Creek Watershed.

The City of Arcata has prioritized process-based restoration and enhancement actions within the wildlife area that lead to self-sustaining low-cost operation and maintenance. Some of the key restoration projects are shown on Figure 2-5.

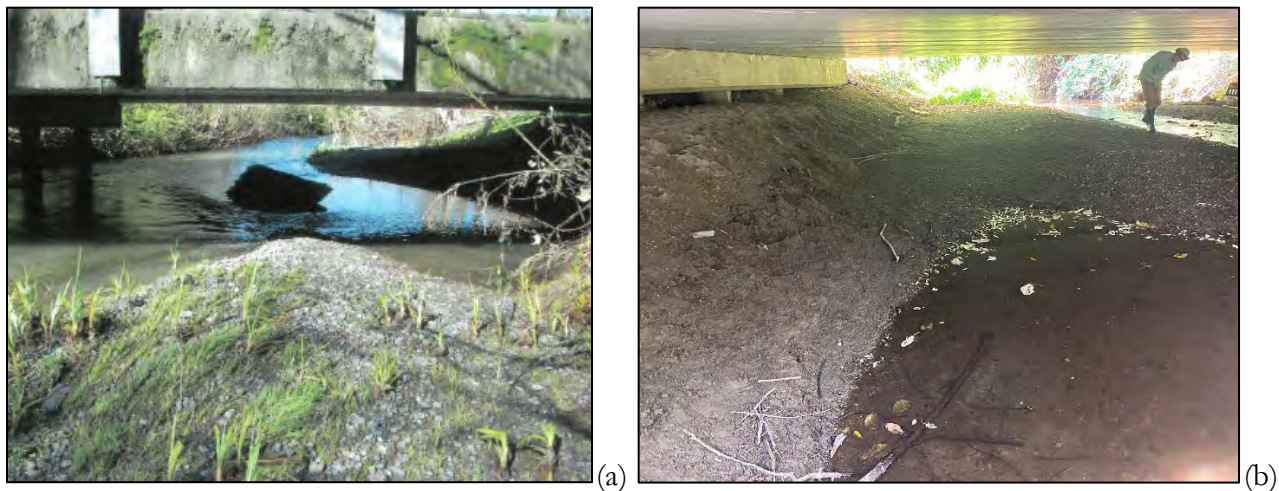
Figure 2-7. Under the northern bay of the Old Arcata Road bridge at Jacoby Creek in (a) March 2006 and (b) September 2021 showing the center bent (left on photos) buried in sediment.

The Old Arcata Road bridge at Jacoby Creek has approximately a 90-foot span bridge supported on piles. A series of concrete bents are in the center of the channel, creating two 42.5-foot bays. Based on record drawings, the pile tips for the bents are minimum 40 feet below the crown of the bridge deck. The southern bay is filled with sediment and effectively provides no flow conveyance (Figure 2-7).

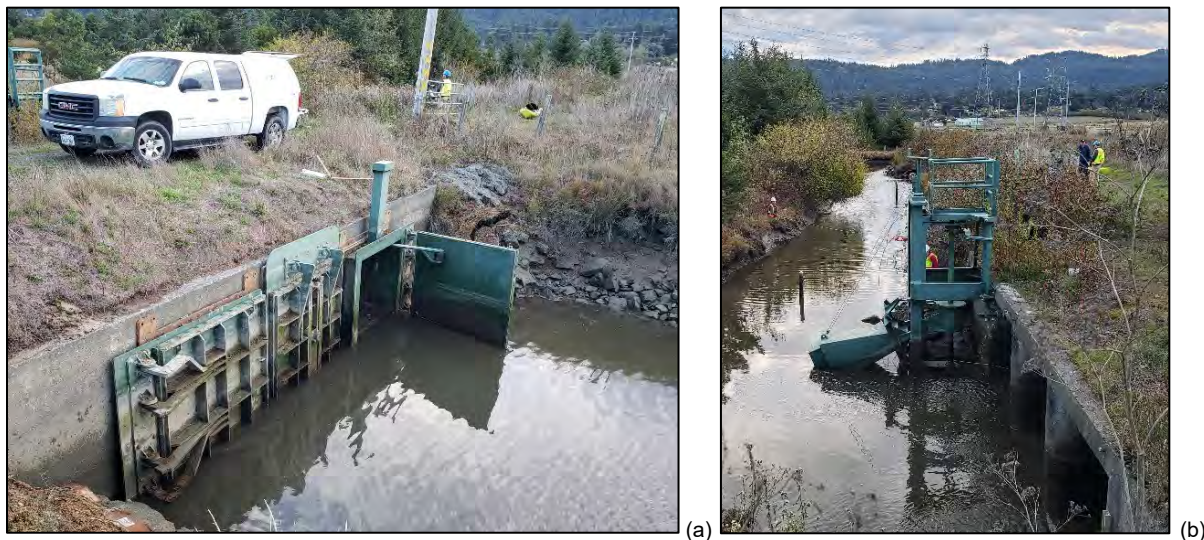
Figure 2-8. The Caltrans maintained Gannon Slough (a) tide gates and (b) MTR float.

The Gannon Slough tide gates include a 4-foot diameter circular side-hinged gate maintained by the City of Arcata installed, which contains a “pet door” within the gate that is cracked open to allow a limited amount of tidal inflow. Caltrans maintains an additional set of tide gates consisting of a triple bay box culvert, with each bay opening of 5-foot x 5-foot. These gates were replaced in 2020 and consist of one top-hinged flap gate and two side-hinged gates (Cal Poly Humboldt and MLA, 2022). The top-hinged gate has a small auxiliary door left slightly open to allow limited tidal inflow. One of the side-hinged gates has a muted tide gate regulator (MTR) with a float on the interior side of the levee used to hold the gate open on incoming tides until interior water levels reach a set elevation (Figure 2-8). Together these gates create muted tidal conditions in Gannon Slough and its tributary sloughs, with high tides contained within the banks of the slough channels.

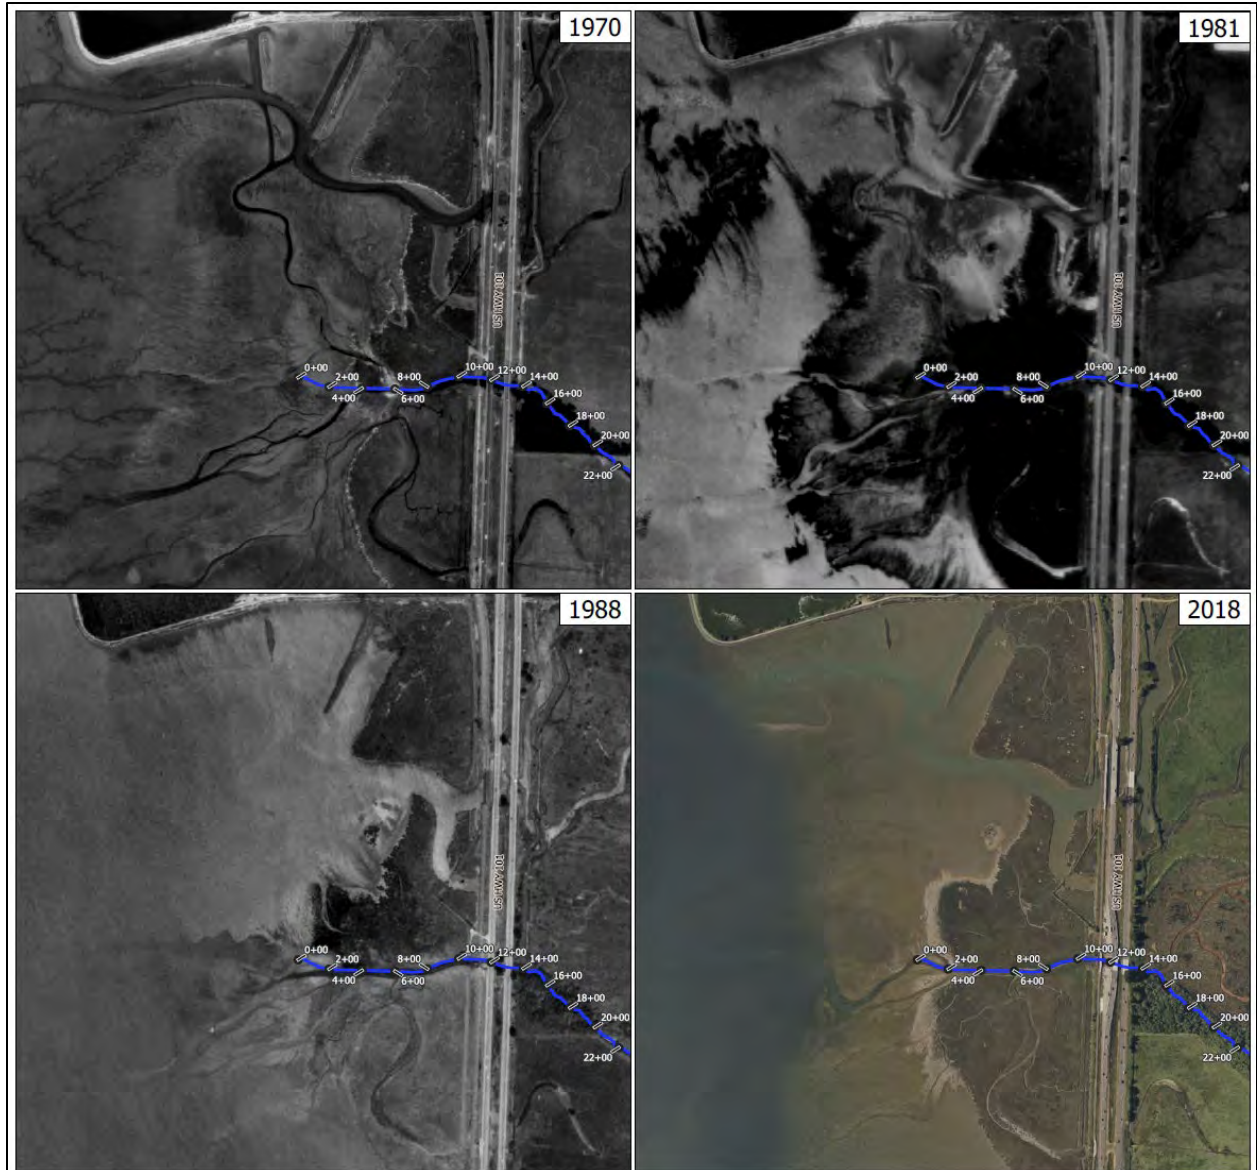
Figure 3-5. Images showing the expansion of the Jacoby Creek salt marsh delta west of US 101 between 1970 and 1981, with the extents remaining relatively stable in subsequent images (images from 2008 Historical Atlas of Humboldt Bay and Eel River Delta, and 2018 Bing Aerial)

evident by the changes in the salt marsh delta at its intersection with the mudflats of Humboldt Bay between 1970 and 1981 aerials. The extensive growth of the delta during this period is likely associated with this confinement of the channel east of US 101 combined with extensive sediment delivery to Jacoby Creek and its tributaries during the 1964 flood of record and the preceding timber harvest practices that exacerbated conditions. Much of this in-channel sediment was likely routed out towards Humboldt Bay during larger flood events between 1970 and 1981, unable to spread out laterally east of US 101, like it would have prior to diking.

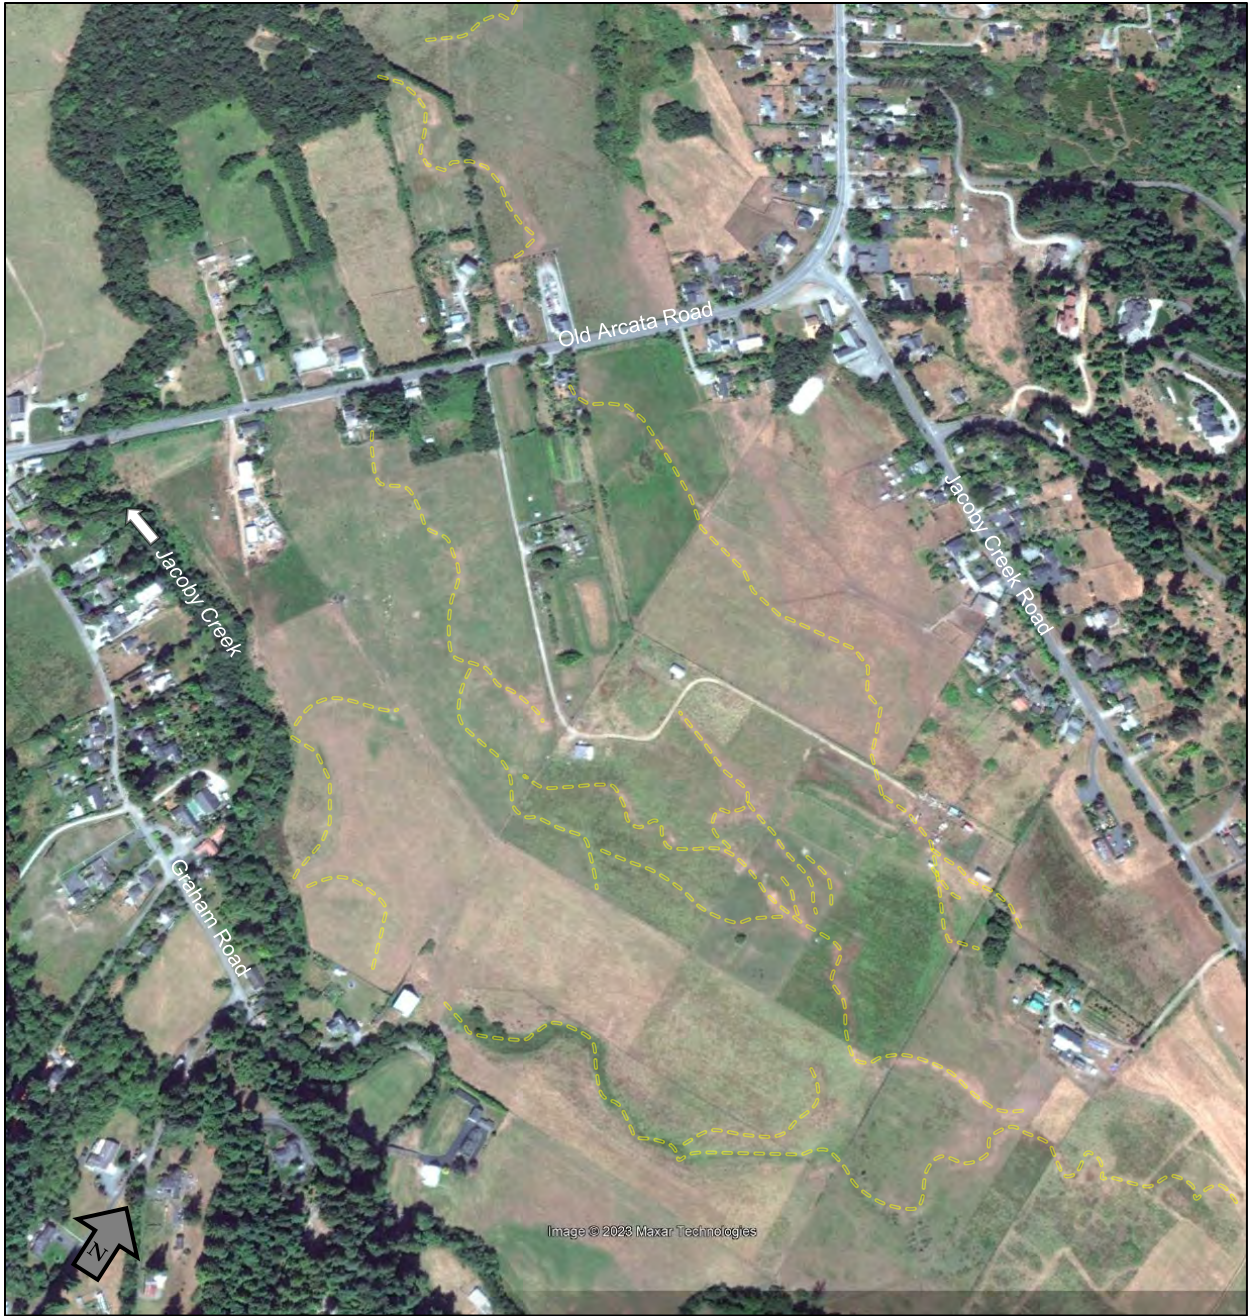
Figure 3-6. September 2011 Google Earth image highlighting channel traces within the grass fields, likely associated with coarser material deposited within historical channels across the valley bottom.

A review of the satellite images available from Google Earth revealed evidence of historical channel traces across the Jacoby Creek valley (Figure 3-6). These are most prominent during the September 16, 2011 image (Figure 3-6) and other images taken during early fall, when there are regions of both green and brown grasses. Coarser streambed material often deposited within the channel bed is better draining, resulting in delayed greening during the early fall rains. Some of the channel traces matched traces observed in the 1965 post-flood image (Figure 3-4).

The 2011 image shows a multi-channel network of historical channel traces upstream of OAR that span the full width of the valley. Some of the channel traces are likely associated with small tributaries rather than Jacoby Creek. The direction of these traces suggests some of the flow was routed down the valley bottom and into the large tidal slough network that are shown in the 1870 map in present-day Arcata Baylands North. This multi-channel network is consistent with the historical descriptions given in newspaper clippings from the 1850's and 60's (Van Kirk, 2015) and in Schafran (1984). This suggests the historical Jacoby Creek delta consisted of a diversity of interconnected low-gradient aquatic habitats that transitioned from tidal marine and brackish to freshwater fluvial over an extended distance.

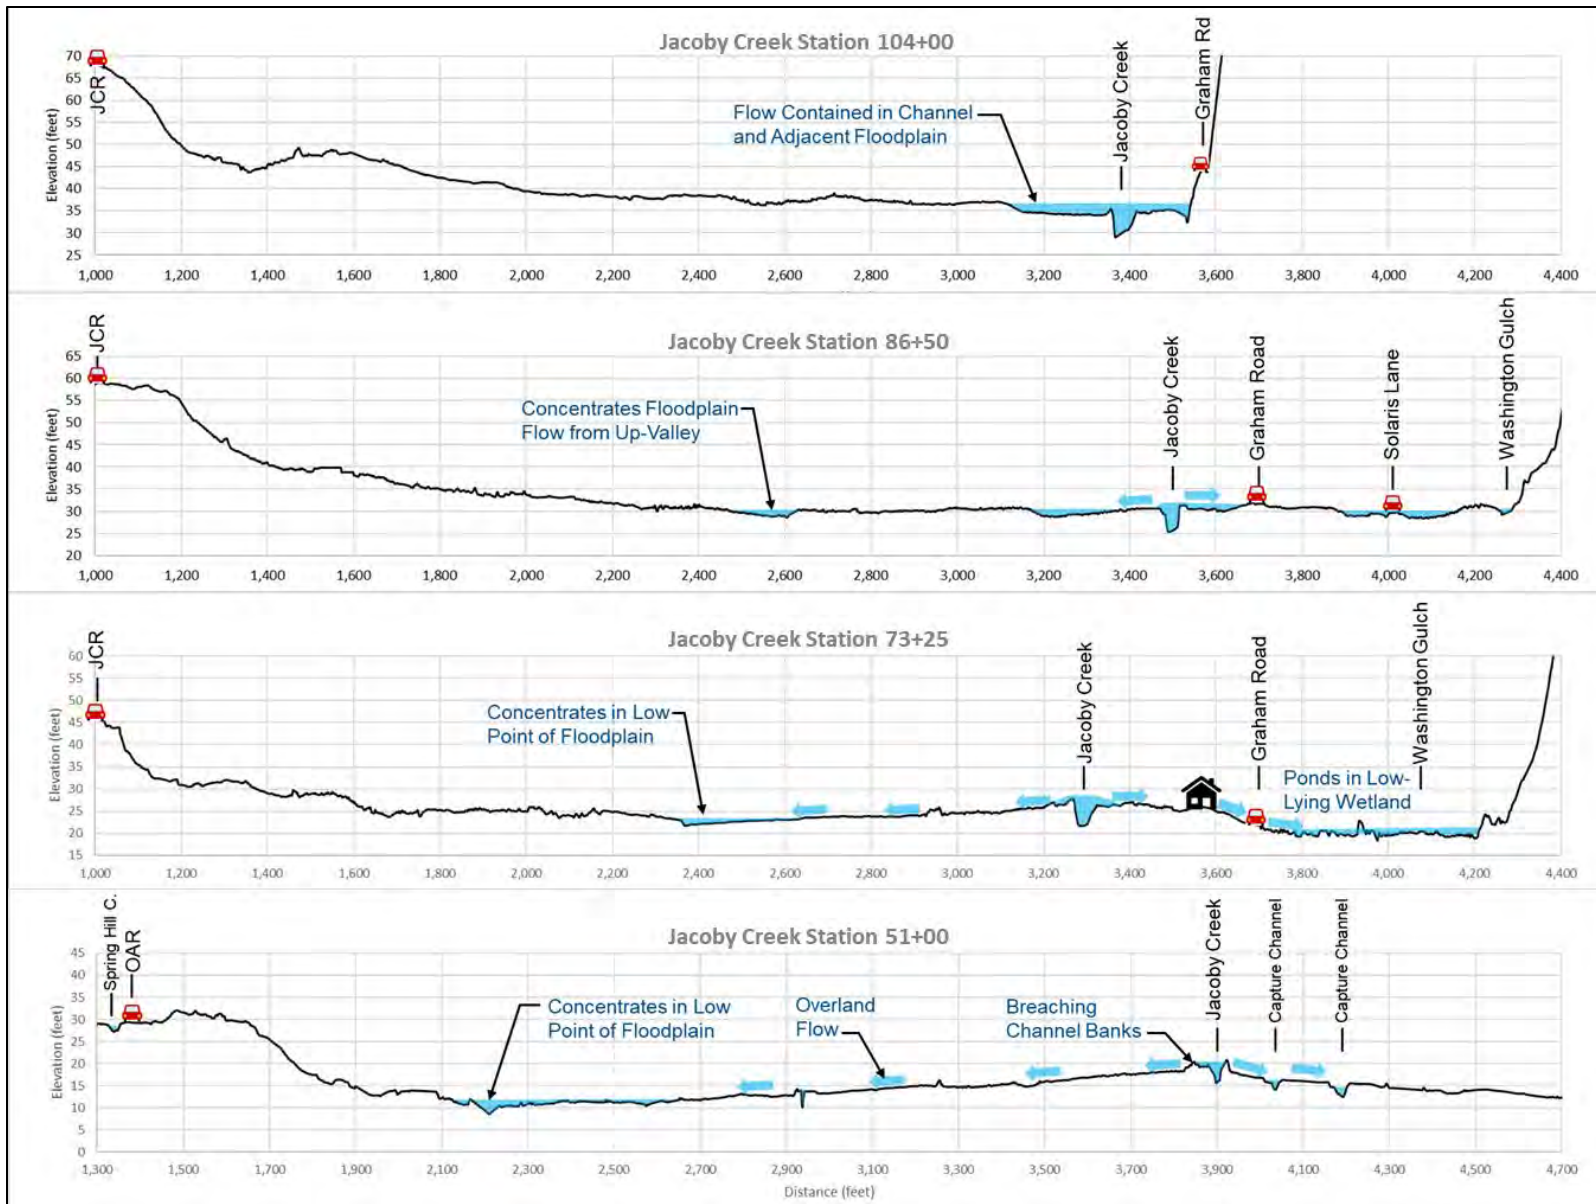
Figure 4-2. Valley cross sections showing elevational differences and floodplain inundation patterns.

Four valley wide cross sections are cut at the locations indicated in Figure 7-1 and are shown in Figure 4-2. They illustrate that moving down-valley the channel banks become perched above the valley bottom. Station 51+00 also shows the levees that have historically been built along the top of bank.

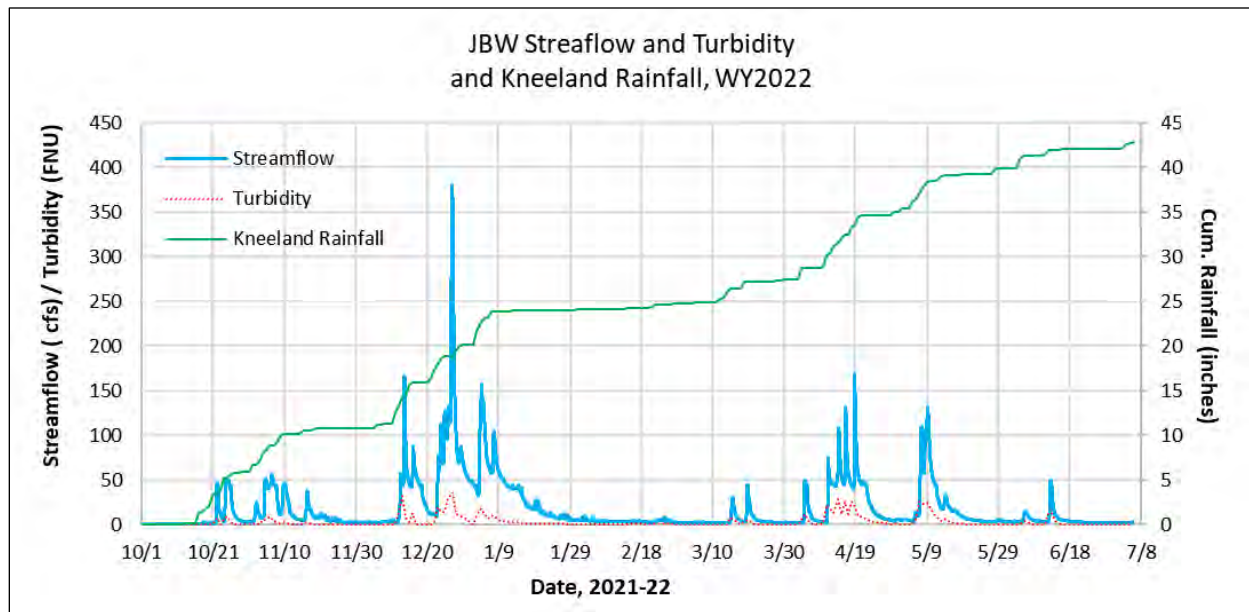
Figure 4-3. Water year (WY) 2022 instantaneous streamflow and turbidity at the JBW gaging station and cumulative precipitation at Kneeland. Maximum instantaneous streamflow of 381 cfs.

The water year (WY) 2022 streamflow, turbidity, and cumulative precipitation are plotted in Figure 4-3. Annual rainfall was only 62% of average and the peak discharge of 381 cfs has an approximate return period of less than 1.01 years. Despite the lack of any substantial large flow events, substantial overbank flooding occurred within the study area.

The peak flow event for WY2022 occurred on December 27, 2021 (Figure 4-3). It was minor event with a return period of less than 1.01-years based on the 20 years of record from the JBW gage. The event was simulated using the project model and Scenario 2 (Table 6-1), to evaluate inundation and drain-off patterns. Figure 6-5 shows the Jacoby Creek inflow hydrograph for the event and five snapshots in time of the inundation depth and flooding extents from the model simulation.

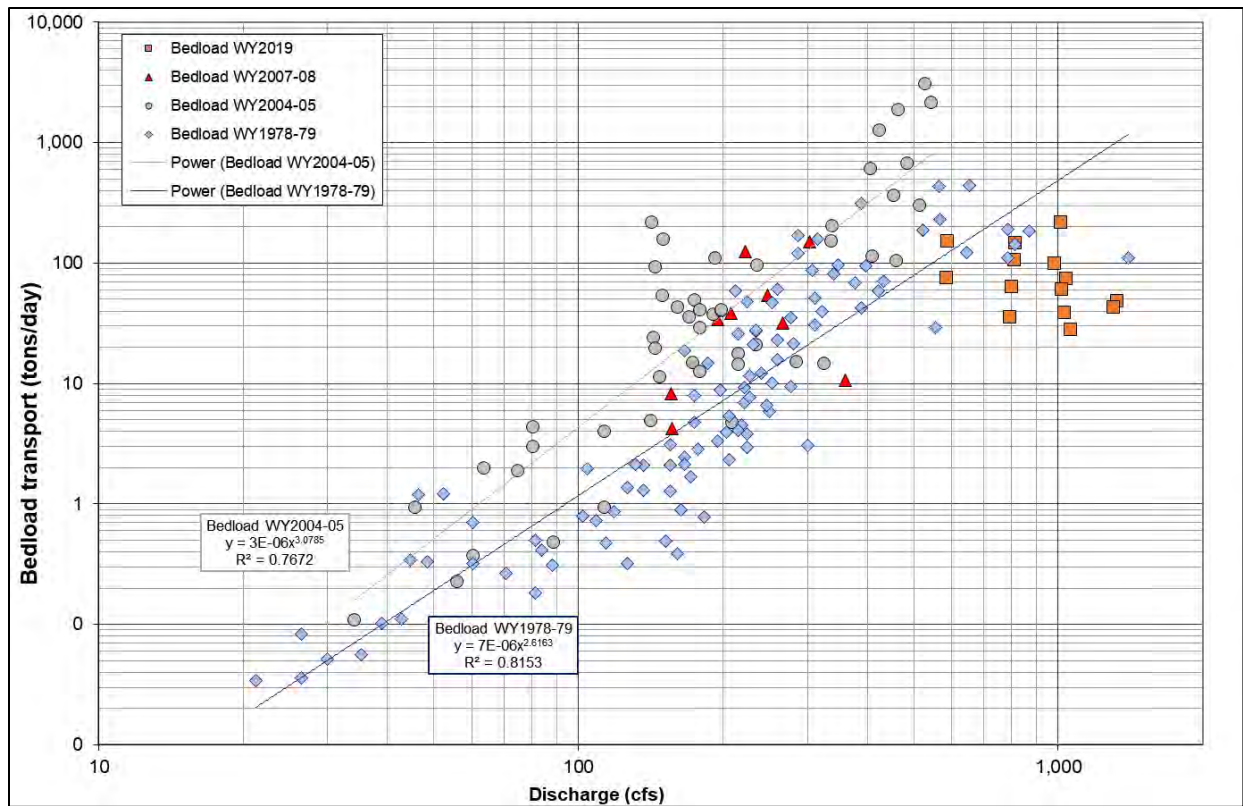
Figure 4-4. Jacoby Creek at Brookwood Bridge (JBW) bedload discharge rating.

High flow bedload samples were taken from the bridge at JBW during different periods. In water year (WY) 1978 and 1979 bedload samples and associated stream discharge measurements were taken at the Brookwood Bridge by the US Forest Service Redwood Science Lab as part of a research project. Subsequently, Randy Klein and Wes Smith collected bedload samples in WY 2004, 2005, 2007, 2008, and 2019. As part of the current study, each of the 13 samples taken in WY 2019 were sieved to determine the cumulative particle size distribution of the material in transport. Measurements of bedload discharge versus streamflow are plotted in Figure 4-4.

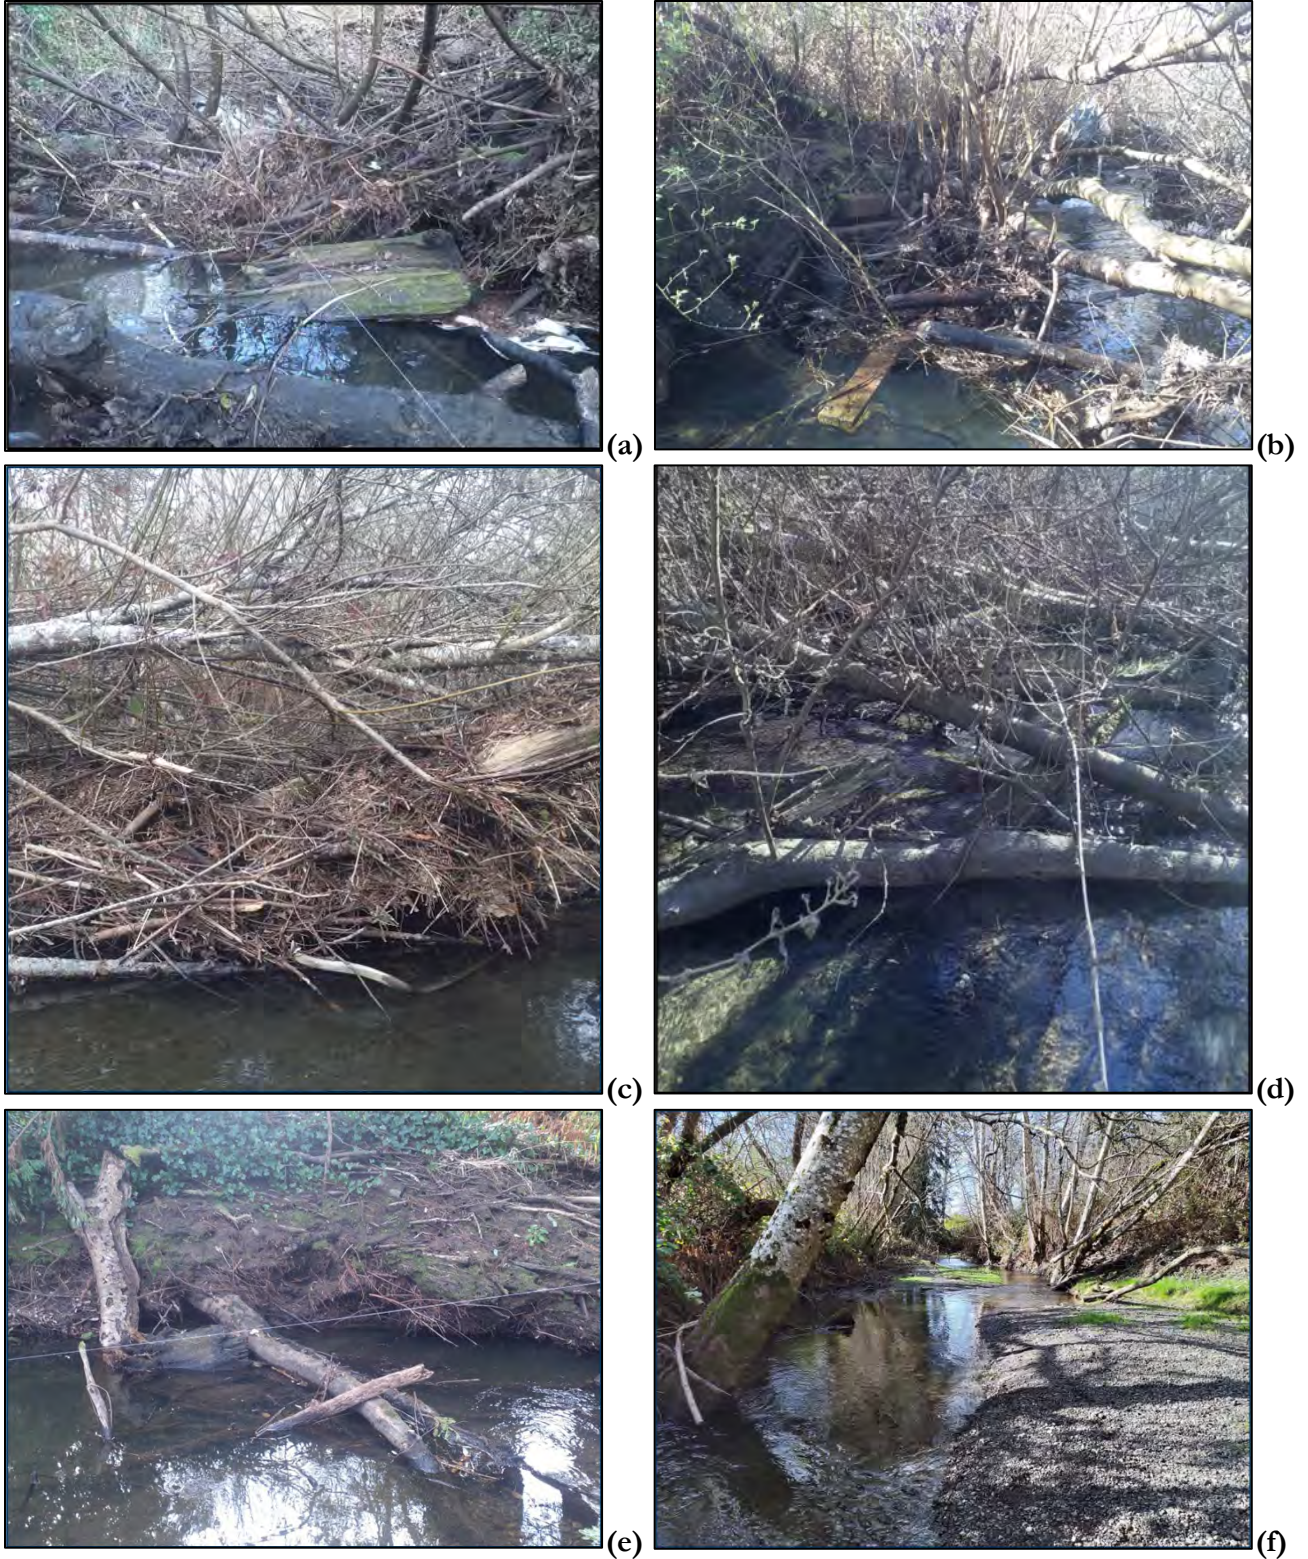
Figure 4-7. Examples of small woody debris jams (a&b) formed by in-channel vegetation and cut lumber and initiated by (c) a fallen alder. Some channel obstructions are completely formed of (d) live willow. Upstream of OAR much of the debris and in-channel vegetation had been cleared in (e) 2019 and (f) 2021.

SWD jams, especially downstream of OAR, often had anthropogenic materials incorporated into the jam (Figure 4-7). It was common to find pieces of lumber in these jams, such as two-by-fours, as well as other wood that did not originate from the stream (i.e., pallet board, wooden planter box). It was also very common to find cut rounds of trees, which were visibly cut by chainsaw, that became trapped in the SWD jams. Aside from wood materials, the SWD jams also collected brush debris, which may or may not have naturally found their way into the stream. Propane tanks, plastic bottles, and metal cans were also found in the SWD jams, particularly near OAR bridge.

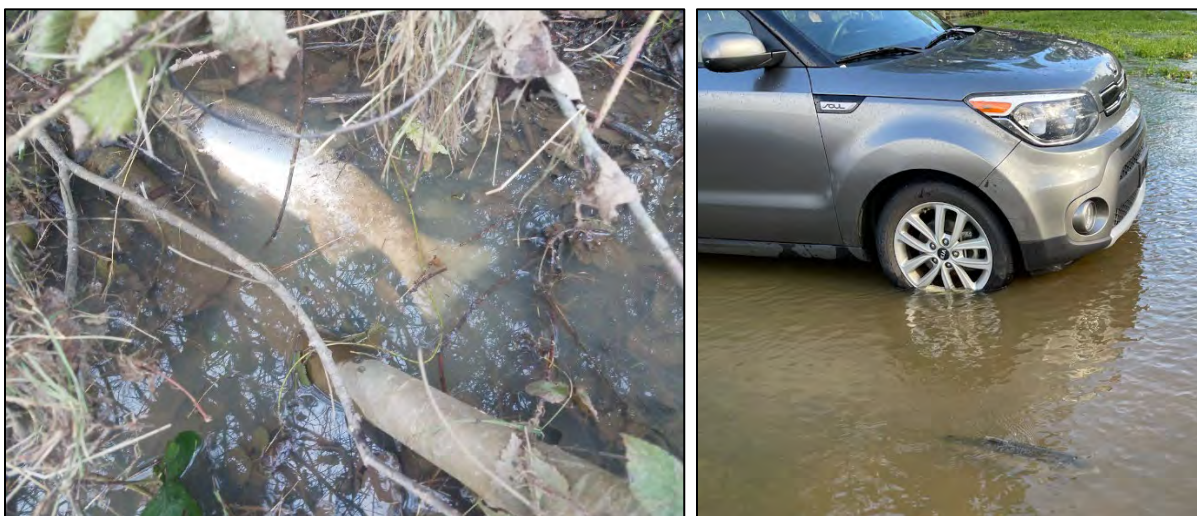
Figure 4-8. Adult unspawned female coho salmon carcass (left) on floodplain and stranded coho salmon rescued from driveway (right). Photos from TGAEC and Carol Anderson.

TGAEC conducted fisheries sampling in flooded pastures and documented adult Coho Salmon stranding during overbank flooding in December 2021 and January 2022. They prepared a field memo, which is provided in Appendix G. The memo documents the observation of three adult Coho Salmon stranded around a residence on the north side of Jacoby Creek downstream of OAR. This included an unspawned female coho carcass recovered on the floodplain in brushy vegetation on December 30, 2021 and a Coho Salmon captured by CDFW biologist near a barn and released back to Jacoby Creek. The memo also documents the capture of a juvenile Coho Salmon on the inundated floodplain on this same property.

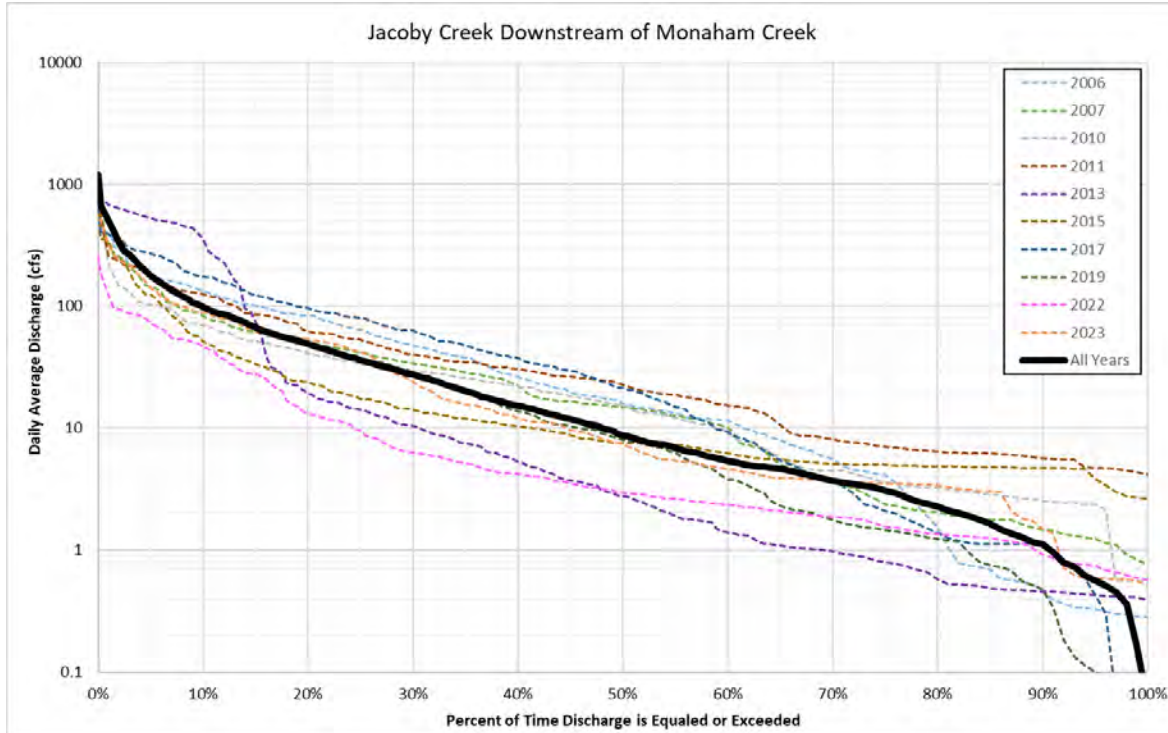
Figure 5-1. Annual flow duration curves (FDCs) for Jacoby Creek downstream of Monaham Creek, calculated using JBW daily average flows scaled by difference in drainage areas. Plots include each FDCs for each water year and from all water years combined.

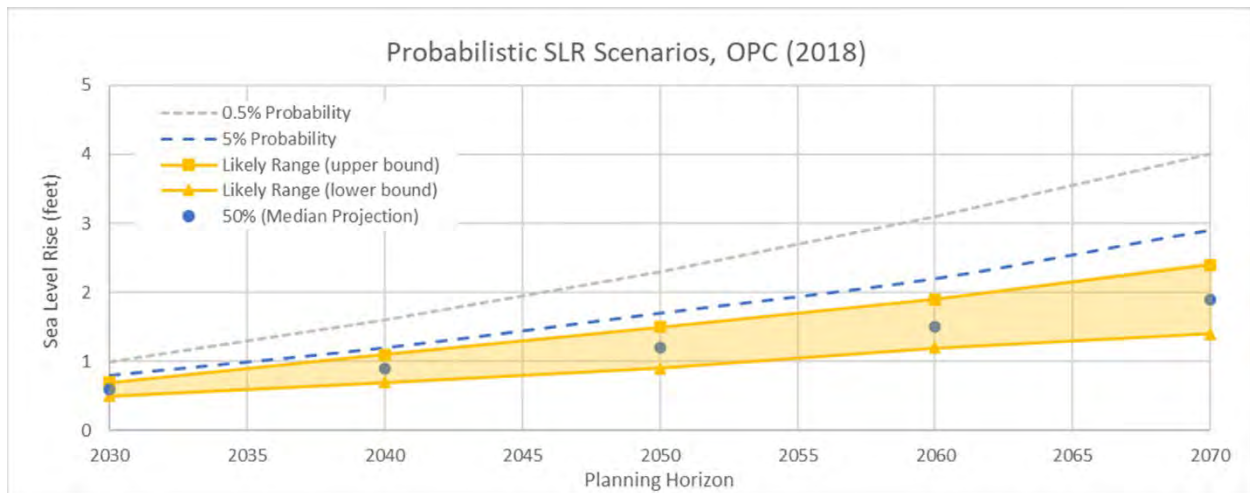
Figure 5-2. Sea level rise projections at North Spit, with baseline level from 2000 (OPC, 2018)

SLR projections may be added to existing tidal datums and extreme high-water level probability estimates in Table 5-2. The increased probability of higher water levels in the future with SLR (Table 5-3) are modeled to indicate the extent of overtopping of shoreline infrastructure and coastal flooding.

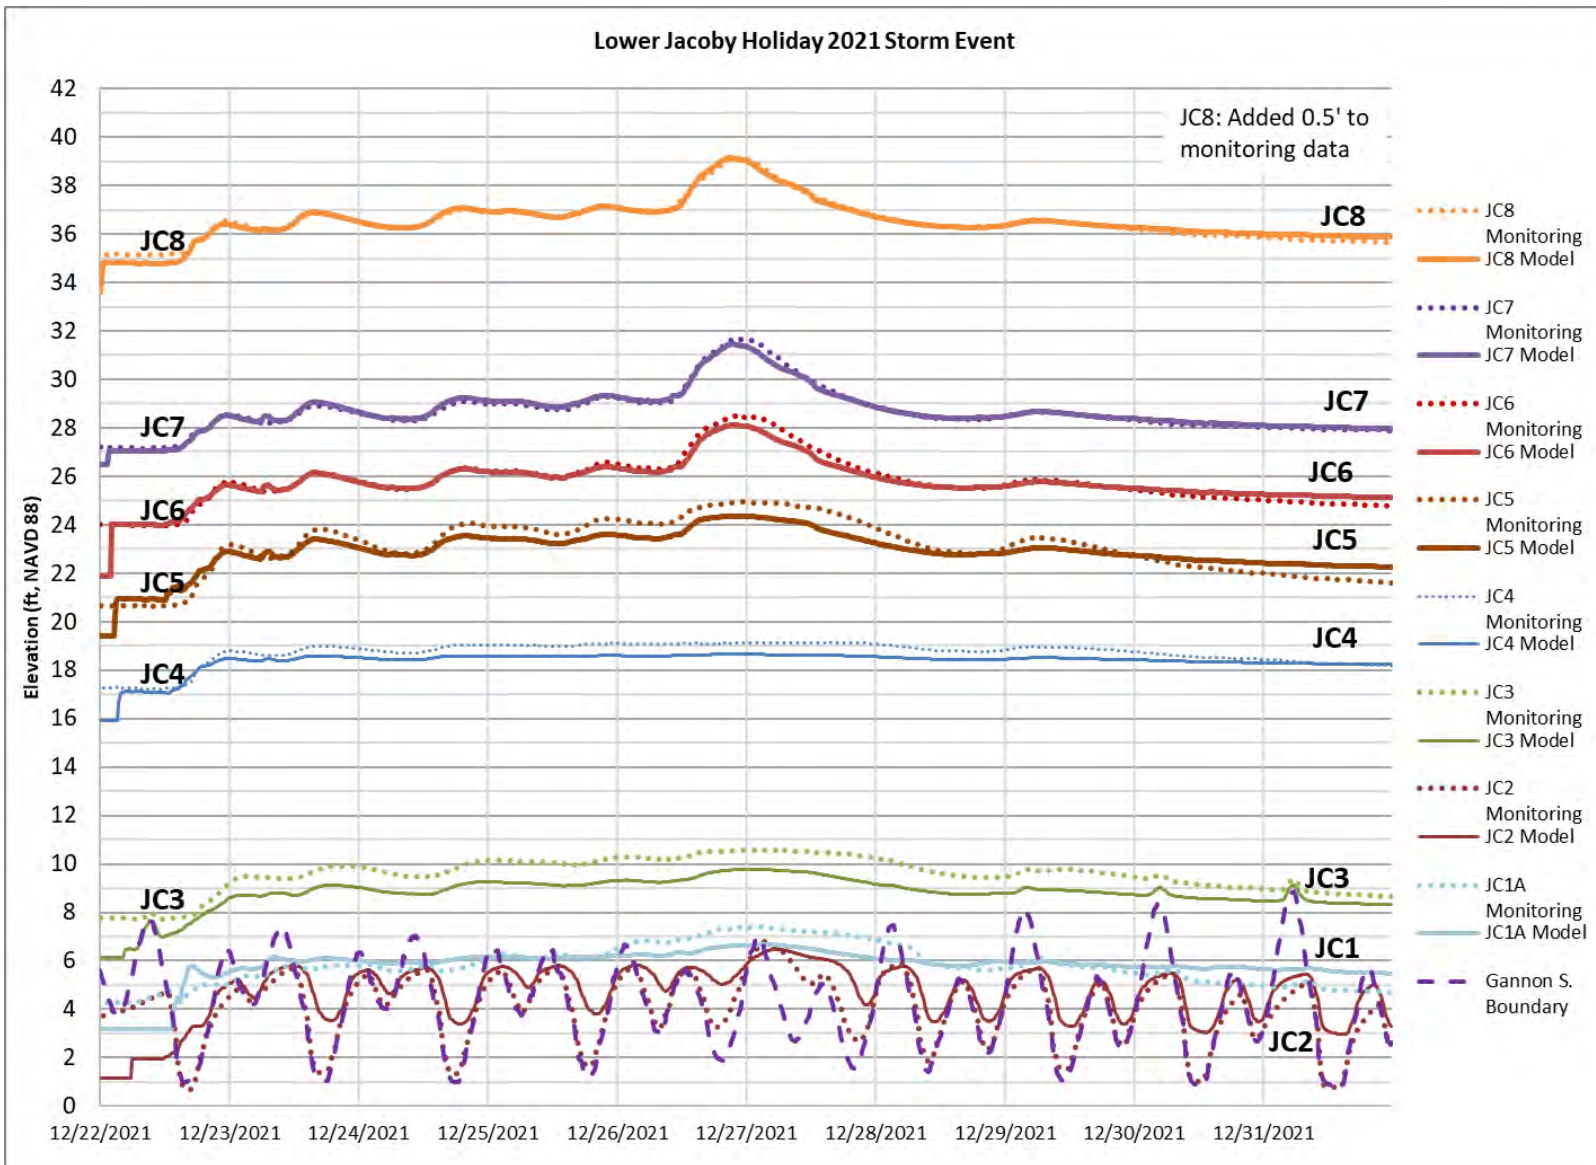
Figure 6-2. Modeled versus measured water surface elevations at water level monitoring locations for WY2022 peak flow event.

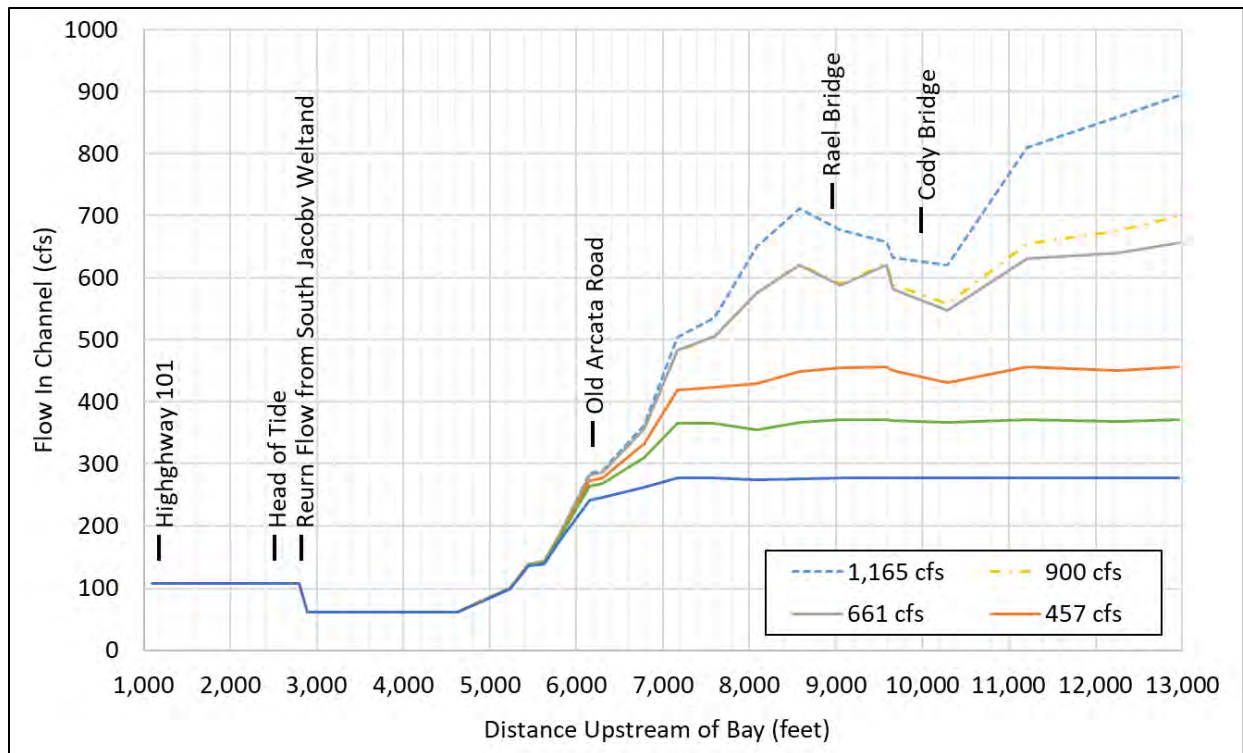
Figure 6-3. Flow remaining in channel at given Jacoby Creek station.

Figure 6-3 shows larger flows spilling out of bank further upstream than smaller flows. At 278 cfs, flows begin leaving the channel approximately 1,000 feet upstream of OAR. At 661 cfs, flows leave the channel downstream of the Rael bridge and do not return. During a 2-year event of 1,165 cfs, flows leave the channel upstream of the Cody bridge and do not return. These substantial flow losses have implications on both overbank flooding as well as the ability of the channel to continue transporting sediment delivered from upstream.

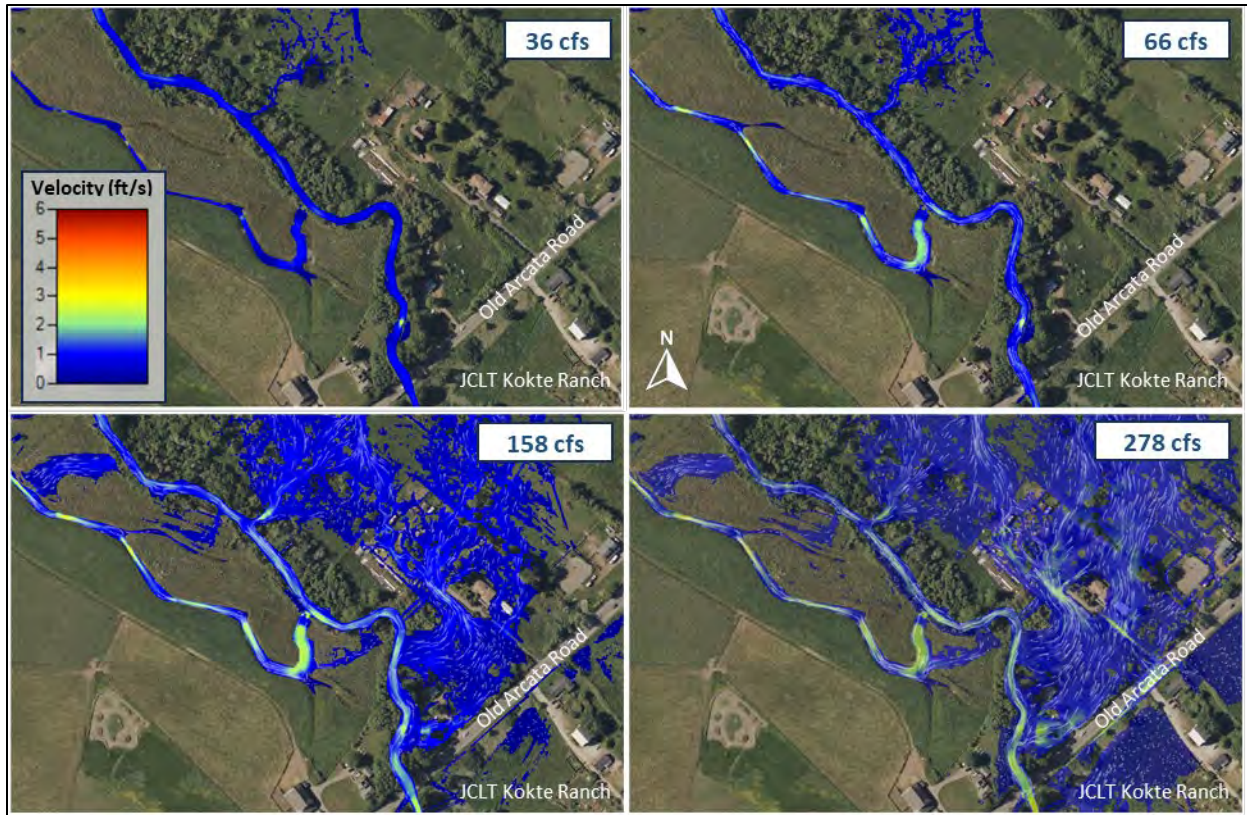
Figure 6-4. Model simulations showing locations flow spills out of Jacoby Creek channel banks downstream of OAR at 36 cfs, 66 cfs, 158 cfs, and 278 cfs.

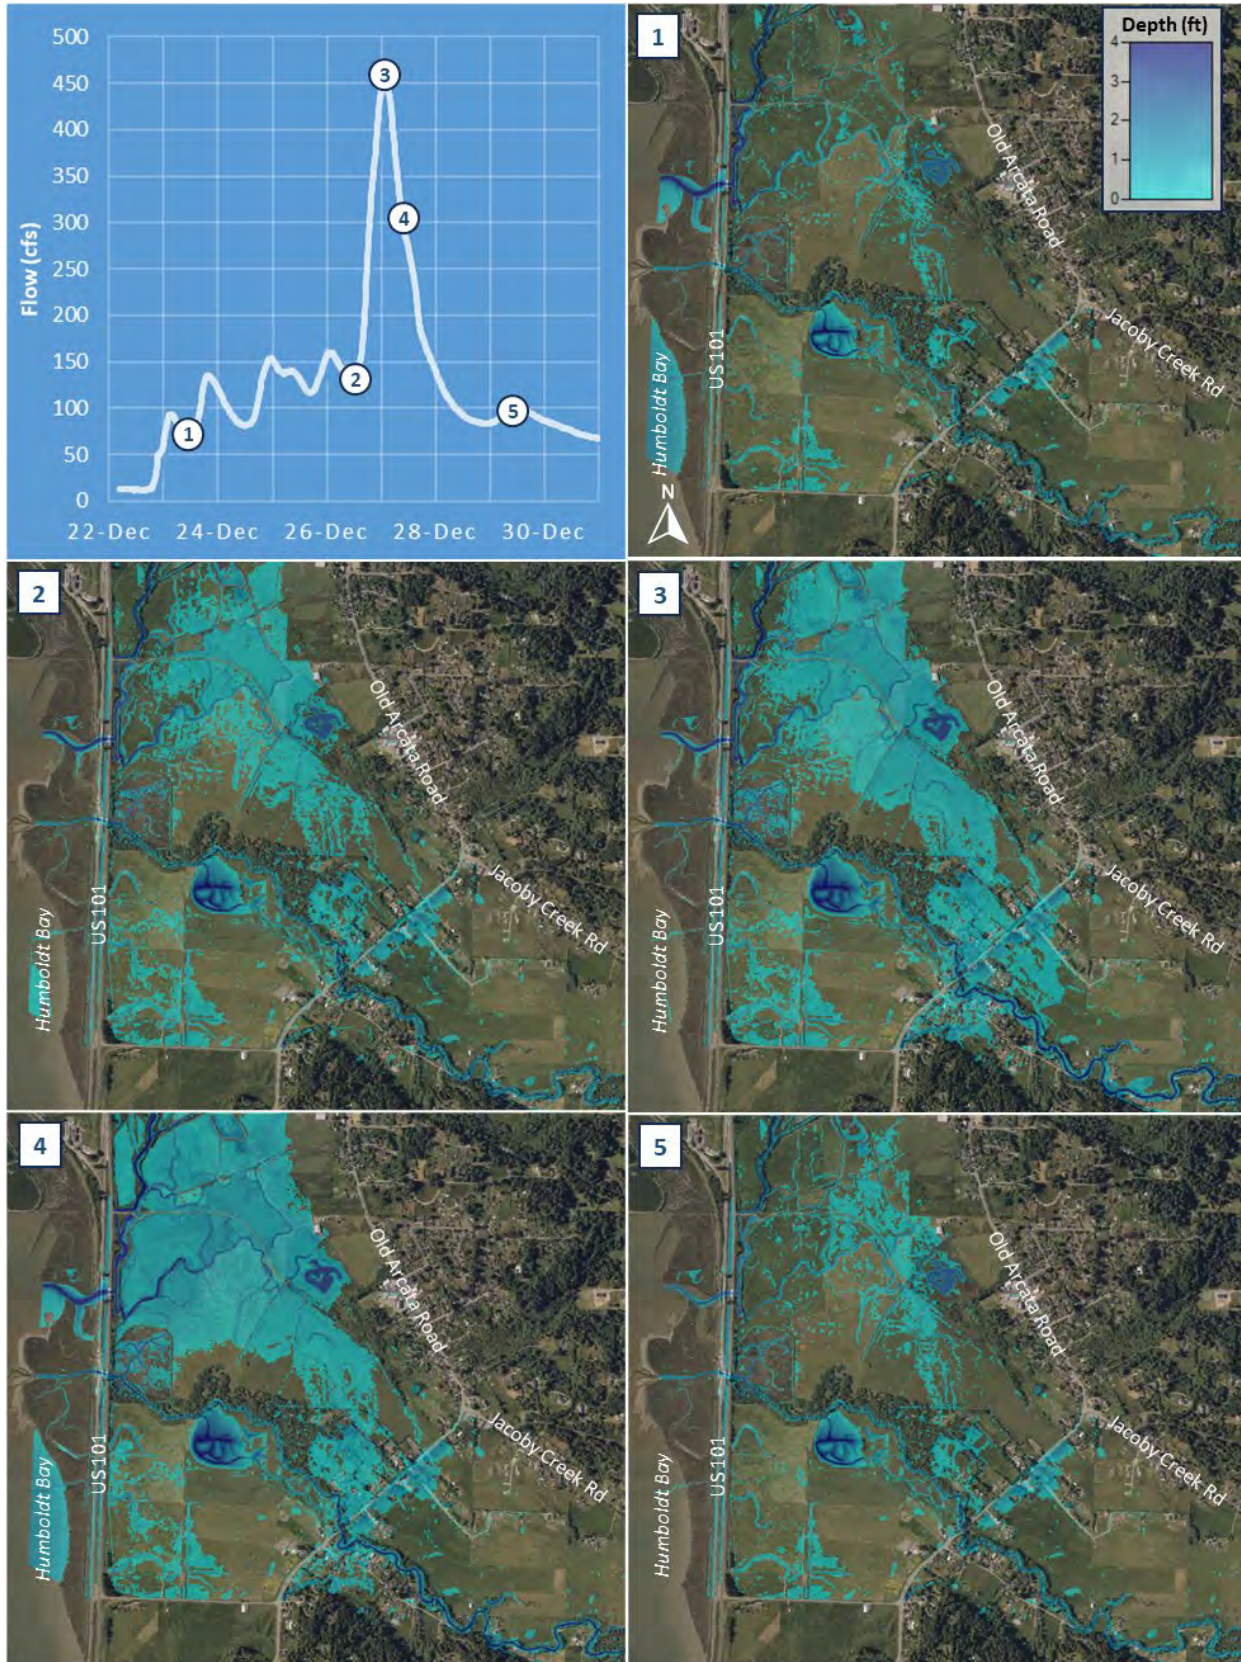
Figure 6-5. Flow at model inflow and snapshots of inundation from 2021 Holiday Event simulation.

Frame 5 is from 2 days after the peak of the event, with in-channel flows returning to 100 cfs. Water continues to spill out of select locations along both banks downstream of OAR, but widespread inundation has ceased and the ponded waters in the Arcata Baylands North have mostly drained out to the bay.
