Final Report
**Jacoby Creek Water Sustainability and Anadromous
Fish Habitat Enhancement Feasibility Study**

Bayside, California

August 2024

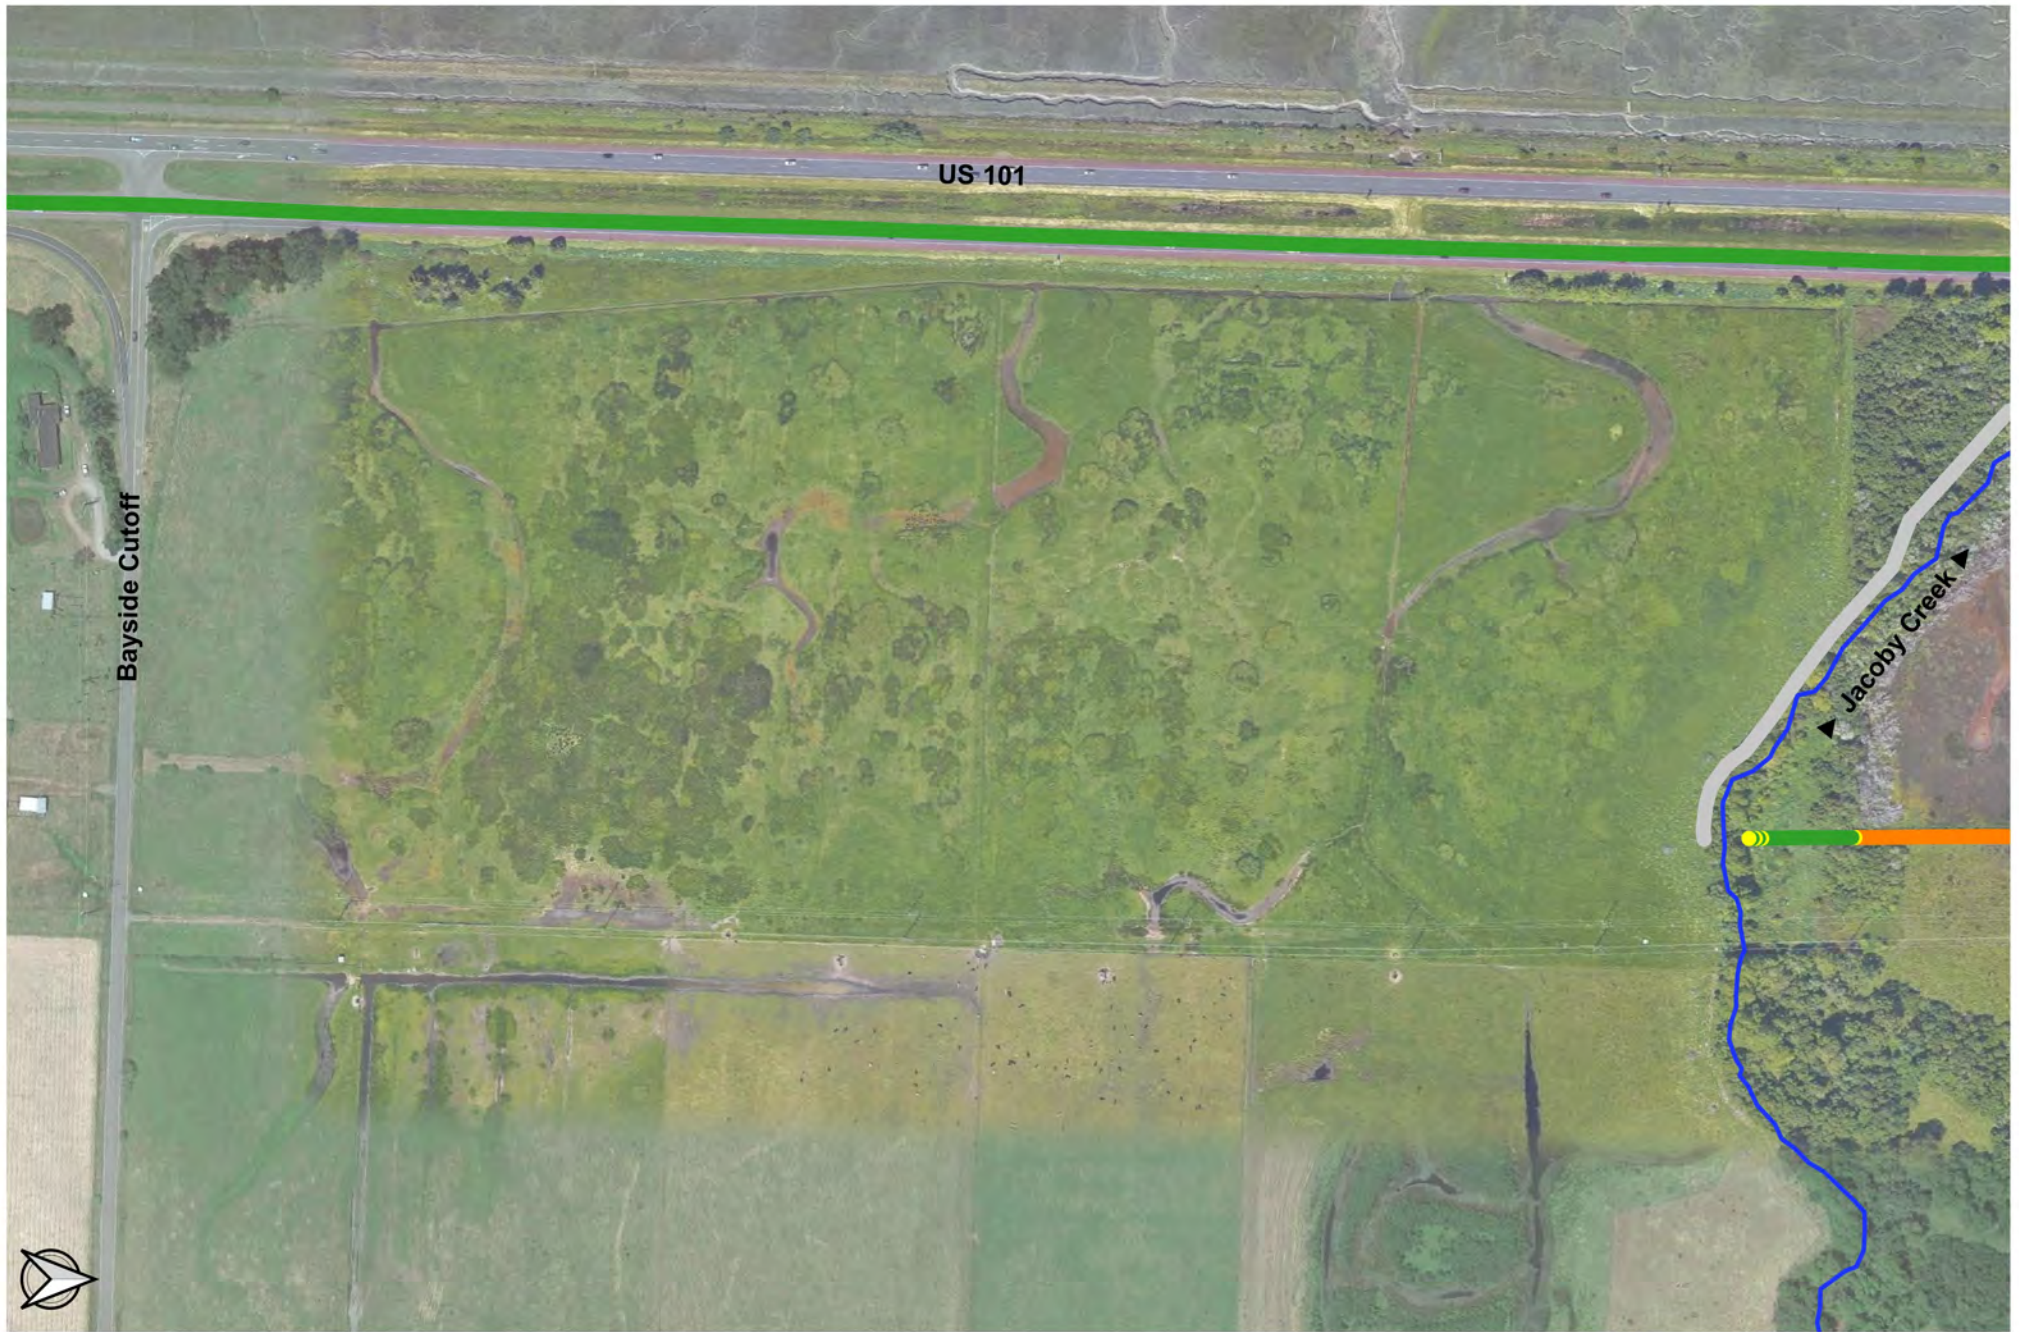
Datums:
 Horizontal: NAD83 State Plane CA Zone 1
 Vertical: NAVD88

Sources:
 Elevation: 2019 Eureka Lidar DEM
 Aerial Image: Google Satellite

The hydraulic modeling results suggest the existing earthen levees paralleling the east side of US 101 are currently vulnerable to tidal water overtopping and the frequency of overtopping will increase with sea level rise. The short-term (mid-century) impacts from overtopping and increased inundation are anticipated to result in continued levee erosion, decline in agricultural pasture productivity from saltwater inundation, and prolonged delays in accessing the utility corridors. The City of Arcata is embarking on a sea level rise vulnerability and adaptation planning process in 2024 that will provide additional information related to coastal and fluvial flood hazards within the study area. Impacts on groundwater levels from sea level rise will also be assessed qualitatively. The results from the planning process will inform adaptation strategies throughout the City, including the study area, for mid and late-century.

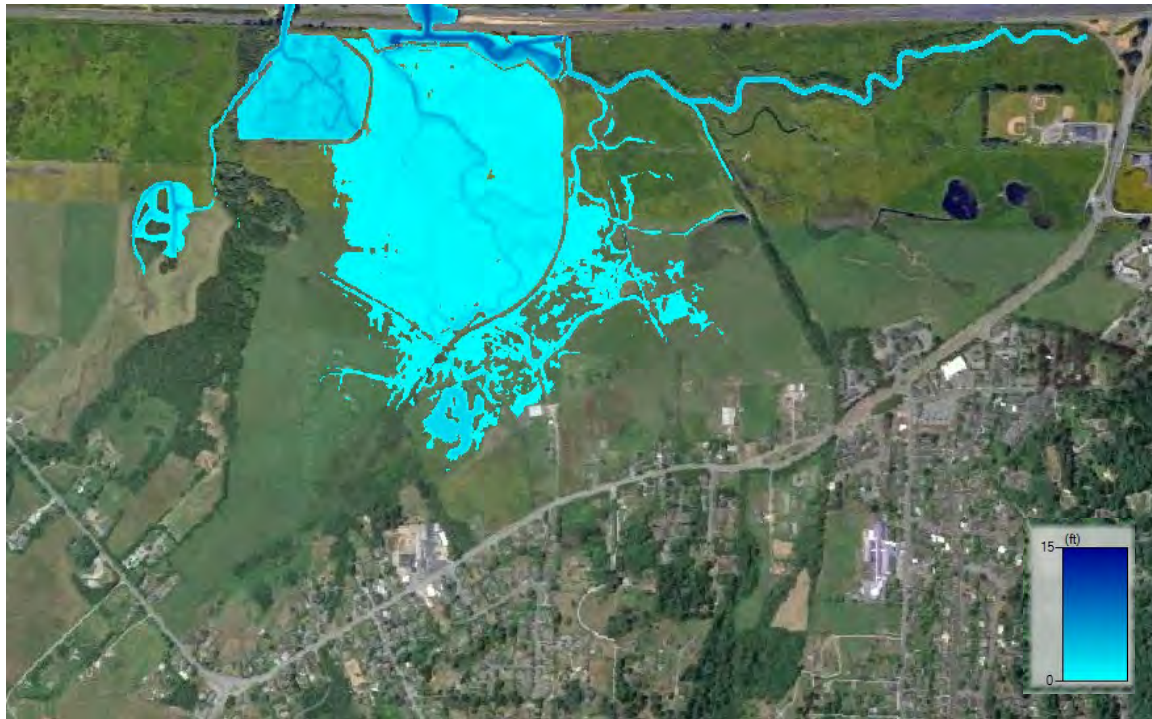
Figure 6-10. Modeled extent of tidal flooding for a peak tide of 9.4 feet in Humboldt Bay.

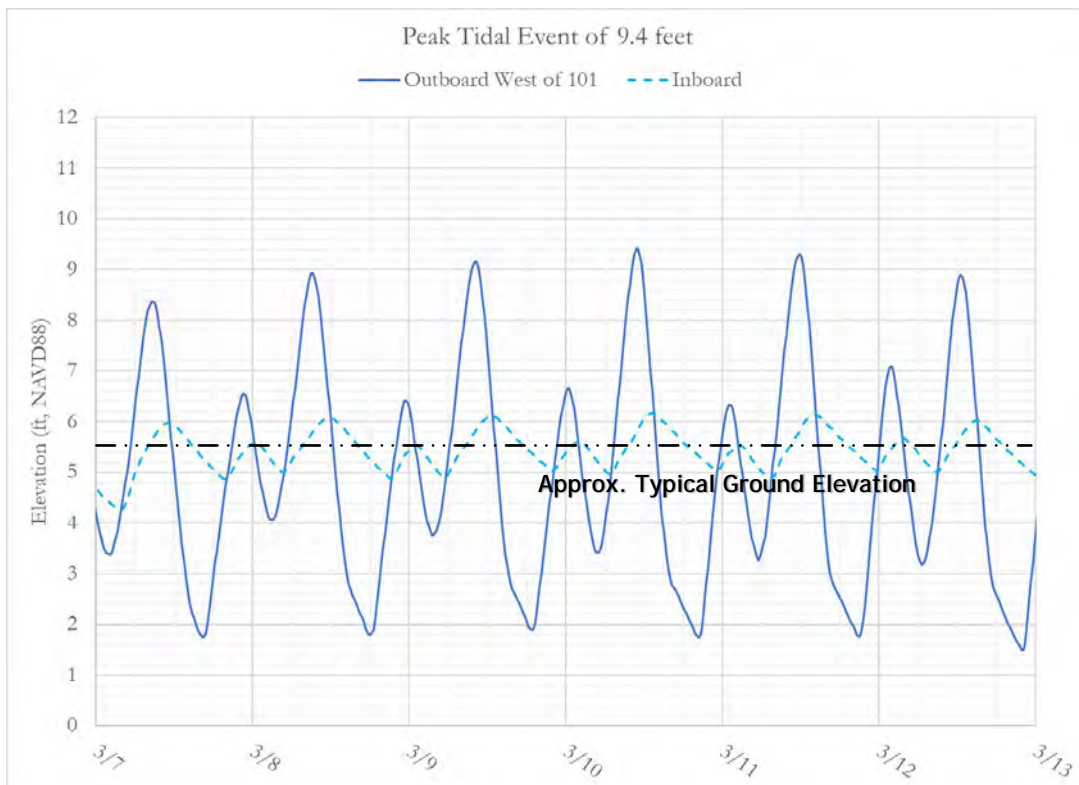
Figure 6-11. Modeled tidal water levels in Humboldt Bay with peak tide of 9.4 feet and resulting peak water levels of 6.2 feet inboard of the levees.

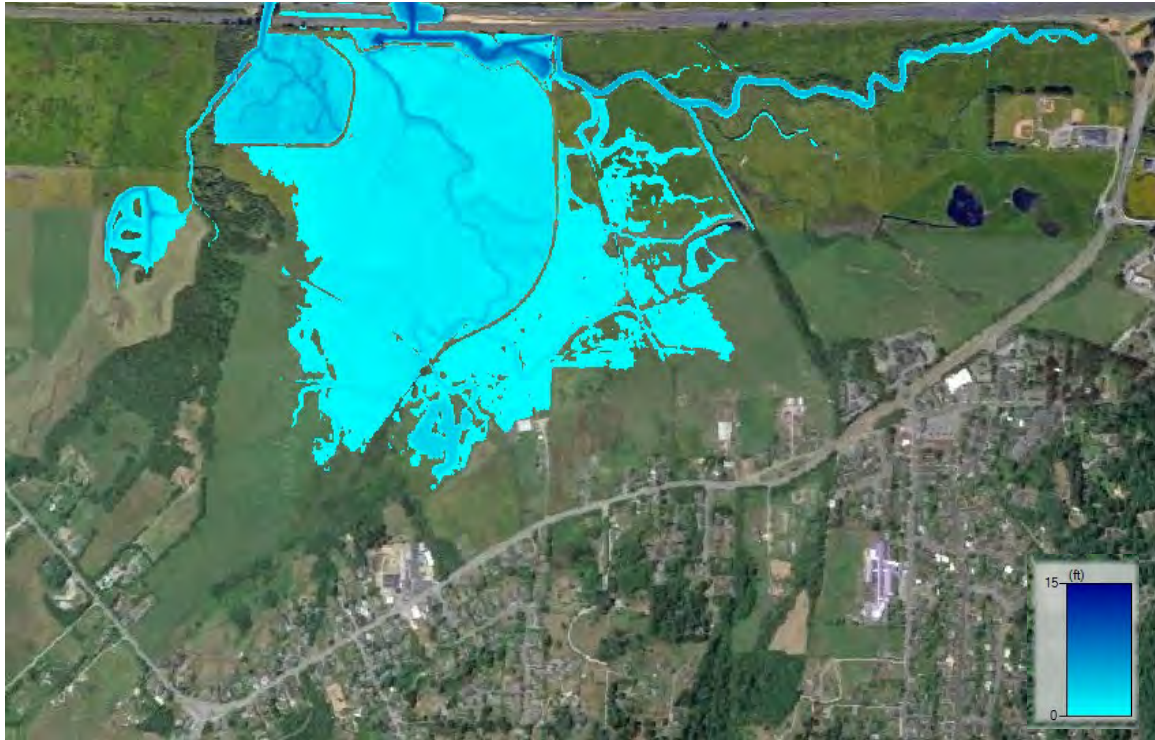
Figure 6-12. Modeled extent of tidal flooding for a peak tide of 10.0 feet in Humboldt Bay.

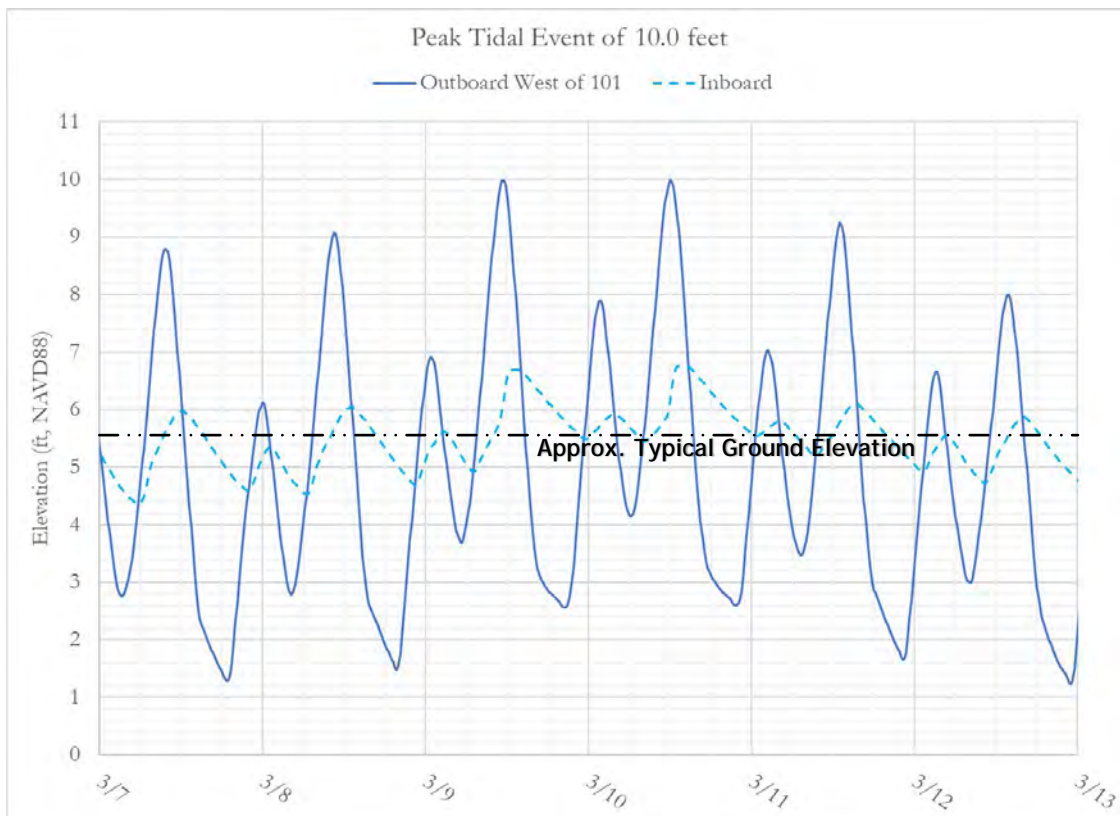
Figure 6-13. Modeled tidal water levels in Humboldt Bay with peak tide of 10.0 feet and resulting peak water levels of 6.8 feet inboard of the levees.

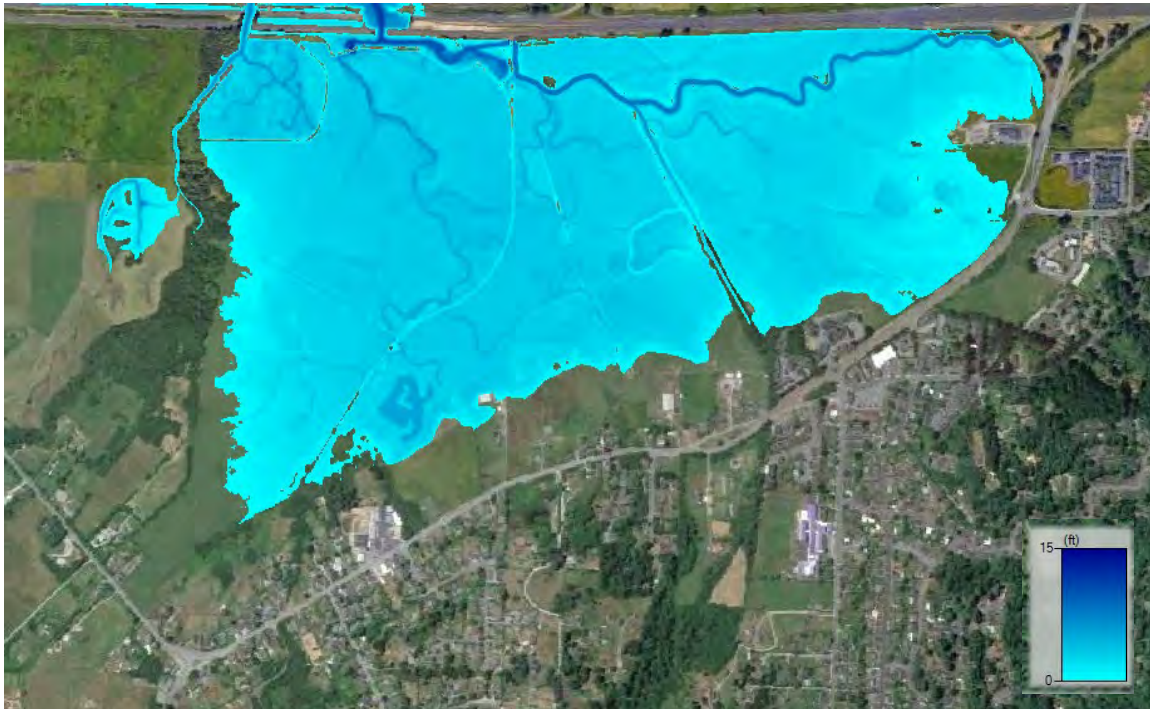
Figure 6-14. Modeled extent of tidal flooding for a peak tide of 10.7 feet in Humboldt Bay.

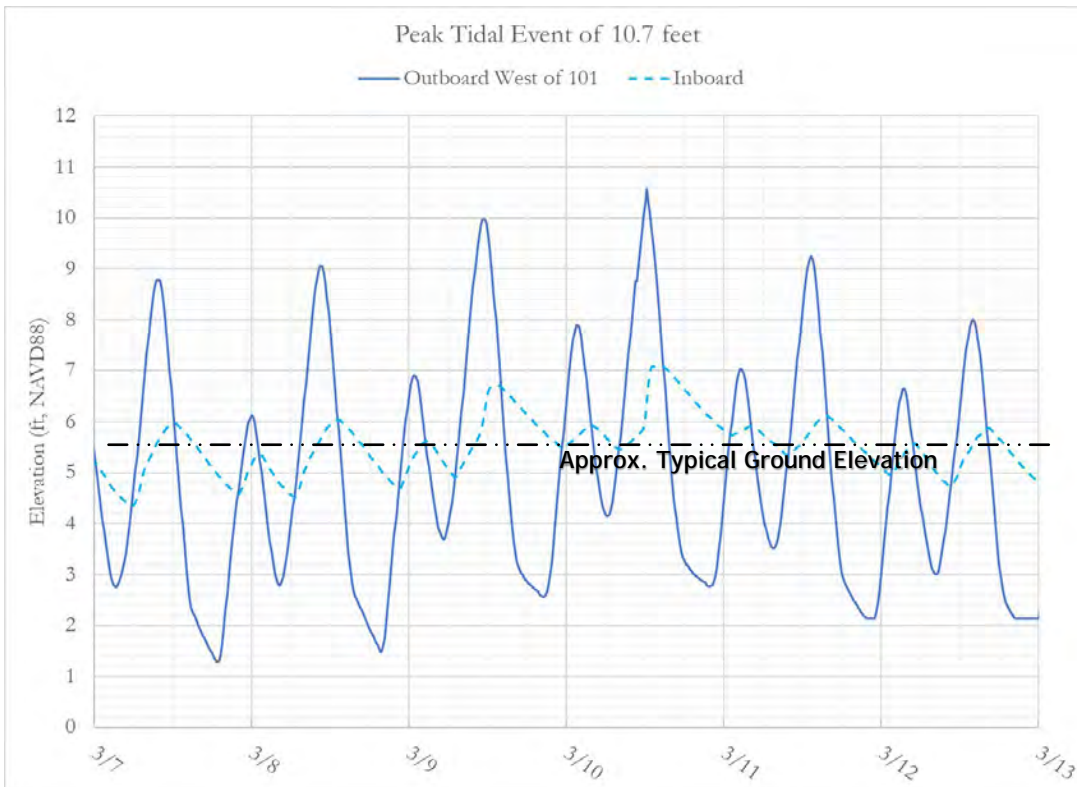
Figure 6-15. Modeled tidal water levels in Humboldt Bay with peak tide of 10.7 feet and resulting peak water levels of 7.1 feet inboard of the levees.

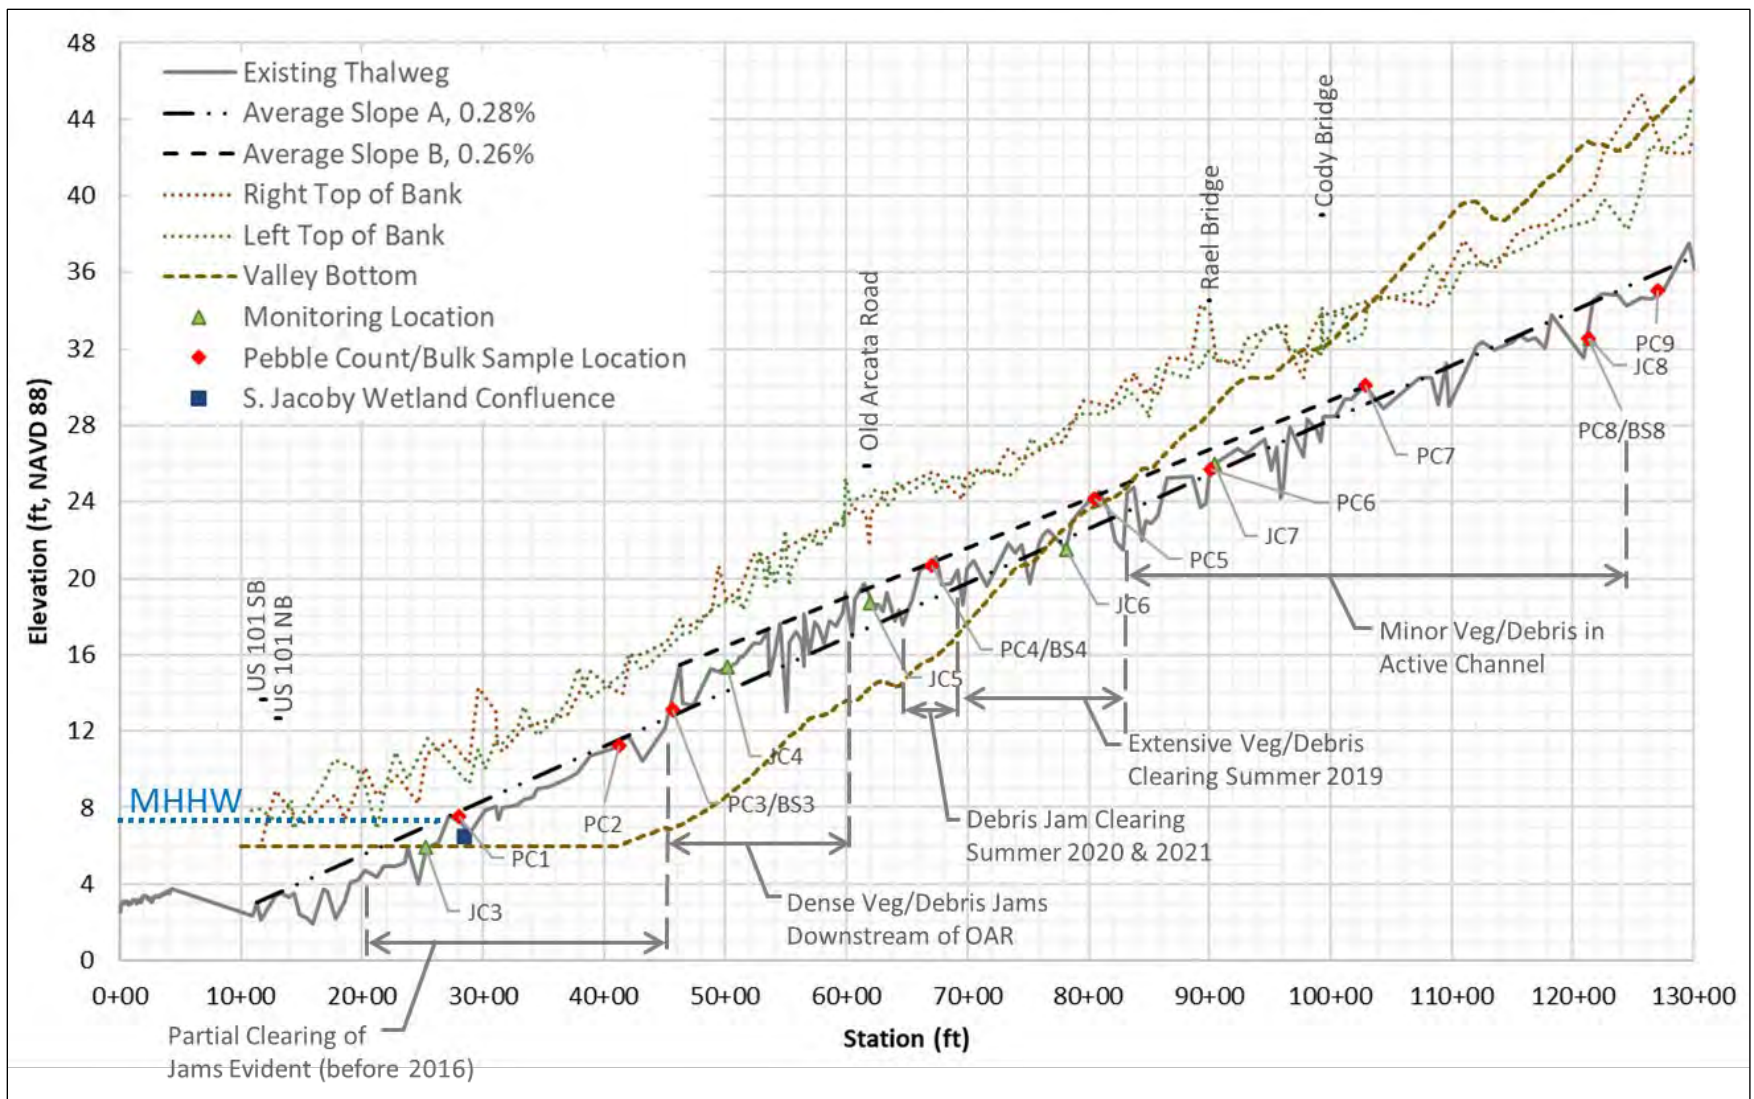
Figure 7-2. Jacoby Creek thalweg and top of bank profile from 2021 with locations of water level gages and sites of pebble counts (PC) and bulk samples (BS) of streambed material. The average overall channel slope (A) of 0.28% and locally aggraded slope (B) are plotted on the profile along with noted in-channel vegetation conditions and debris accumulations are noted.

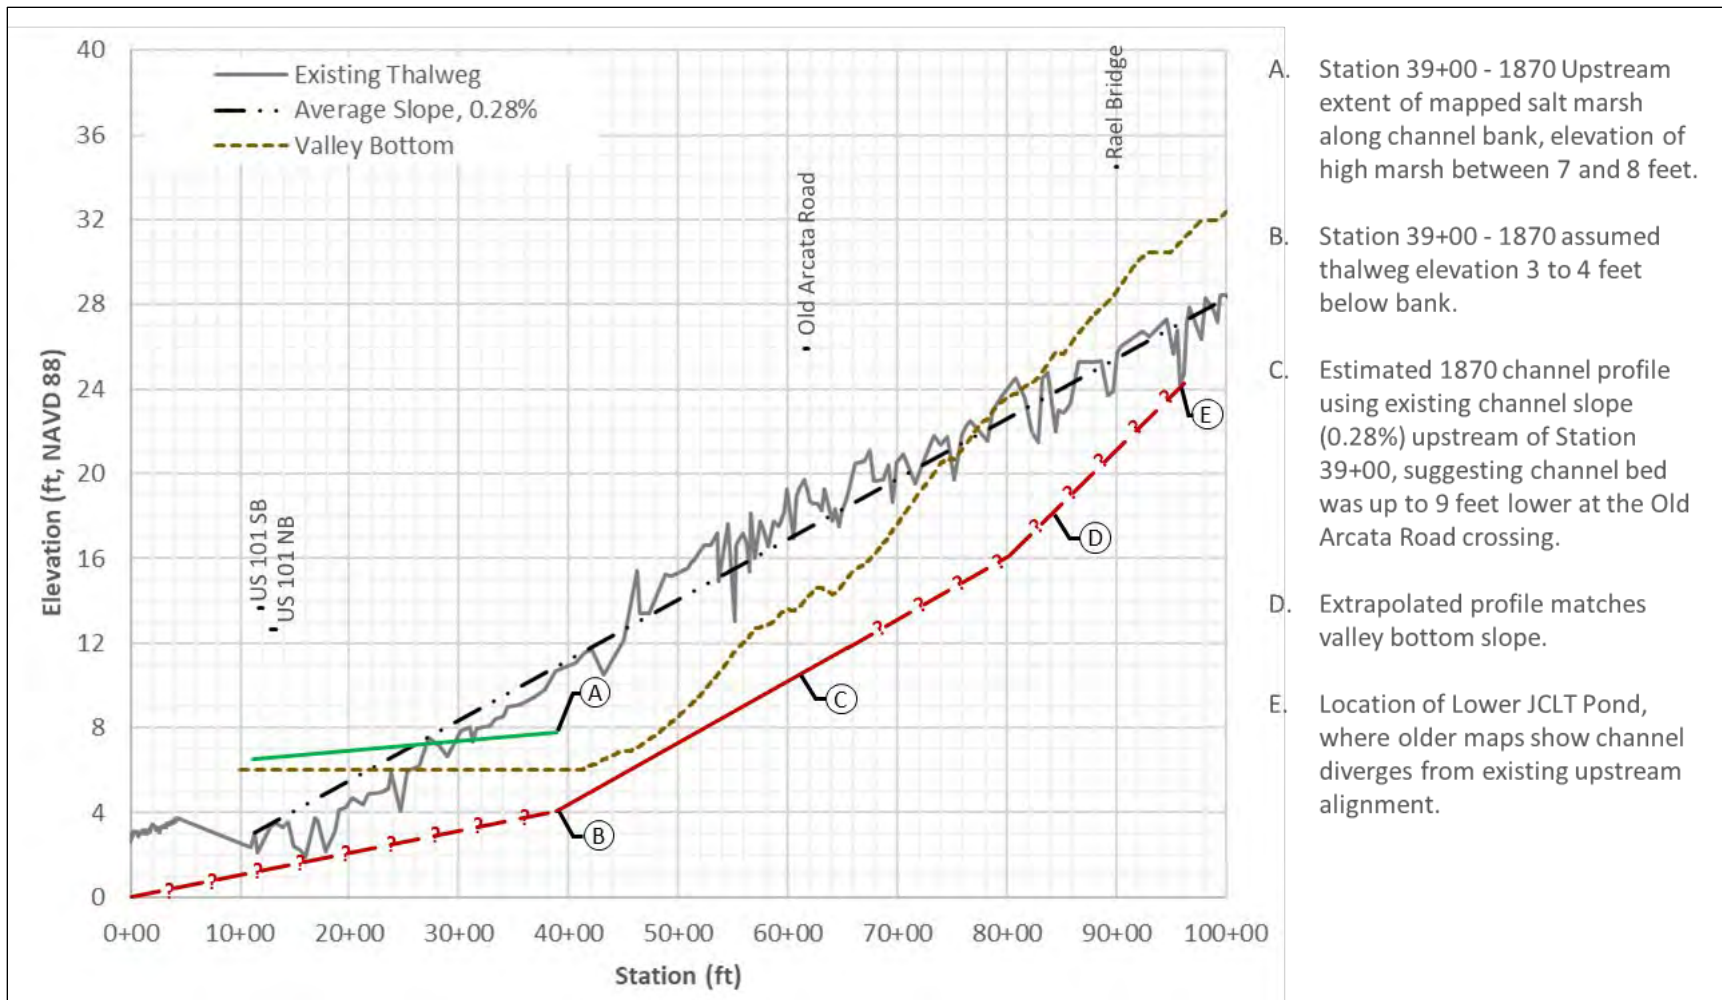
Figure 7-3. Estimated historical channel profile prior to diking along Jacoby Creek, based on 1870 USCS map and slope of present-day channel and valley.

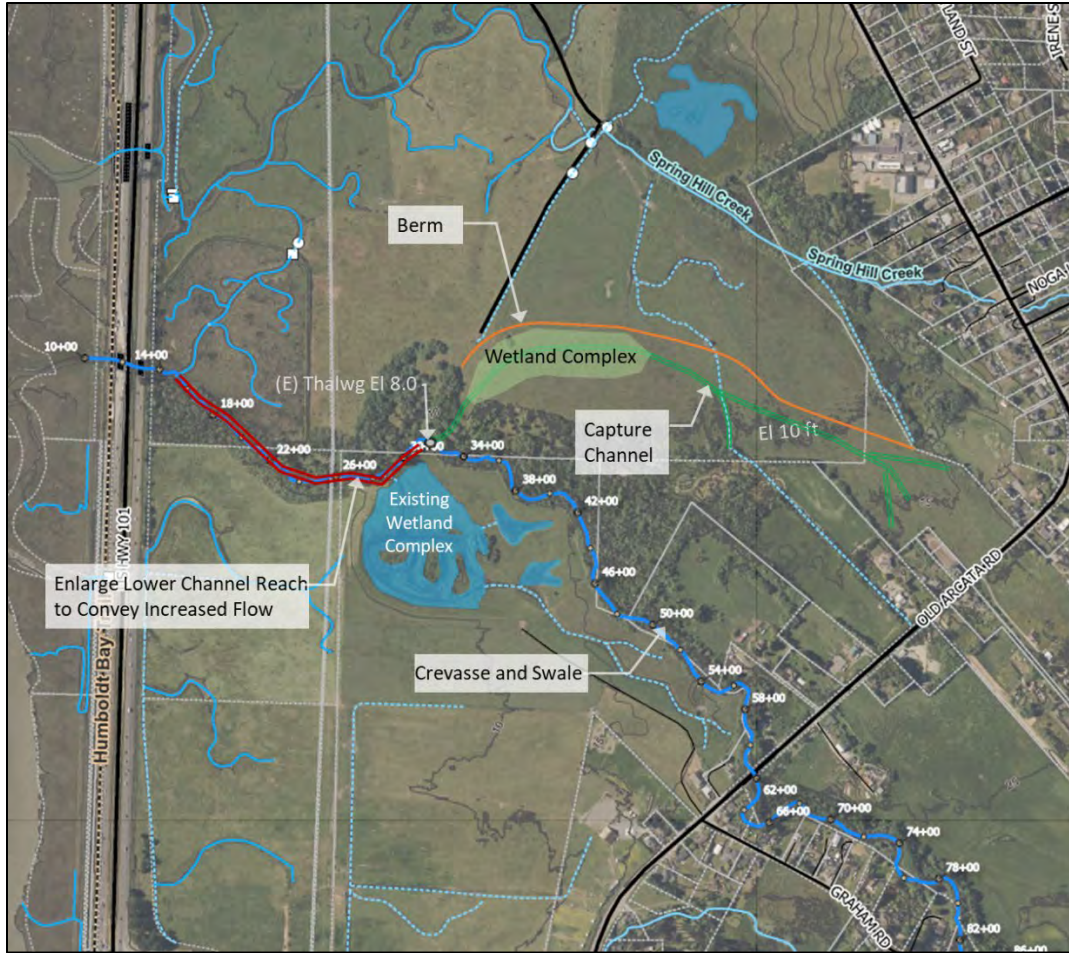
Figure 9-2. Baylands Approach 2 - Capture channel and freshwater wetland.

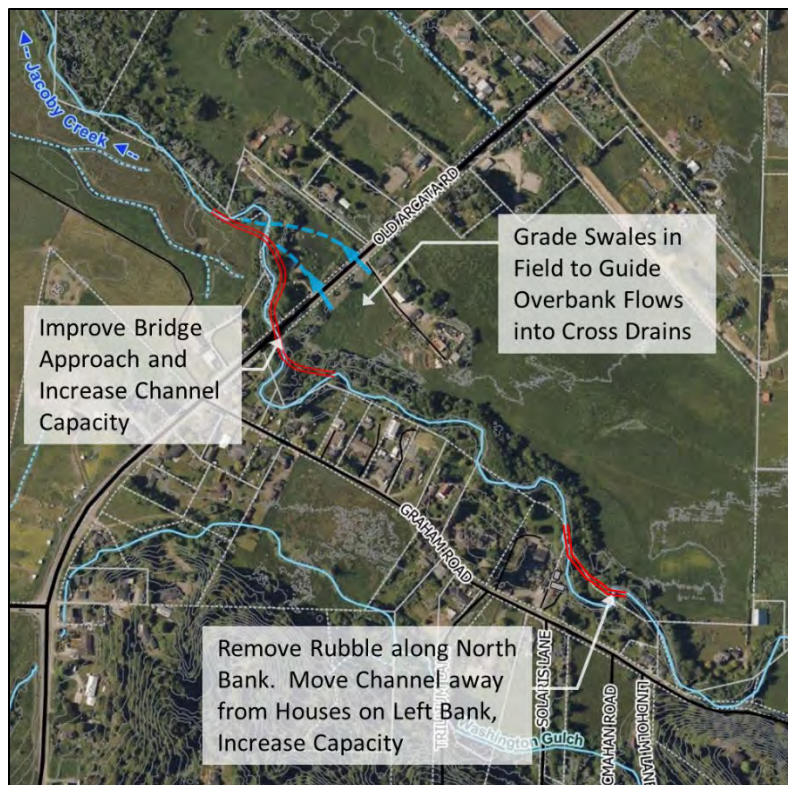
Figure 9-4. Upstream of Baylands 2 -Channel realignment at bridge and upstream meander.
