Table D-1. Summary of Hazard Scenarios

Tidal Hydraulics, Wind, Sea Level Rise, Resource Response and Impacts

HAZARD SCENARIO 1

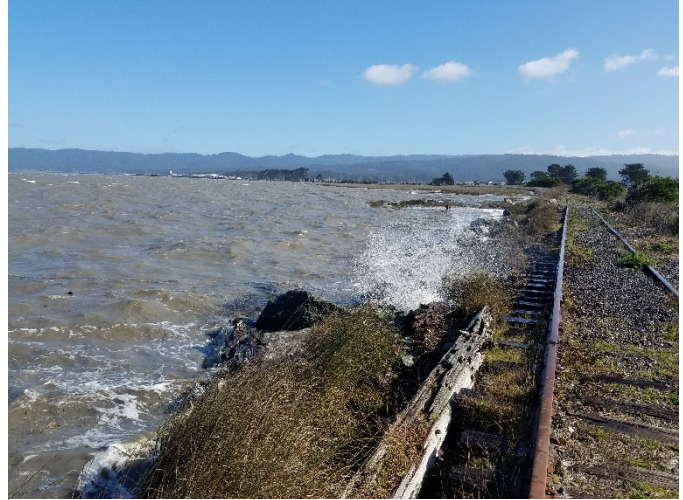
Example King Tide with Wind Wave Runup on Rail Prism

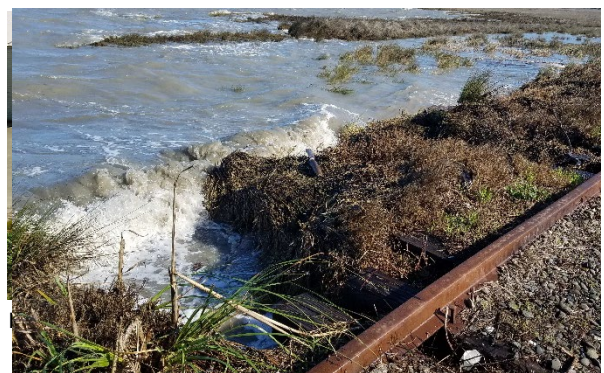
Wave-induced Lateral Erosion along Rail Prism.

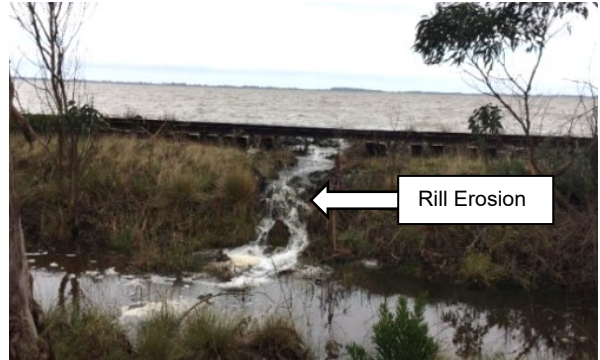
Overtopping Flow at Lowest Point of Rail Prism

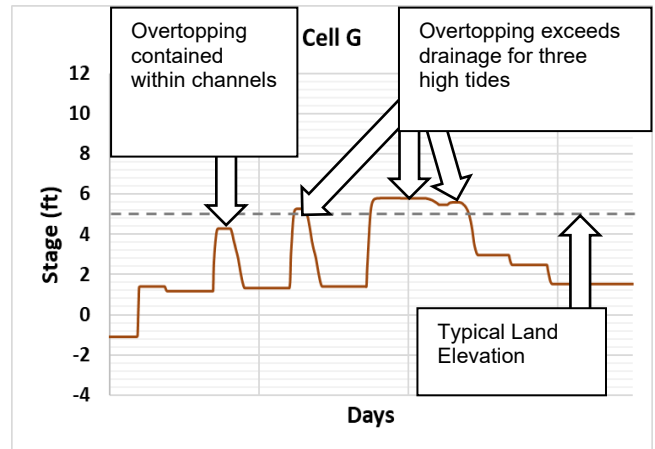
Example Hydrograph of Flooding within Cell

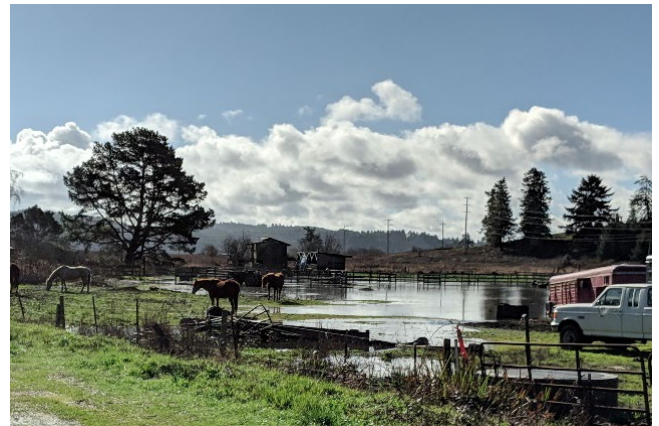
Example Shallow Flooding of Agricultural Lands

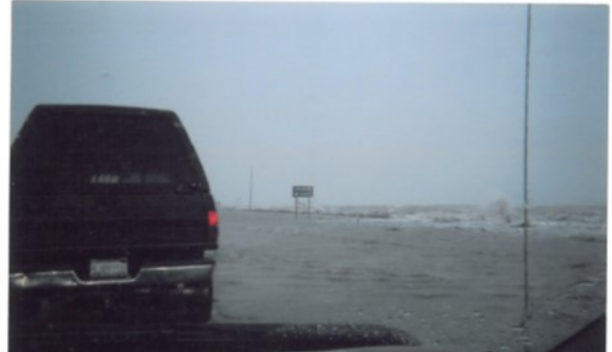
Photo of December 31, 2005 storm from Highway 101 Southbound.

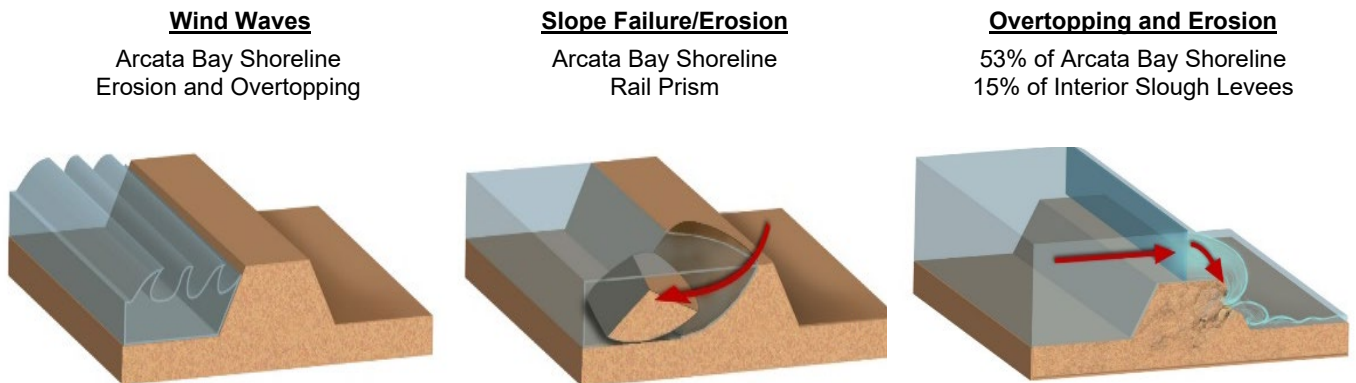
Highlighted shoreline processes in this scenario include wave erosion, slope failure/erosion of bay- and slough-facing slopes, and overtopping with land-facing slope erosion. Conceptual examples shown below.

Example Shoreline Structure Responses (National Science Foundation, 2020)

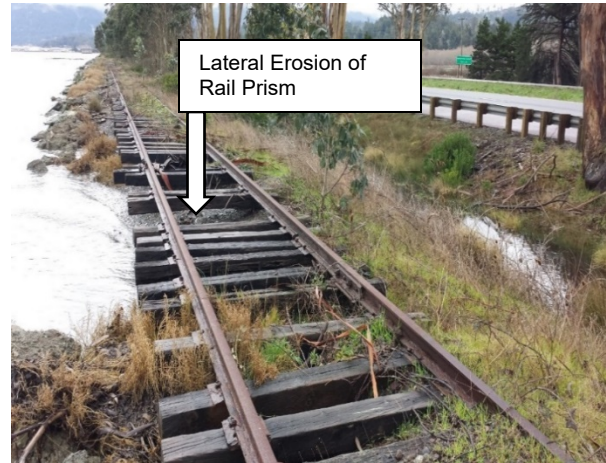
Example Wave-Induced Erosion of Rail Prism Resulting in Displacement of Ballast and Undermined Tracks

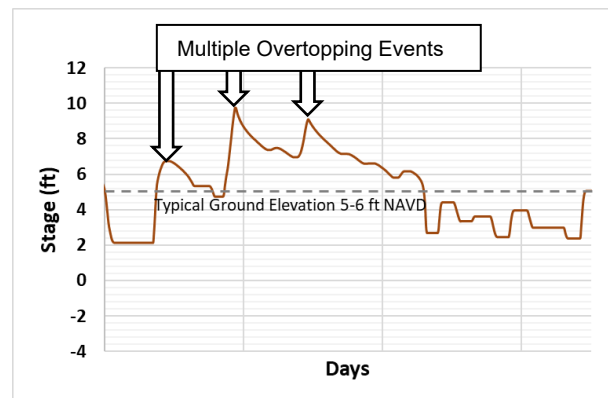
Example Multiple Overtopping Events

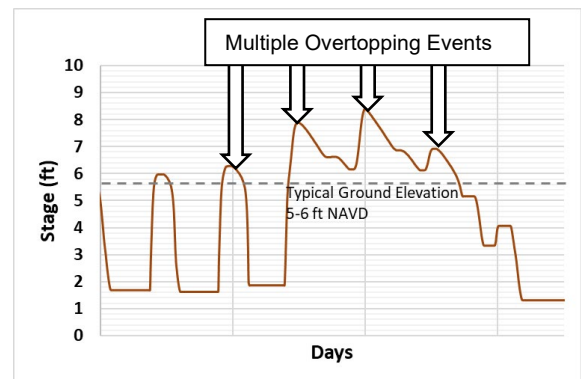
Multiple Overtopping Events Occur in Most Cells

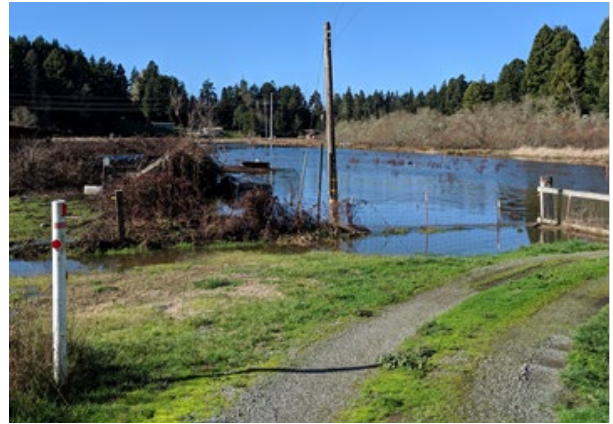
Example Inundation of low-lying lands

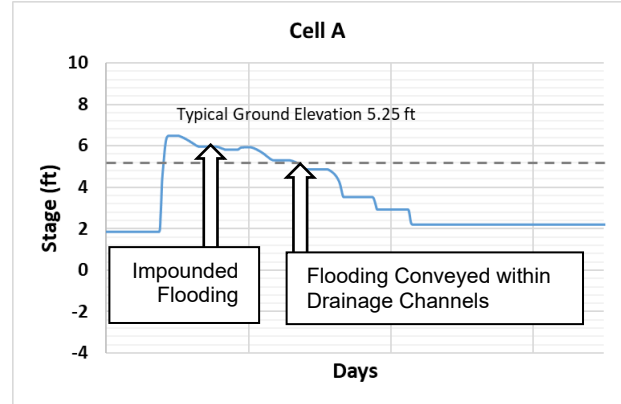
Overtopping Events, Followed by Stalled Drainage

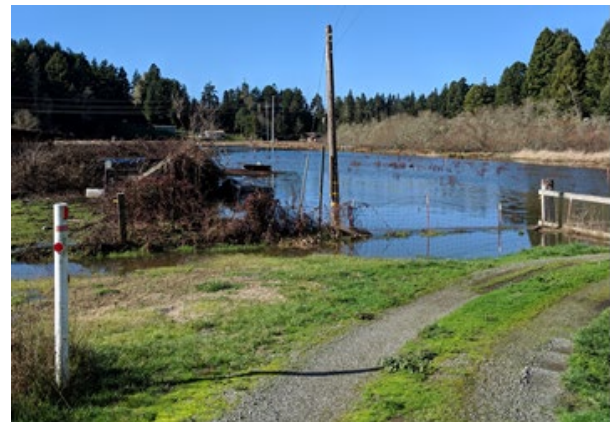
Example Inundation of low-lying lands

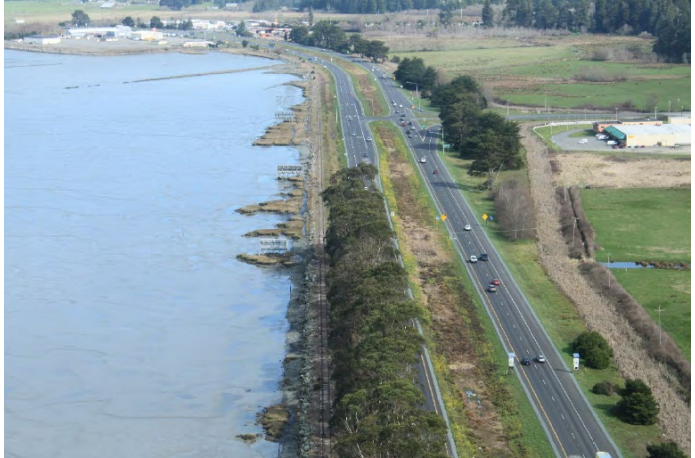
The Planned Humboldt Bay Trail South will Increase the Elevation and Improve Rock Slope Protection Along the Bay Shoreline.

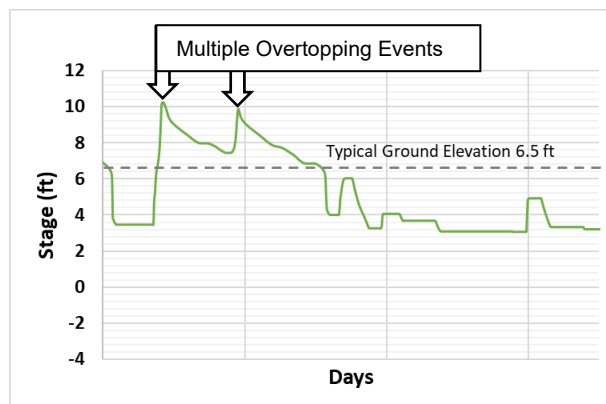
Multiple Overtopping Events

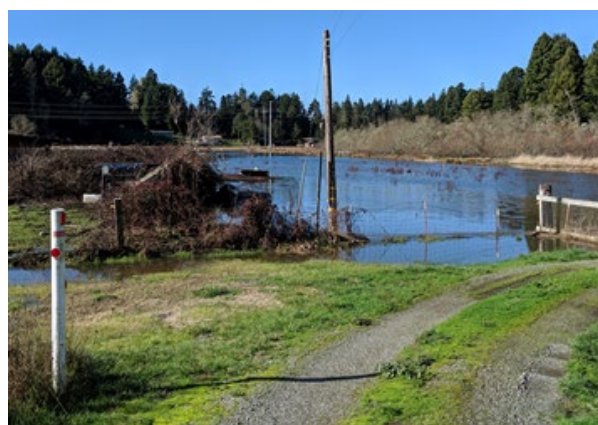
Example Inundation of low-lying lands

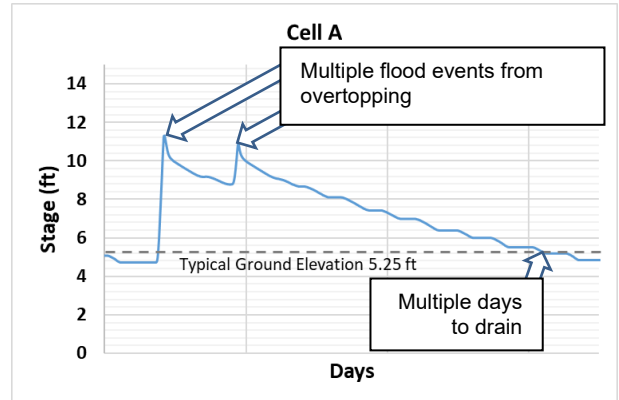
Multiple Overtopping Events, Followed by Multiple Days to Drain the Protected Lands

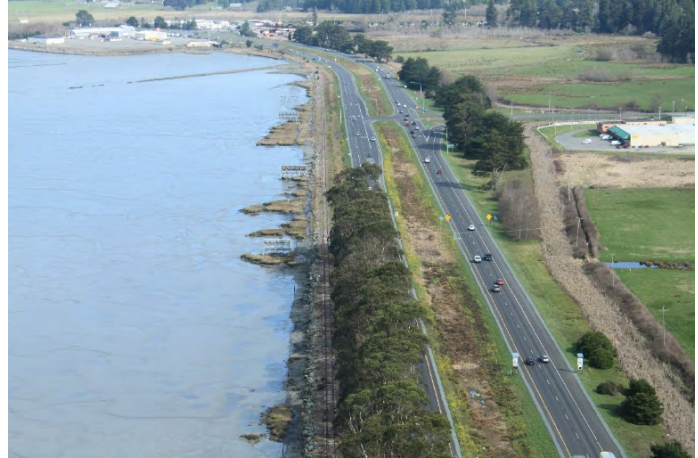
The Planned Humboldt Bay Trail South will Increase the Elevation and Improve Rock Slope Protection Along the Bay Shoreline.

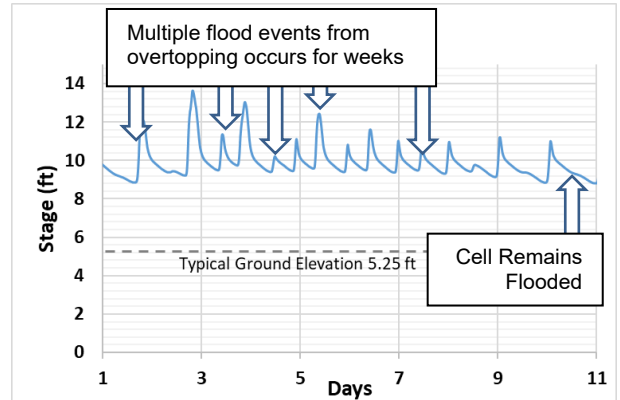
Multiple Overtopping Events, Followed by Multiple Days to Drain the Protected Lands

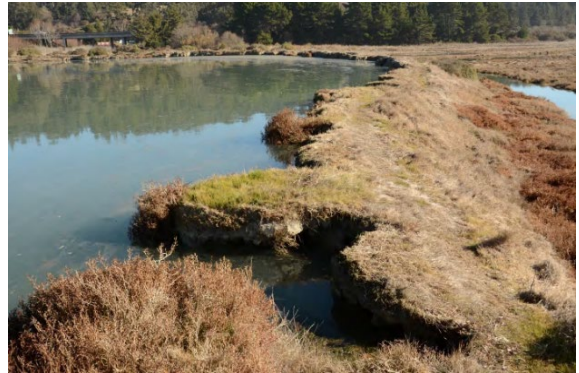
Example Levee Crest Erosion from Overtopping
(Laird, 2013)

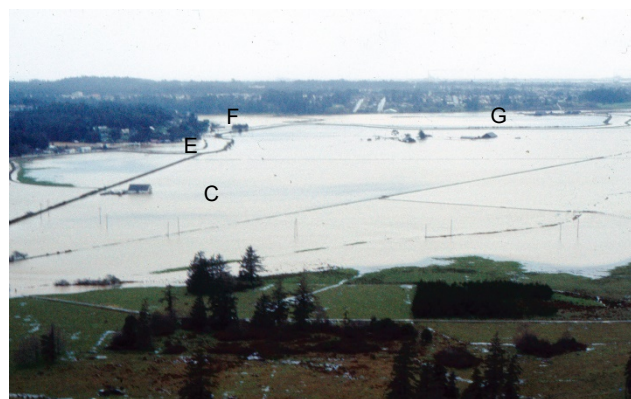
Example Flooding of Cell C, E, F and G Similar to the Modeled 10-year Fluvial Event

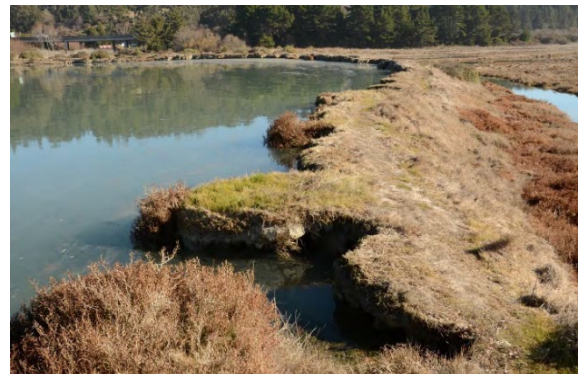
Example Levee Crest Erosion from Overtopping

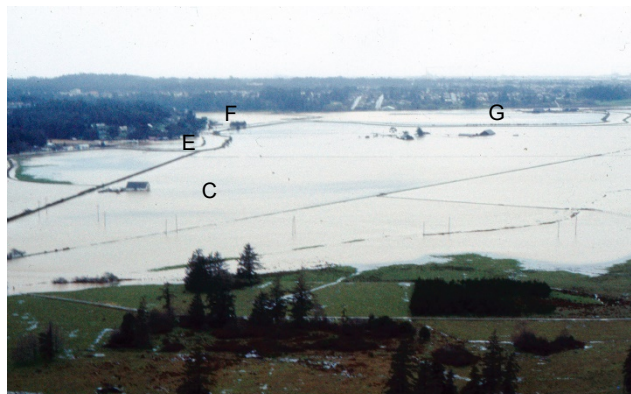
Example Flooding of Cell C, E, F and G Similar to the Modeled 10-year Fluvial Event
