## Jacobs Avenue Levee: Preliminary Needs Assessment

March 1, 2021

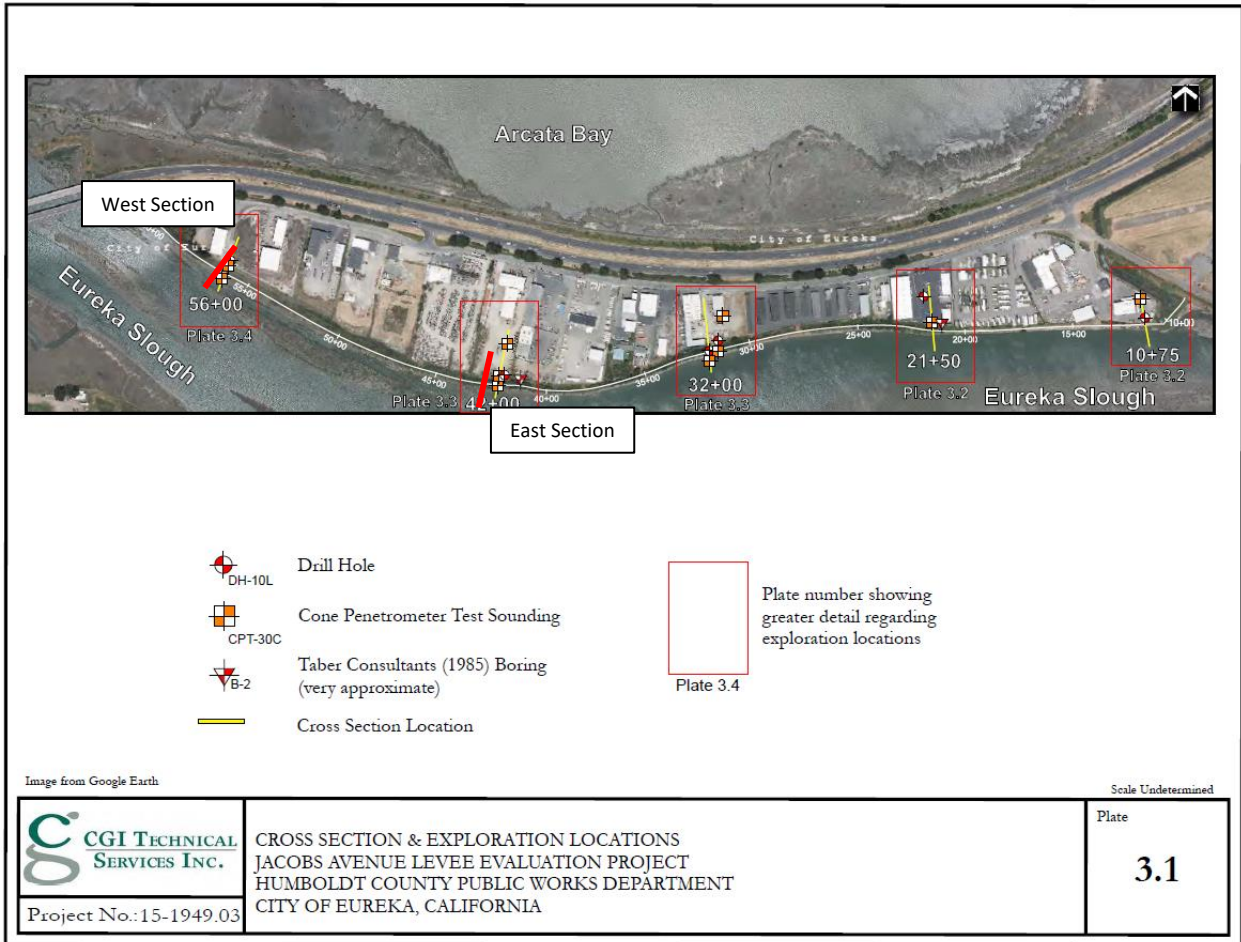
**Figure 8. Location of Analysis Sections**

Slope stability and seepage were analyzed for levee cross sections near the CGI borings and are shown on Figure 8. These sections are representative of the west and east sections.

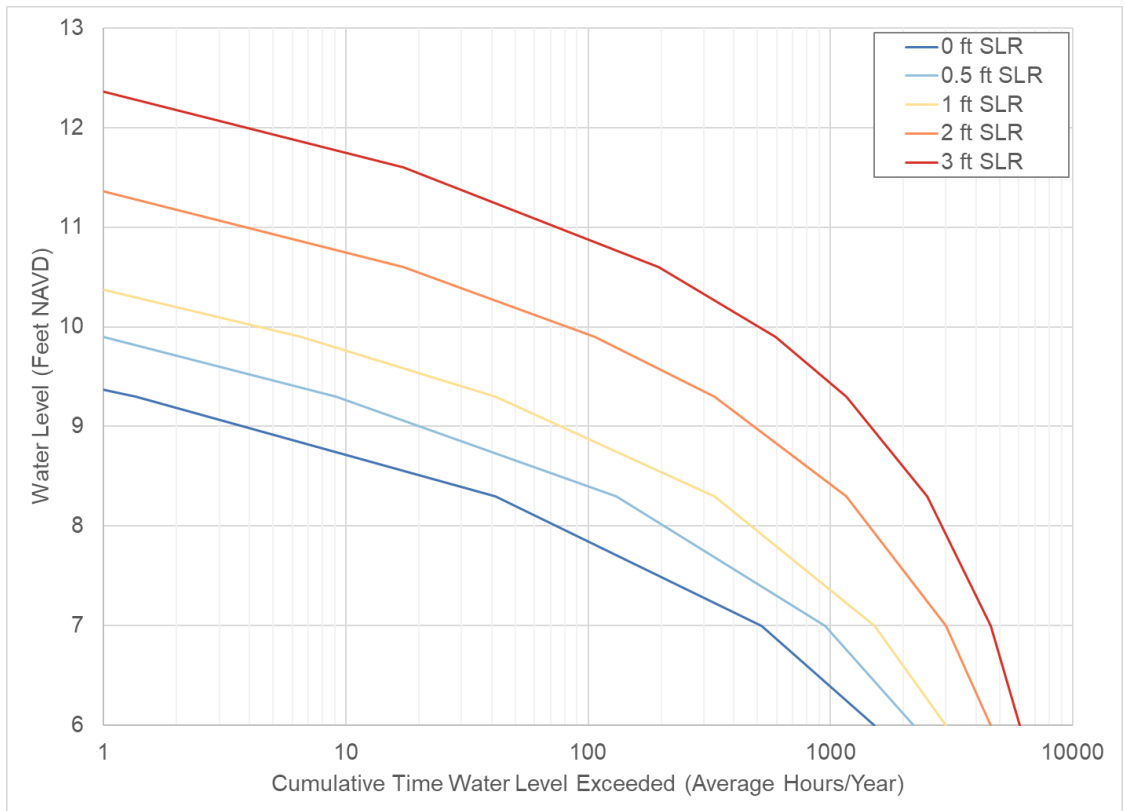
**Figure 13. Cumulative amount of time water levels exceeded in a year at Jacobs Avenue levee**

Sea level rise will increase all water levels throughout the tidal cycle, resulting in increasing water level datums, groundwater elevation, and the frequency of extreme events. The western levee segment begins to overtop at tidal water levels between 9.9 and 10.6 feet, which have a 10-yr and 100-yr recurrence or 10% and 1% chance of occurring in any given year, respectively. With one foot of sea level rise, the annual chance of occurrence is increased to 99% and 50% chance of occurring in any given year. Sea level rise will also increase the number of hours that a given water level is exceeded (Table 2.3 and Figure 13). Based on measured water levels at the North Spit from 1978 to 2020, tidal still water levels have not overtopped the levees. With two feet of sea level rise, an estimated 17 hours of overtopping would be expected per year. The duration of overtopping increases to 195 hours with three feet of sea level rise. Local wind effects may increase these peak water levels and duration of overtopping. Increases in water level datums will diminish the duration of favorable hydraulic conditions for drainage, resulting in an increased duration of flooding of the landward side of the levee during typical winter conditions and following overtopping events. Increasing
